## LKK Auto Consultants Pte Ltd

## ADJUSTMENT ON REPAIR COST FOR VEHICLE NO. GBD 7937G

### PHOTOGRAPHS FOR VEHICLE NO. GBD 7937G

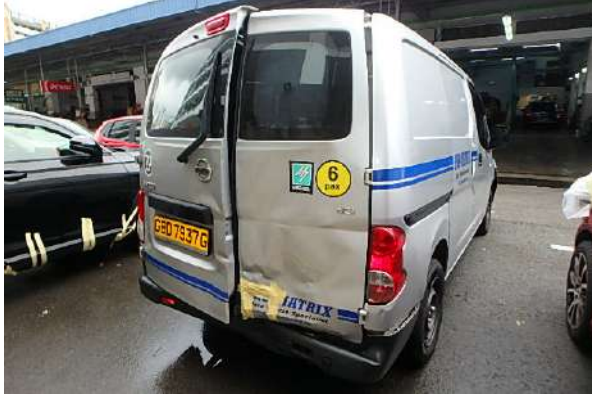
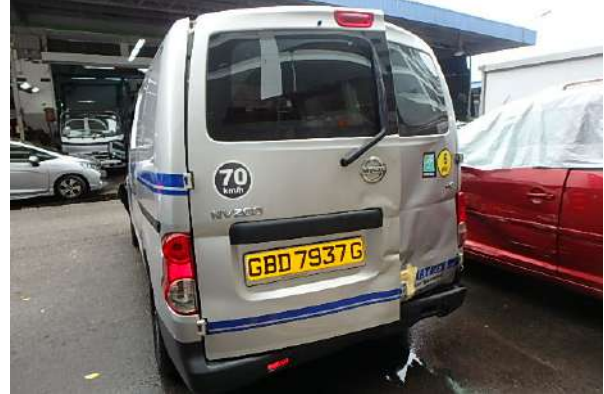
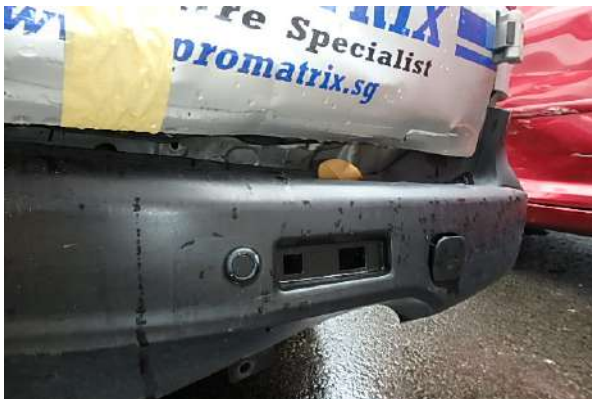
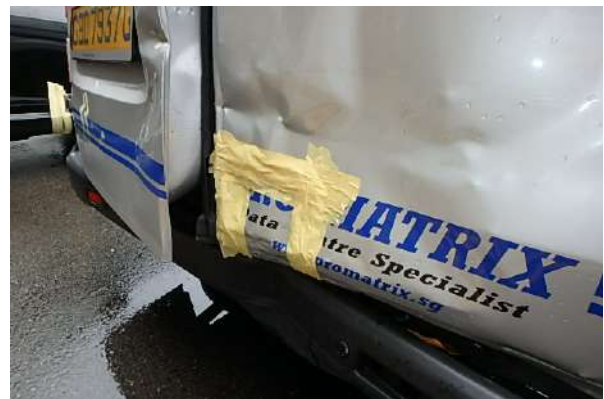
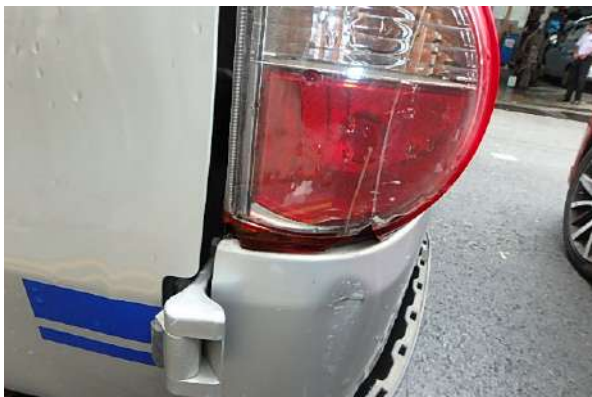
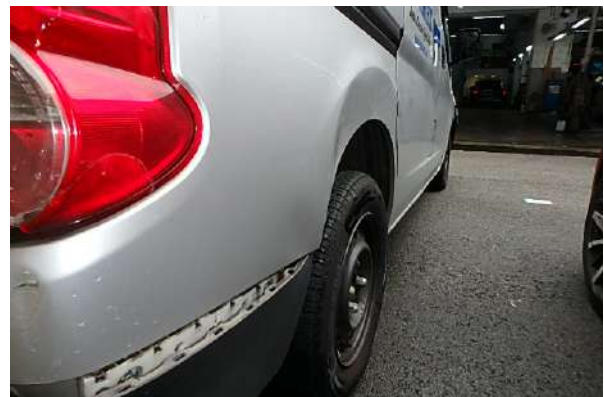
| Affiliated to Federation Internationale Des Experts En Automobile | | | | |
|---|---|---|---|---|
| | THE VEHICLE SUSTAINED DAMAGES AT THE FRONT AND REAR PORTION.<br>DAMAGES SEE DETAILS. | | | |

### INSPECTION
