## LKK Auto Consultants Pte Ltd

Vehicle No. GBC 8051K  
Insured Veh. PA 8146R  
Claim No. SNM22D203343C02  
Policy No.  
Accident Date 06/05/2022  
Inspection Date 17/05/2022

## ADJUSTMENT ON REPAIR COST FOR VEHICLE NO. GBC 8051K

### PHOTOGRAPHS FOR VEHICLE NO. GBC 8051K

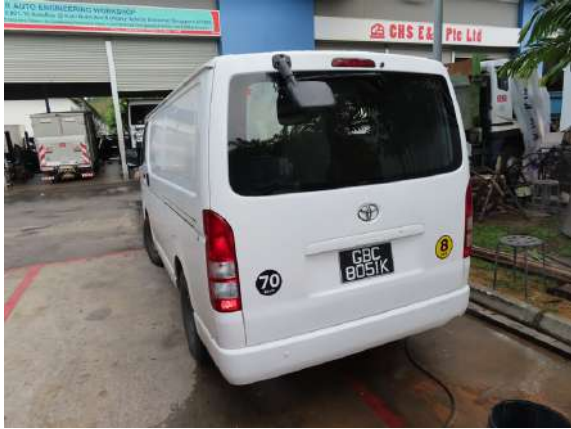
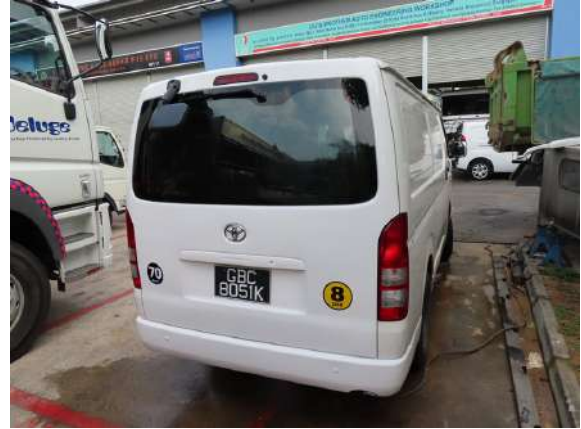
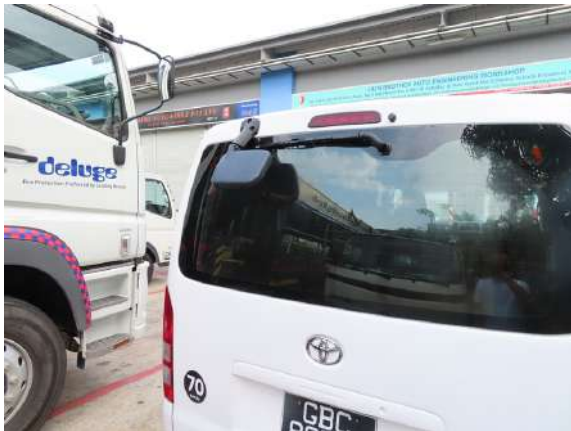
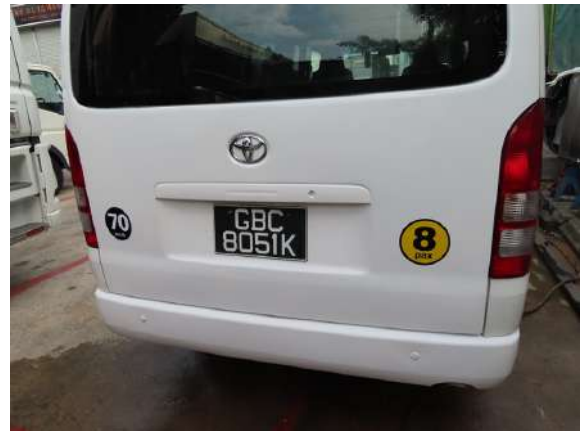
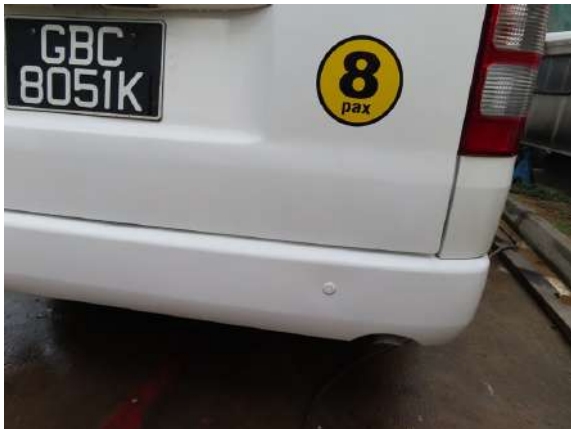
### RE-INSPECTION

### PHOTOGRAPHS FOR VEHICLE NO. GBC 8051K

| Affiliated to Federation Internationale Des Experts En Automobile | | | | |
|---|---|---|---|--|
| THE VEHICLE SUSTAINED DAMAGES AT THE REAR PORTION & REAR WINDSCREEN SHATTERED.<br>DAMAGES SEE DETAILS. | | | | |
