## LKK Auto Consultants Pte Ltd

Affiliated to Federation Internationale Des Experts En Automobile				
LONPAC INSURANCE BHD 300 BEACH ROAD #17-04/07 THE CONCOURSESINGAPORE 199555			Ref: CC4/LPC22004665/Kpa3q2 Date: 27/07/2022 Code: LPC2	
<b>1. Policy Particulars :- THIRD PARTY CLAIM</b>				
Insured Veh.	GBD 2314L	Veh. Inspected	GBF 5485X	
Policy No.	Z21VC05007844	Coverage (\$)	0.00	
Claim No.	21/22/22/VC05/025745	Excess (\$)	0.00	
Assign From	GERALD	Assign Date	18/05/2022	
<b>2. Vehicle Particulars &amp; Condition</b>				
Make & Model	TOYOTA HIACE (M)	c.c	2982	
Engine No.	HIDDEN	Year of Reg.	2016	
Chassis No.	JTFHT02P900209071	Colour	YELLOW	
Odometer	162749 KM	Steering	IN ORDER	
Brakes	IN ORDER	Modification	NIL	
General	GOOD			
<b>3. Conditions of Tyres</b>				
	Size	Make	Balance	
R/H Front Tyre	195 R15X8	GRENLANDER	9 mm	
L/H Front Tyre	195 R15X8	GRENLANDER	9 mm	
R/H Rear Tyre	195 R15X8	GRENLANDER	9 mm	
L/H Rear Tyre	195 R15X8	GRENLANDER	9 mm

## ADJUSTMENT ON REPAIR COST FOR VEHICLE NO. GBF 5485X

### PHOTOGRAPHS FOR VEHICLE NO. GBF 5485X

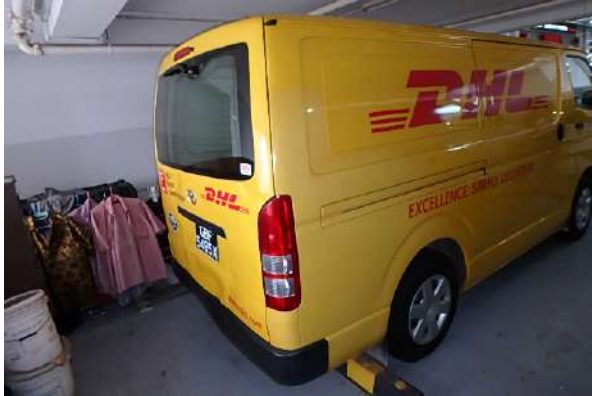
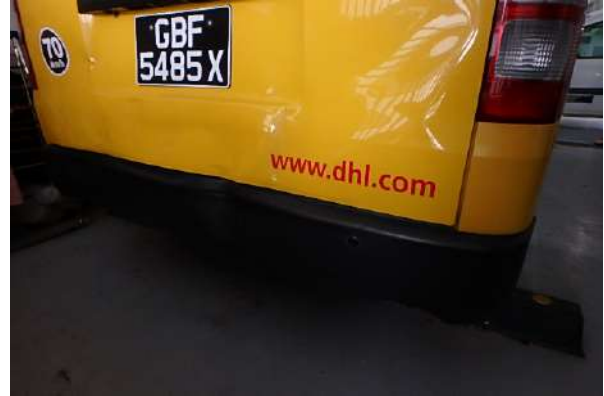
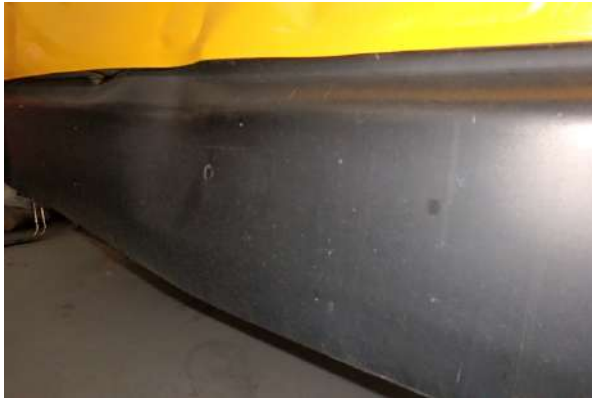
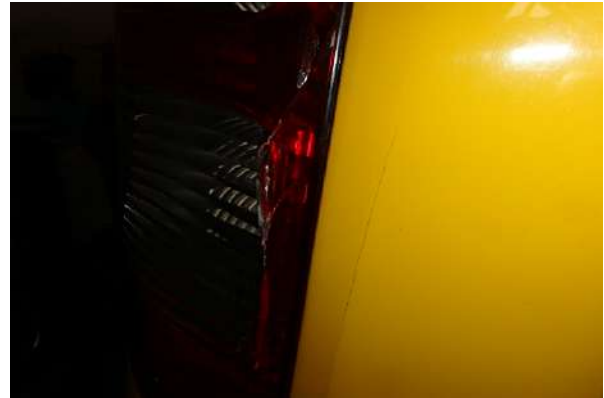
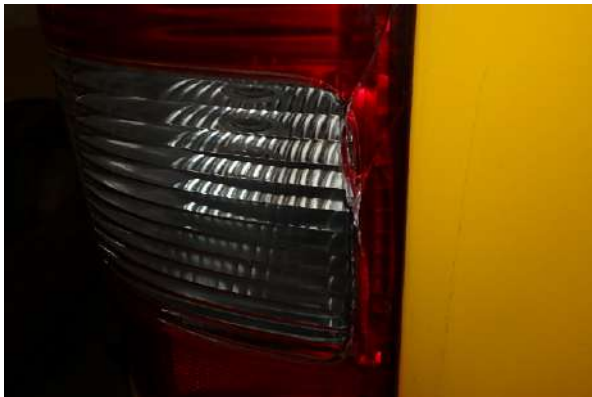
### INSPECTION

<b>4. Description of Damages</b>				
THE VEHICLE SUSTAINED DAMAGES AT THE REAR PORTION. DAMAGES SEE DETAILS.				
<b>5. General Information</b>				
Accident Date	30/04/2022	Inspection Date	19/05/2022	
Survey held at	TONG LUCK AUTO PL 160 SIN MING DRIVE #07-01/06 SIN MING AUTOCITY SINGAPORE 575722			
<b>5a. Remarks</b>				
A)THE INSPECTION WAS CONDUCTED ON A"WITHOUT PREJUDICE" BASIS. B)IN ACCORDANCE TO YOUR INSTRUCTIONS, WE HAVE NOT AUTHORISED REPAIRS.				
<b>5b. Estimate Days of Repair</b>				
ESTIMATED NORMAL PERIOD FOR REPAIR:			6 Working Days

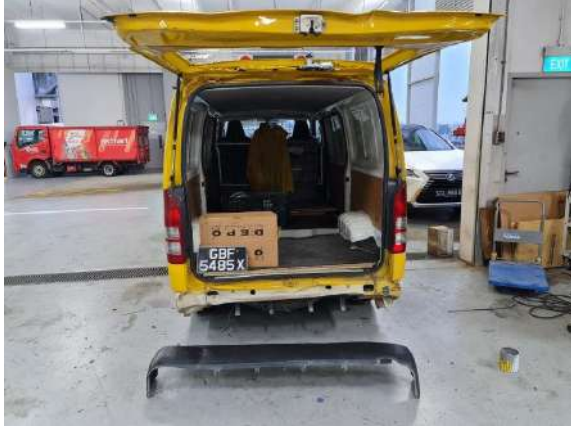
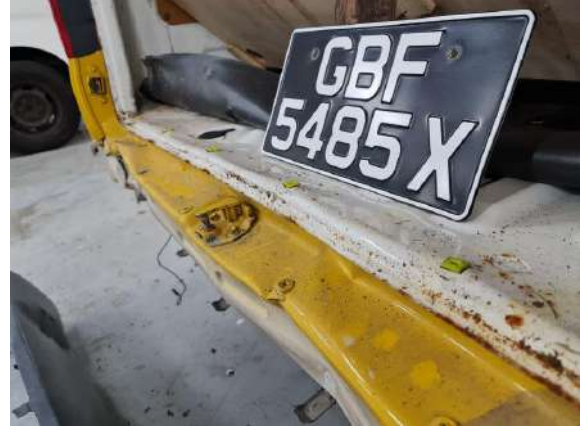
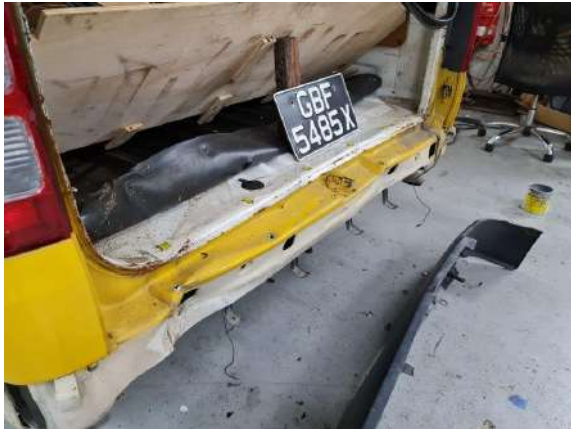
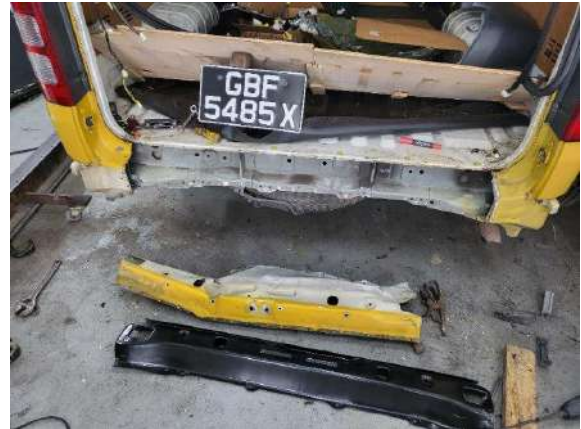
### RE-INSPECTION

### PHOTOGRAPHS FOR VEHICLE NO. GBF 5485X
