KM AUTO ASSESSORS PTE. LTD.

AUTOMOBILE INSPECTION REPORT

NO. 9/3/TP012

Reg. No.	SGC 4844 G	Make/Model	TOYOTA LEXUS GS300 AUTO	Year	2006
Engine No.	3GR0129870	Chassis No.	JTHBG96S005022633	Colour	Dark Grey
Condition of Tyres			Speedometer Reading - Km		
Front N/S	PIRELLI 225/50R17	worn	20	%	126154
Rear N/S	B/STONE 225/50R17	worn	20	%	
As Requested By		YOURSELF		On	19-Mar-19
The Above Vehicle

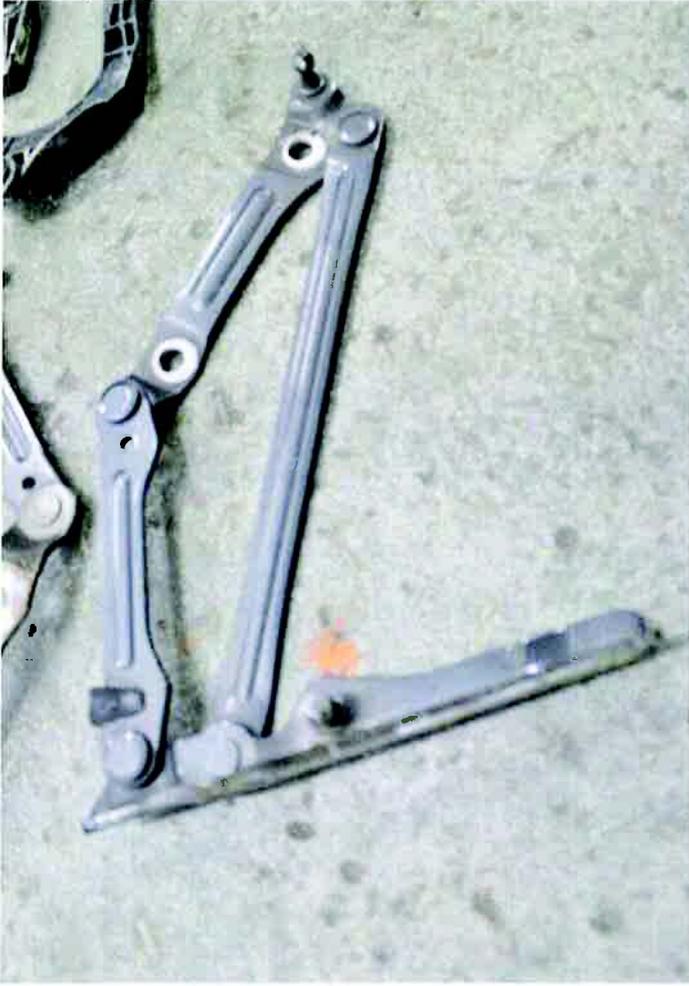
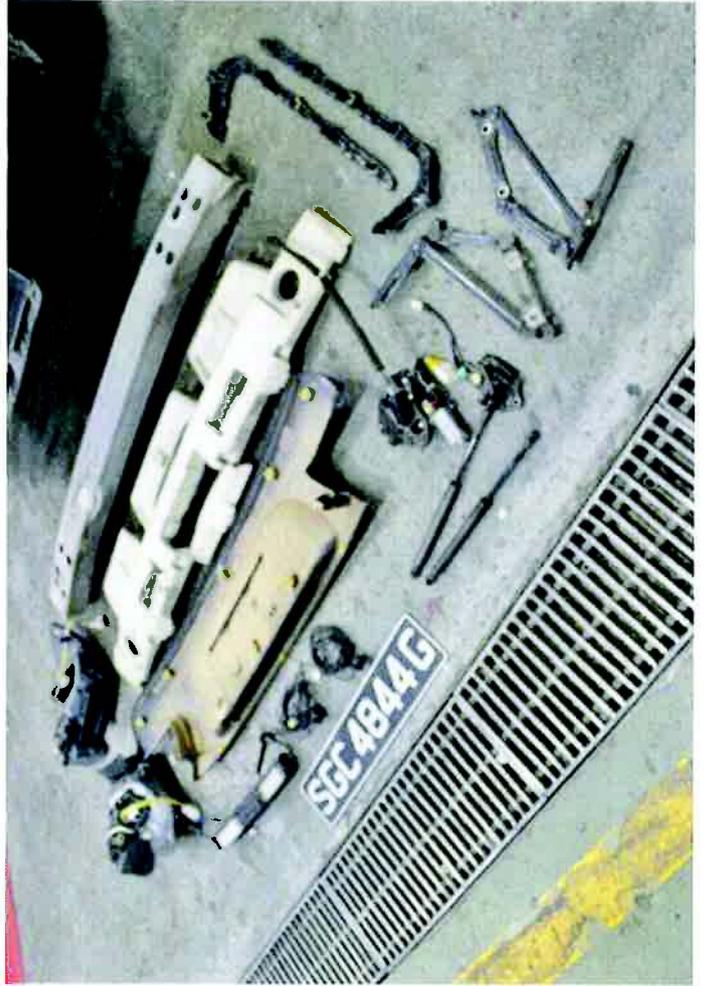
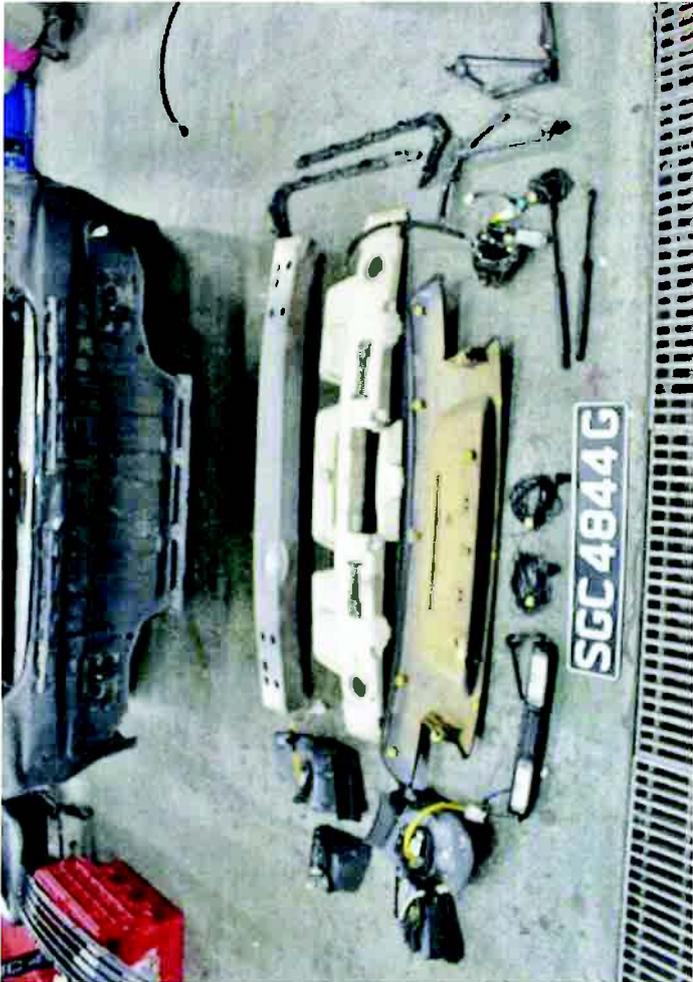
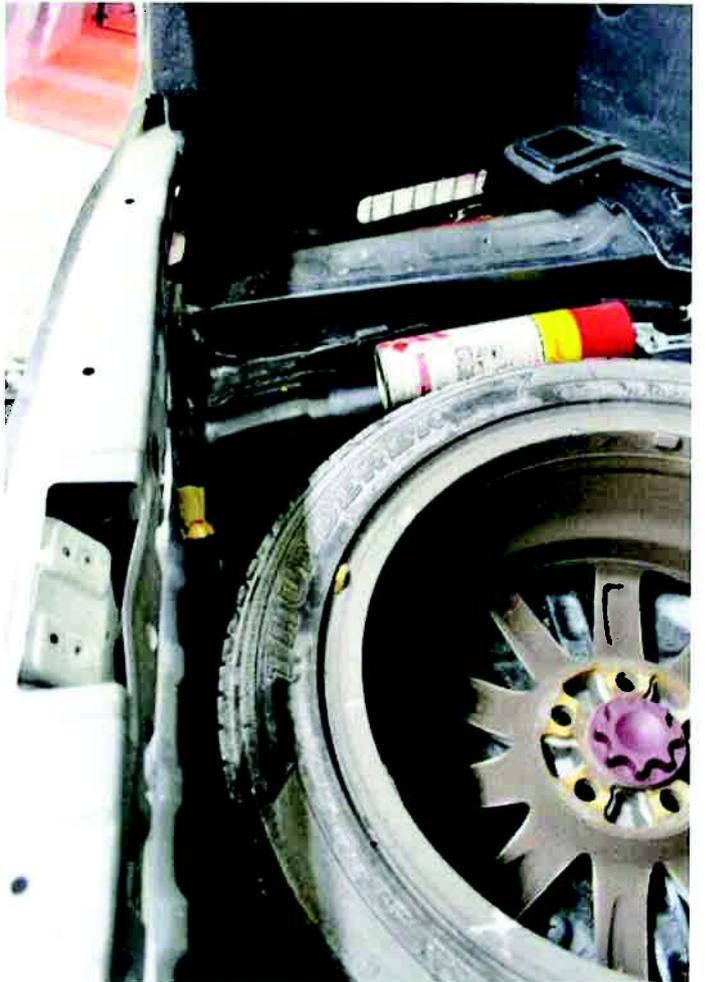
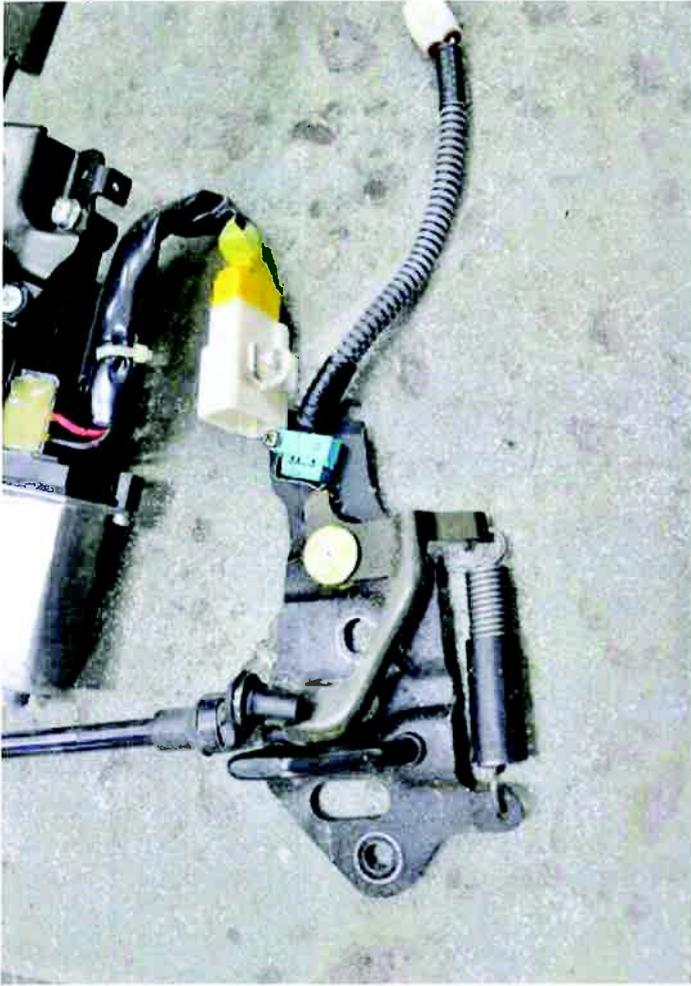
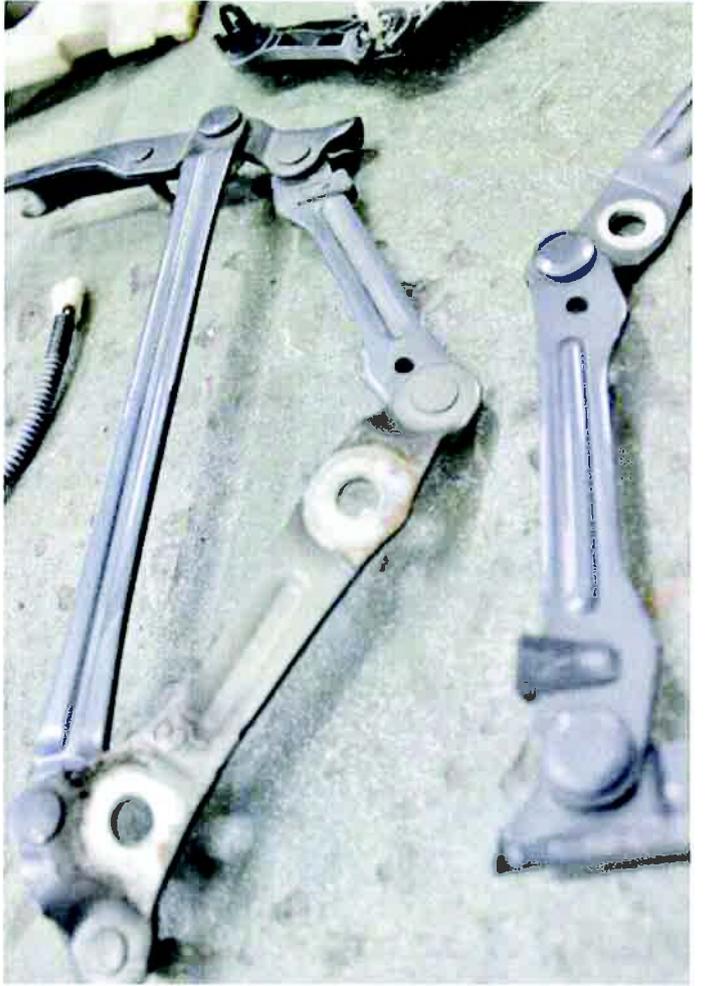
Photographs:- 165 Copies were taken at time of inspection and are attached .

Boot lid dented and bent, inner frame bent, centre garnish dented, bent and deformed, reflectors grazed and dislodged, lock assy. bent and jammed, hinges and dampers bent and stiffened, boot rubber kinked and deformed, rear panel dented and bent, both rear lamps assy. dislodged, fenders bent, bumper assy. grazed, dented, bent, deformed and dislodged, fasteners torn, reverse sensors distorted, exhaust pipes pushed inwards, boot floor panel assy. bent.
