WG APPRAISAL SERVICES

| Vehicle No: | SMT8437L | |

ACCIDENT DAMAGED VEHICLE INSPECTION REPORT

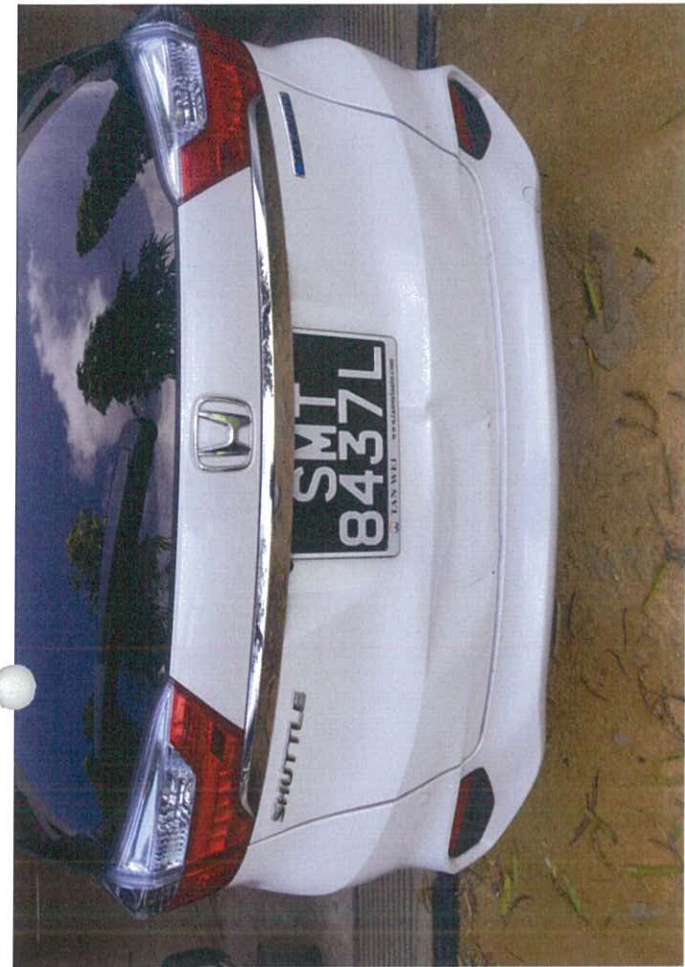
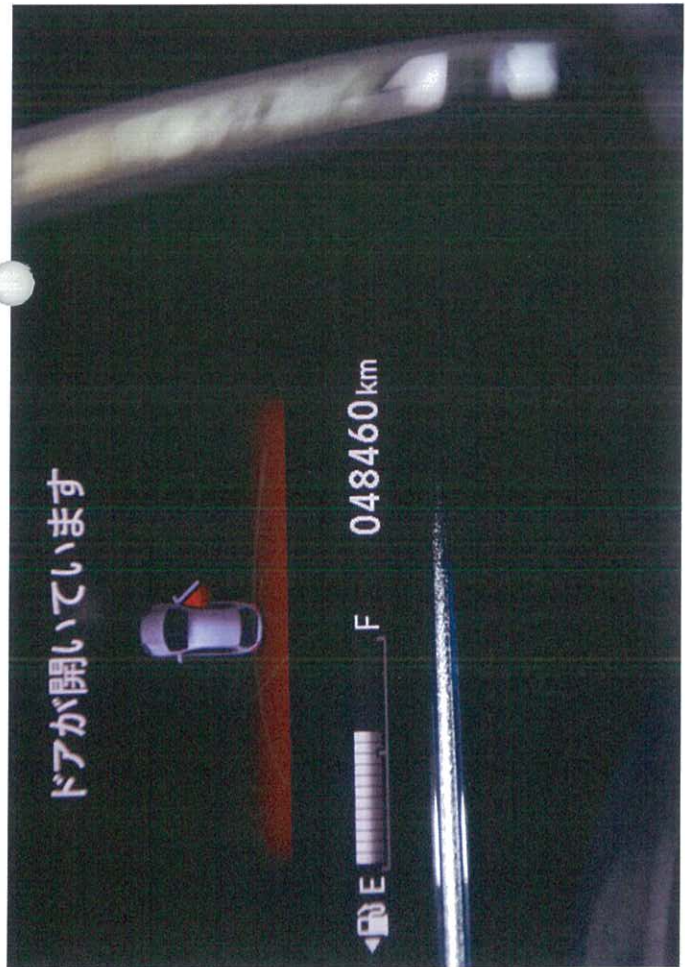
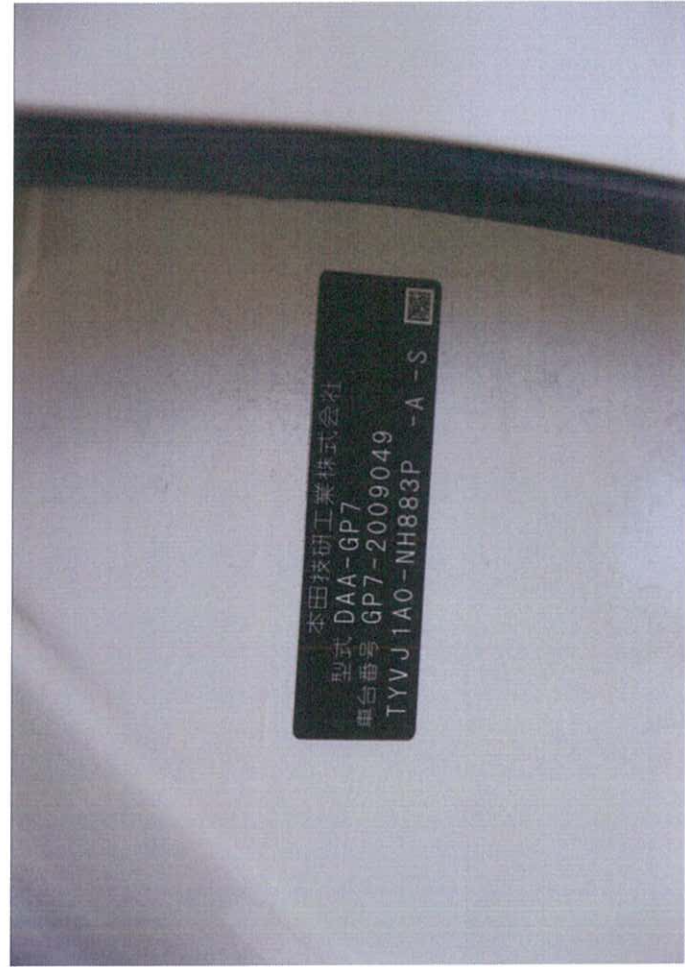
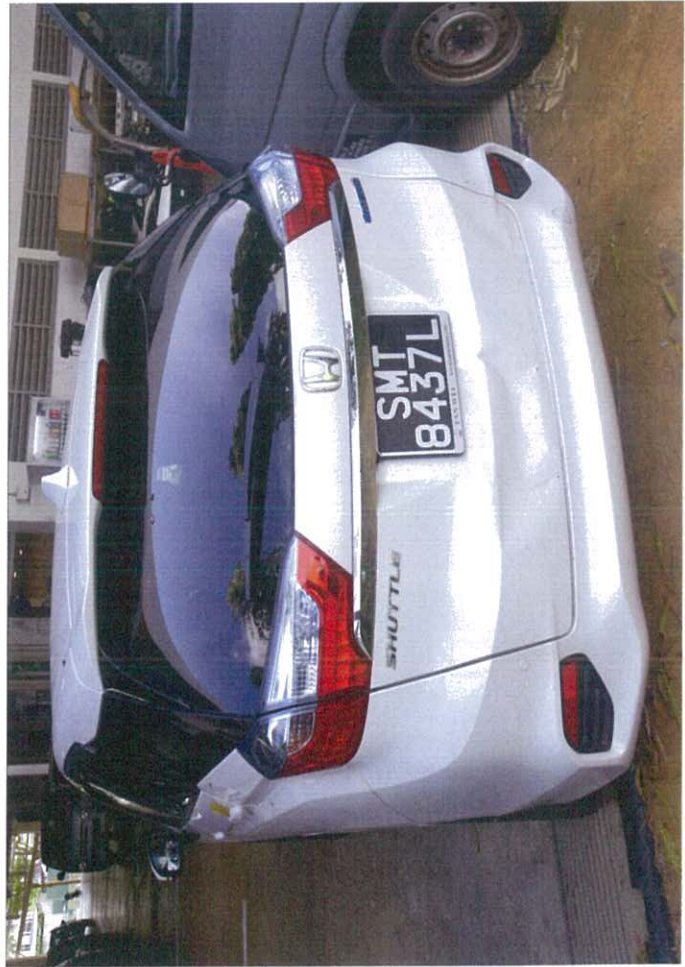
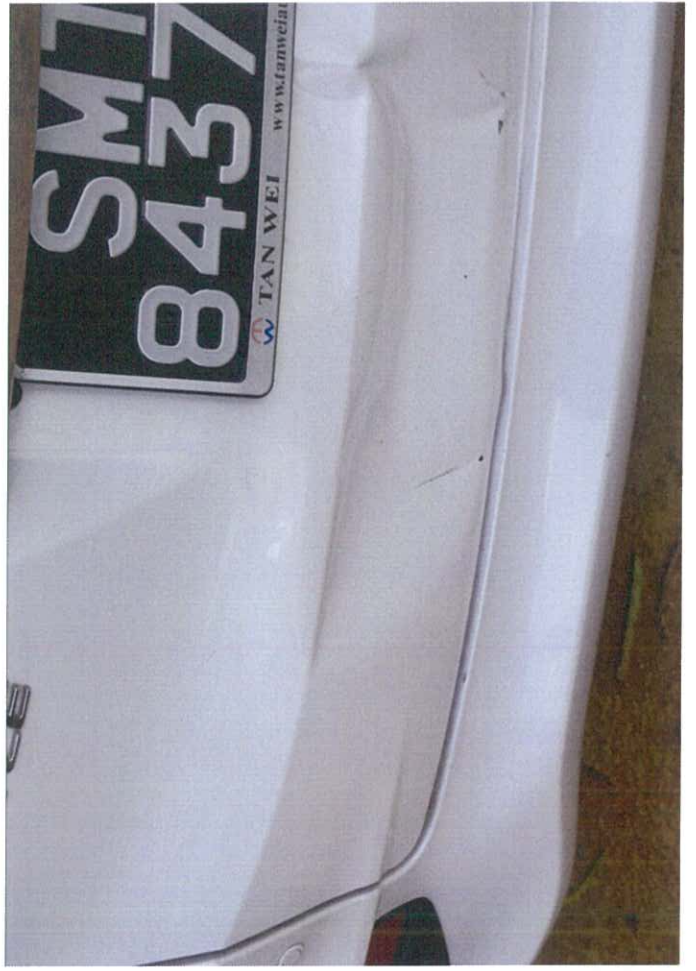
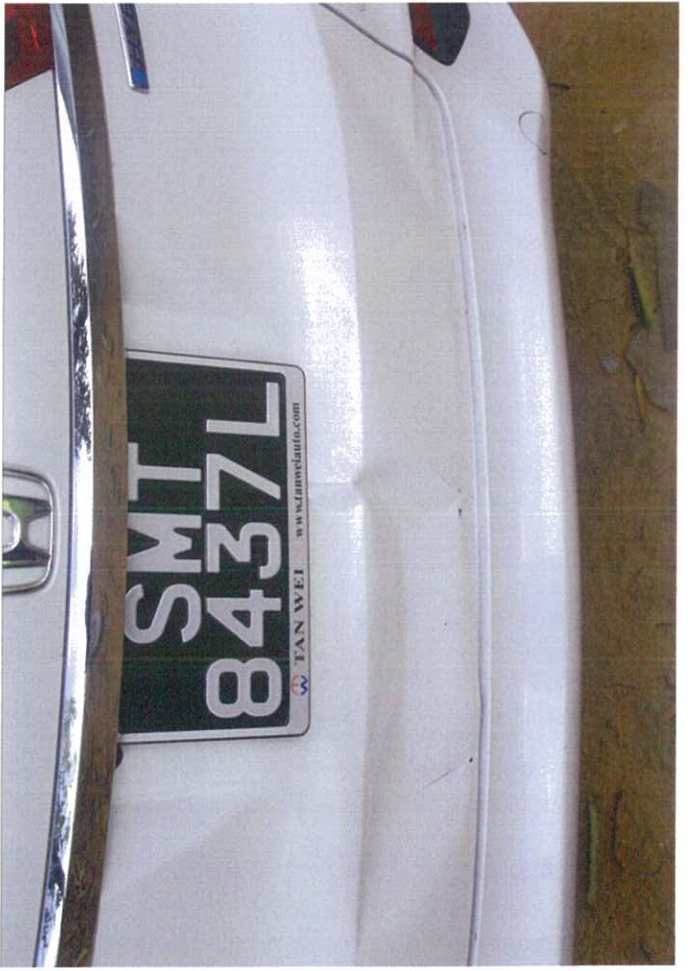
The vehicle sustained damage at the rear portions..
For details, refer to assessment for repairs and photographs attached.

Enclosed Fifty (50) photographs depicting damage to the vehicle.
