## LKK Auto Consultants Pte Ltd

### PROFESSIONAL SERVICE FEE

Vehicle No. SLP 1562L

## ADJUSTMENT ON REPAIR COST FOR VEHICLE NO. SLP 1562L

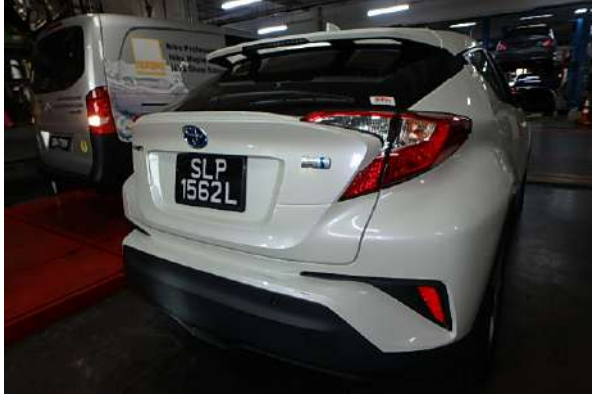
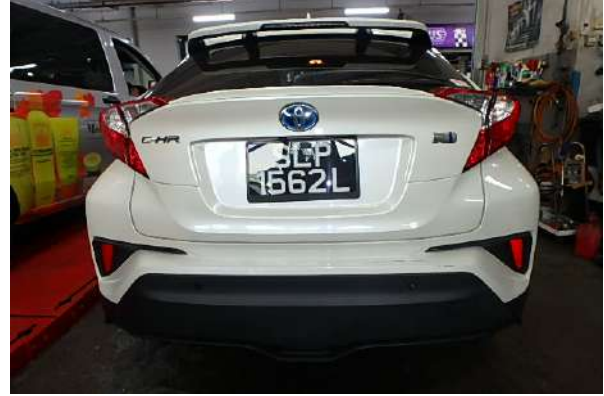
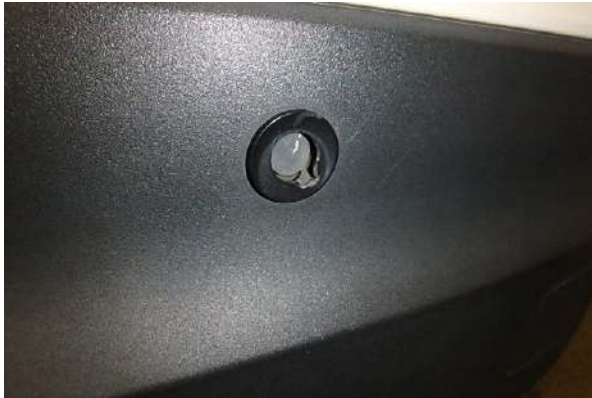
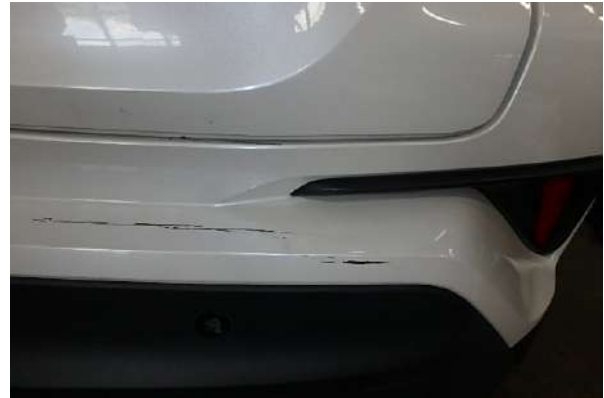
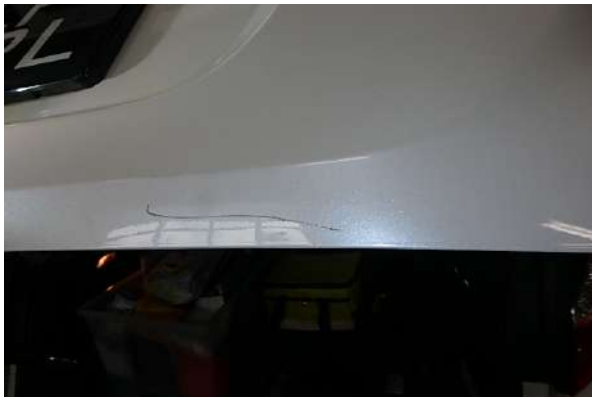
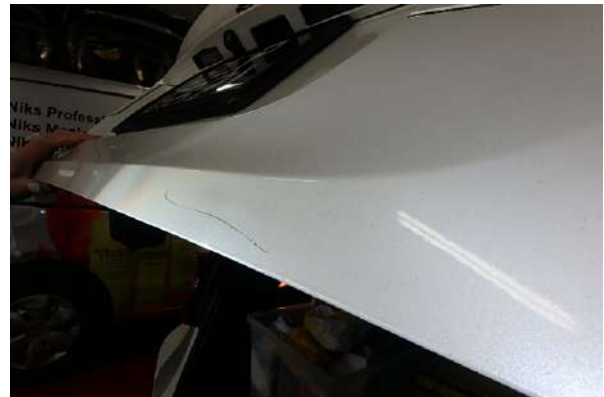
### INSPECTION

| Affiliated to Federation Internationale Des Experts En Automobile | | | | |
|--|---|---|--|--|
| THE VEHICLE SUSTAINED DAMAGES AT THE REAR PORTION.<br>DAMAGES SEE DETAILS. | | | | |

### PHOTOGRAPHS FOR VEHICLE NO. SLP 1562L

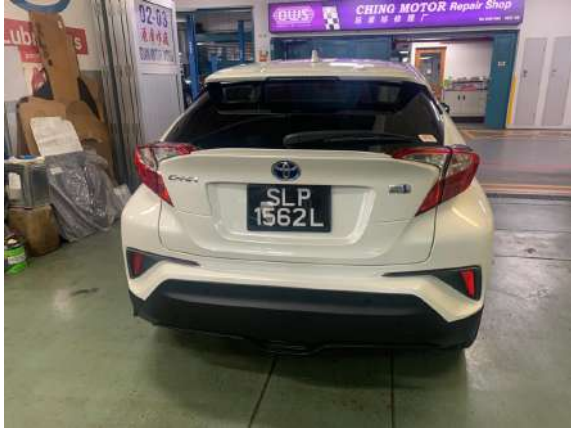
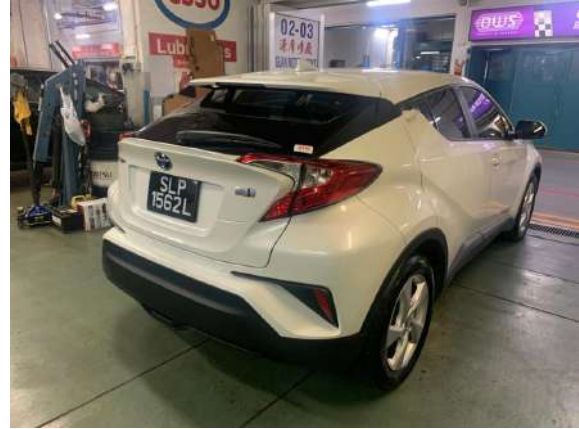
**RE-INSPECTION**

**PHOTOGRAPHS FOR VEHICLE NO. SLP 1562L**
