## LKK Auto Consultants Pte Ltd

## ADJUSTMENT ON REPAIR COST FOR VEHICLE NO. SJB 3501Y

### PHOTOGRAPHS FOR VEHICLE NO. SJB 3501Y

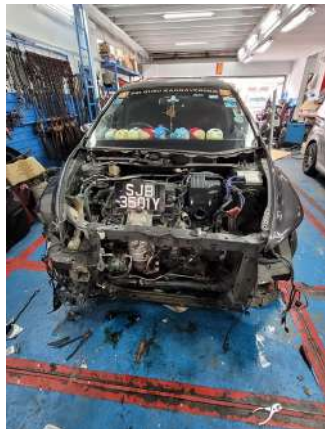
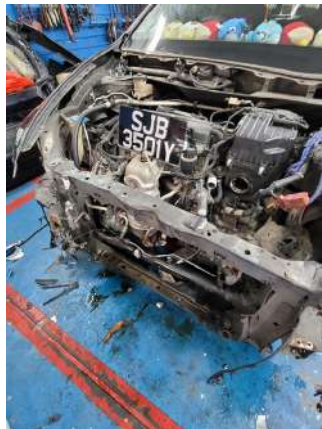
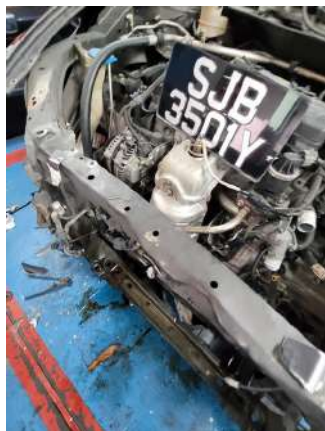
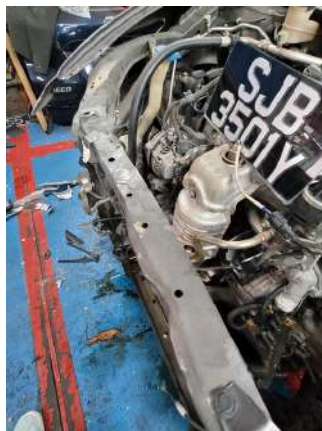
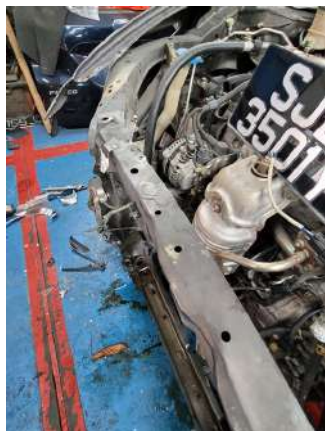
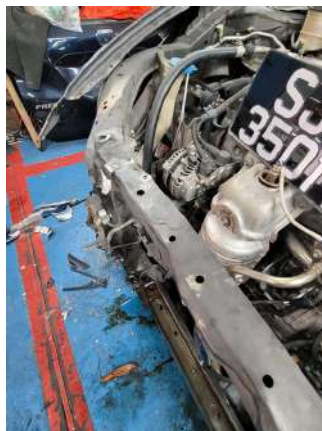
**PHOTOGRAPHS FOR VEHICLE NO. SJB 3501Y**

**RE-INSPECTION**

| Affiliated to Federation Internationale Des Experts En Automobile | | | | |
|---|---|---|---|--|
| THE VEHICLE SUSTAINED DAMAGES AT THE FRONT PORTION.<br>DAMAGES SEE DETAILS. | | | | |

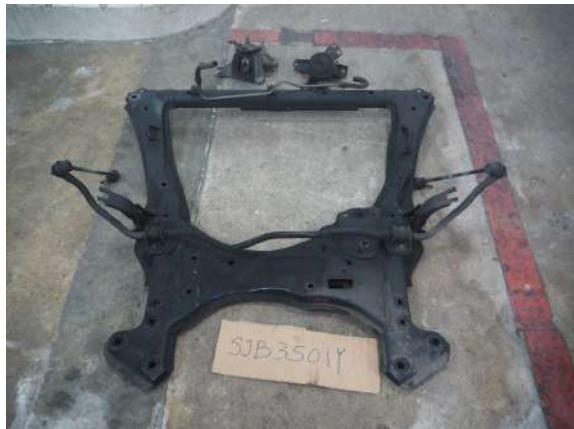
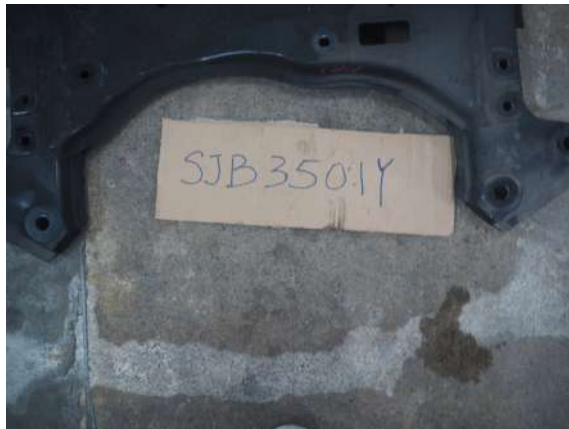
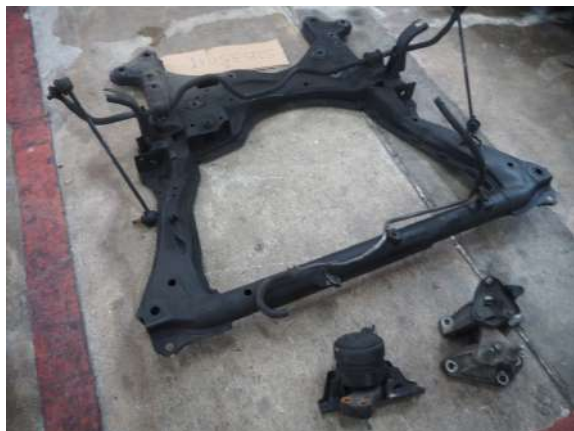
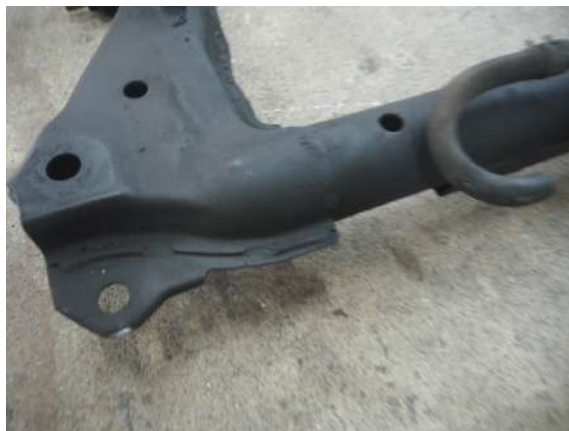
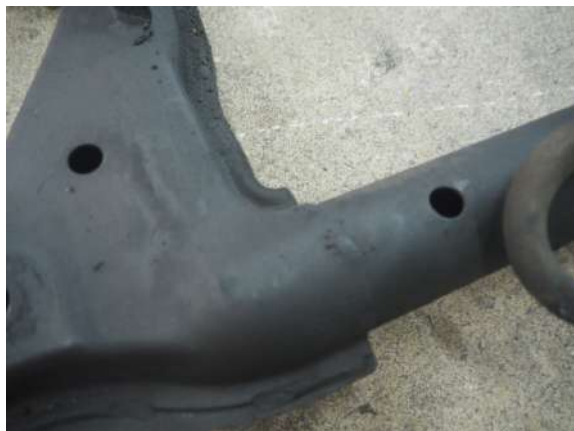
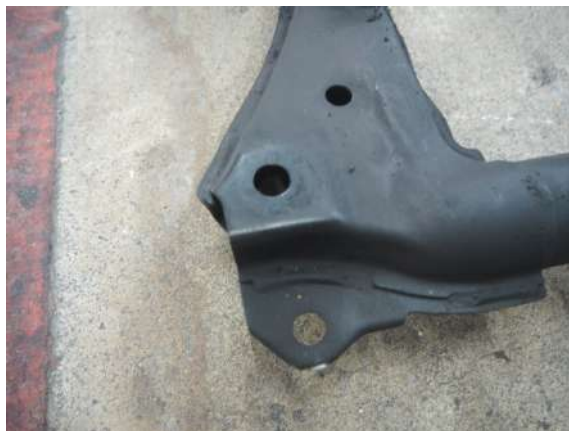
PHOTOGRAPHS FOR VEHICLE NO. SJB 3501Y

RE-INSPECTION
