## LKK Auto Consultants Pte Ltd

### PROFESSIONAL SERVICE FEE

Vehicle No. SJV 6345G  
Insured Veh. GBC 9395L  
Claim No. 22/22/22/VC05/025868  
Policy No. Z22VC05010497  
Accident Date 29/05/2022  
Inspection Date 02/06/2022

## ADJUSTMENT ON REPAIR COST FOR VEHICLE NO. SJV 6345G

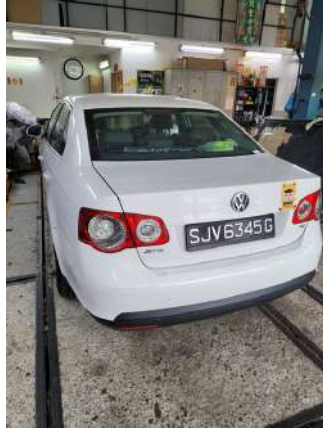
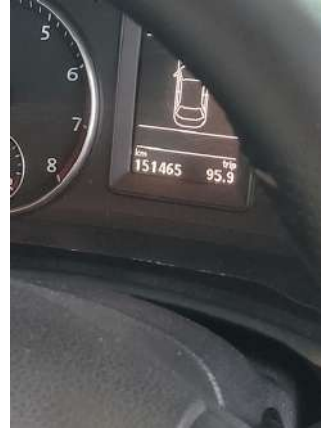
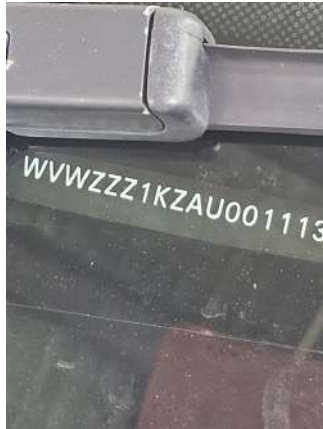
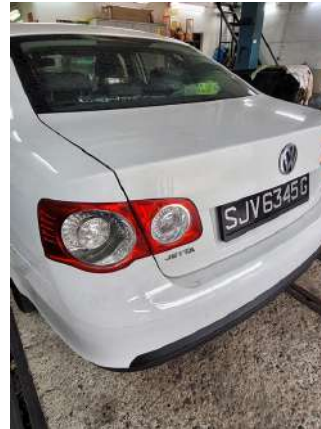
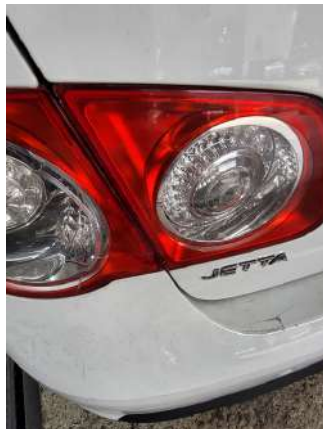
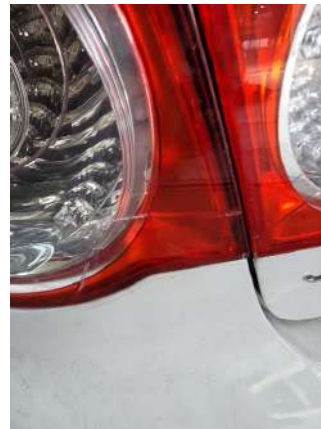
### INSPECTION

### PHOTOGRAPHS FOR VEHICLE NO. SJV 6345G

| Affiliated to Federation Internationale Des Experts En Automobile | | | | |
|---|---|---|---|--|
| THE VEHICLE SUSTAINED DAMAGES AT THE REAR N/S PORTION.<br>DAMAGES SEE DETAILS. | | | | |
