To: WJ Car Rental Pte Ltd

| Ref No | : 2021/10009 | Date of Report | : 6/12/2021 |

| Model / Make | : Toyota C-HR | Pre-accident damage | : NIL |

DESCRIPTION OF DAMAGE

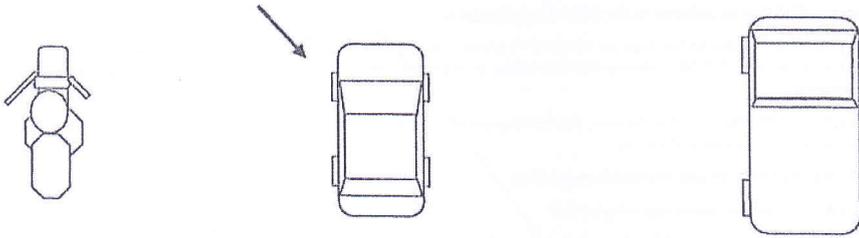
At the time of inspection, this vehicle sustained damages to the **Lh Portion**.

Front bumper, front lh fender, front lh door, rear lh door dented, headlamp holder torn, rear lh fender dented/ torn. Front and rear lh sport rim grazed. Front and rear tyre wall torn, front and rear lh undercarriage push in etc.
