Precise Appraiser Pte Ltd

REFERENCES

DAMAGED VEHICAL PARTICULARS

DESCRIPTION OF DAMAGE

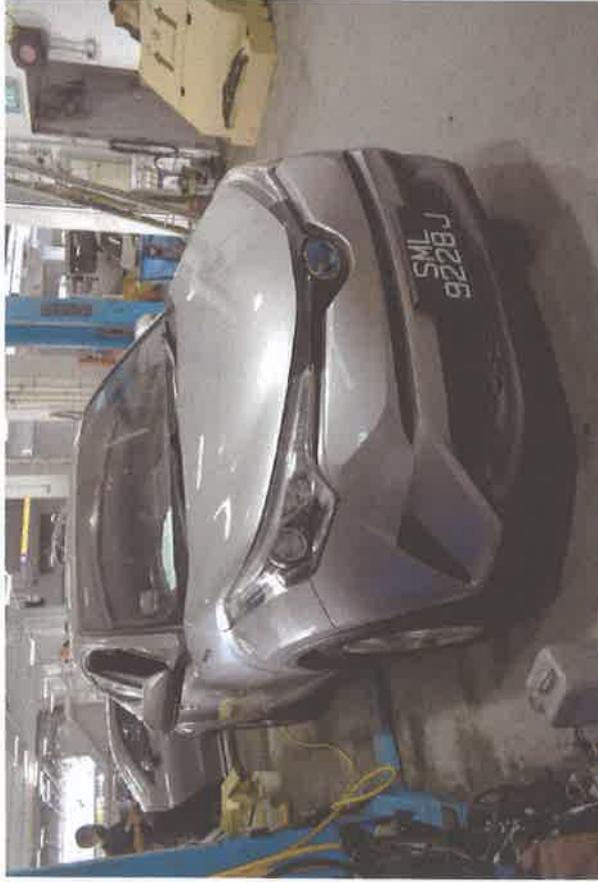
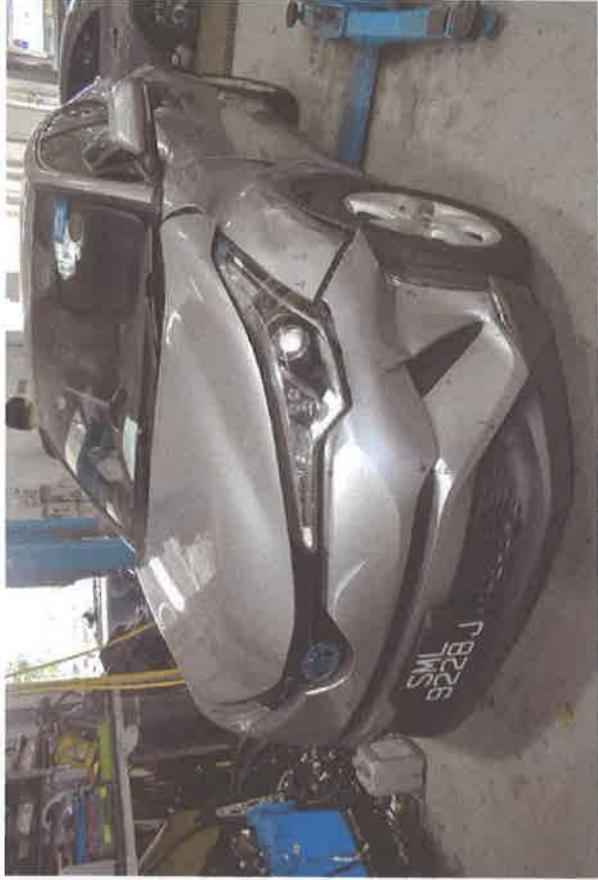
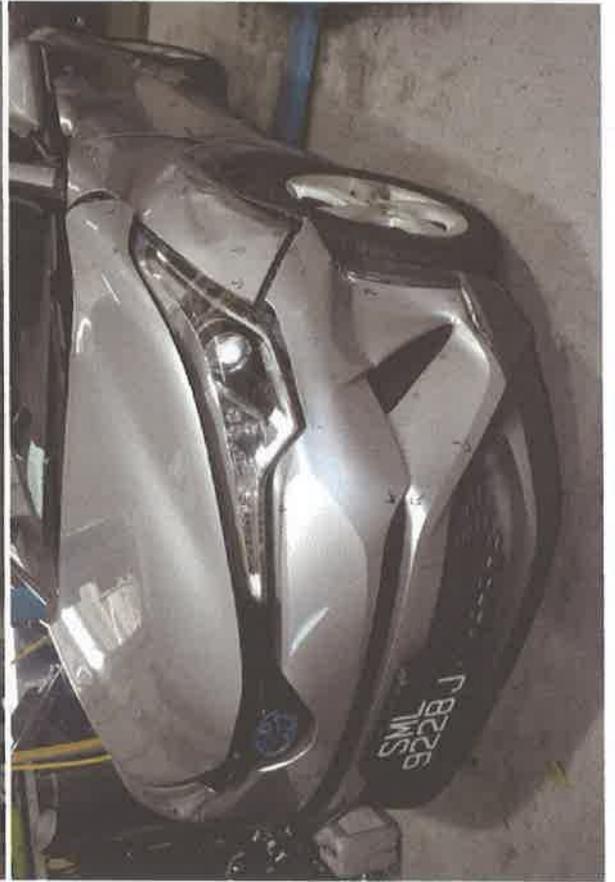
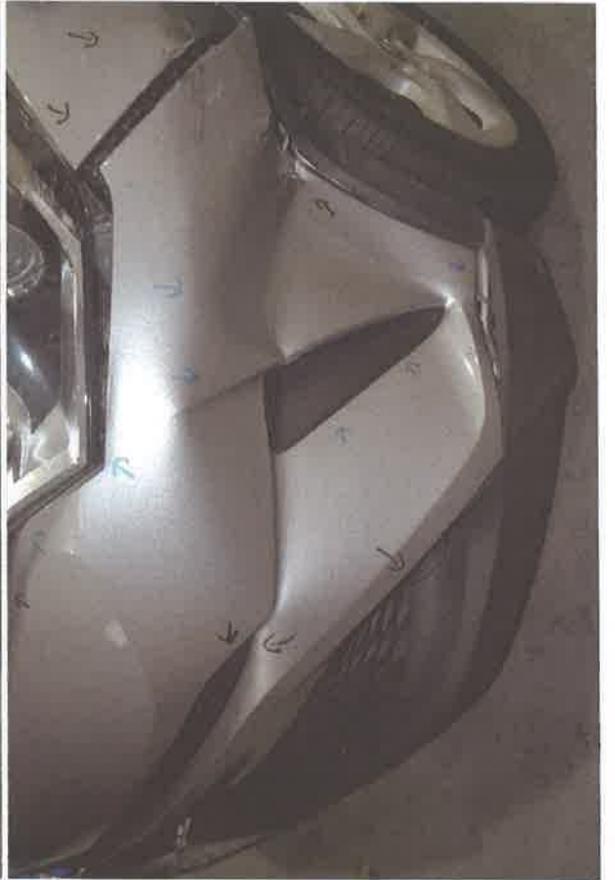
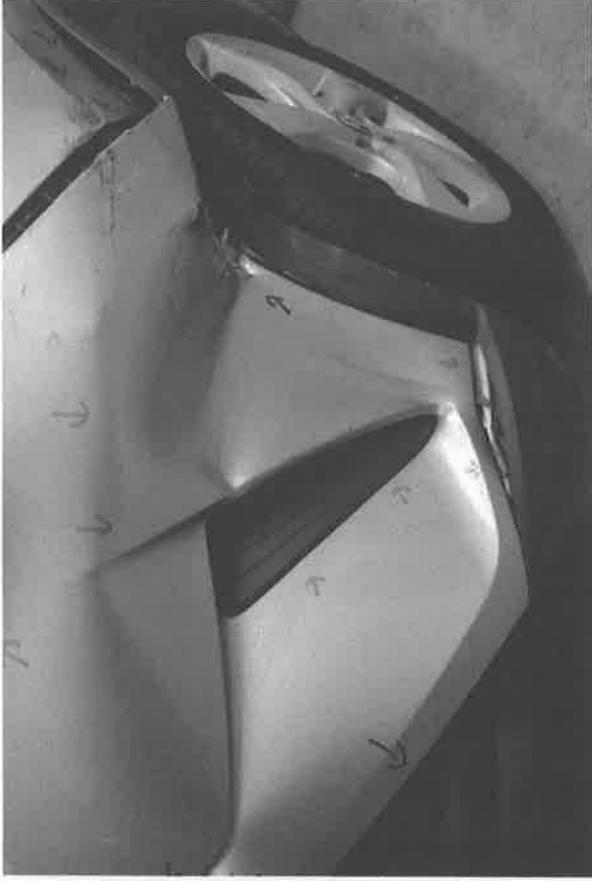
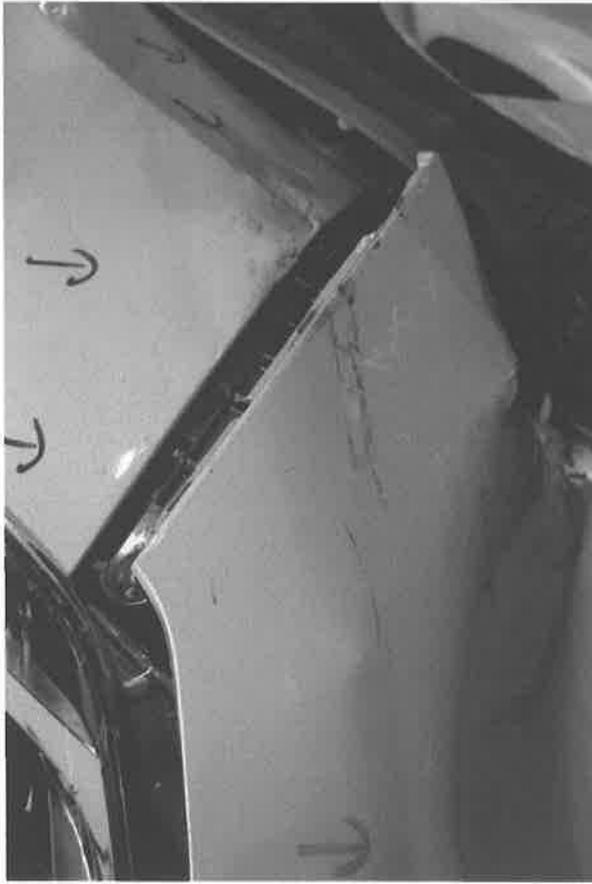
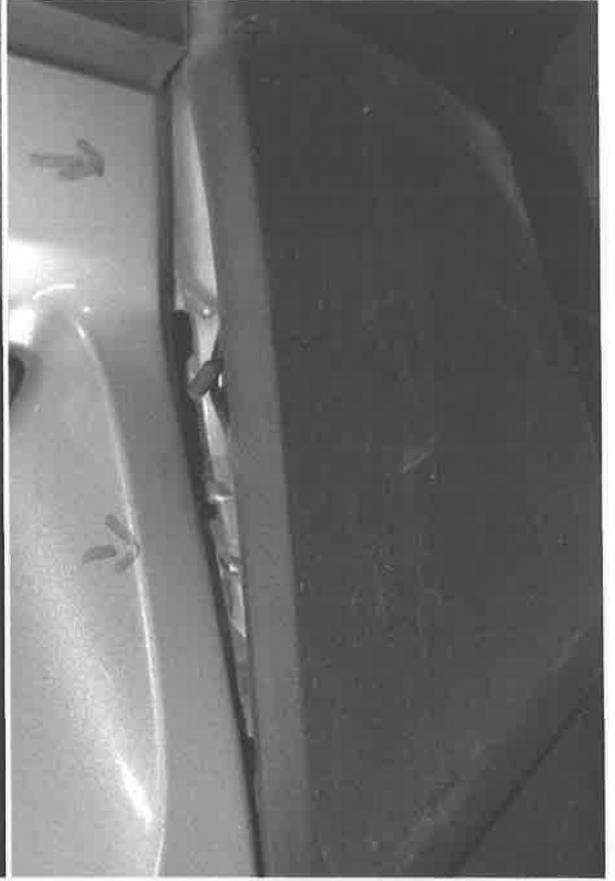
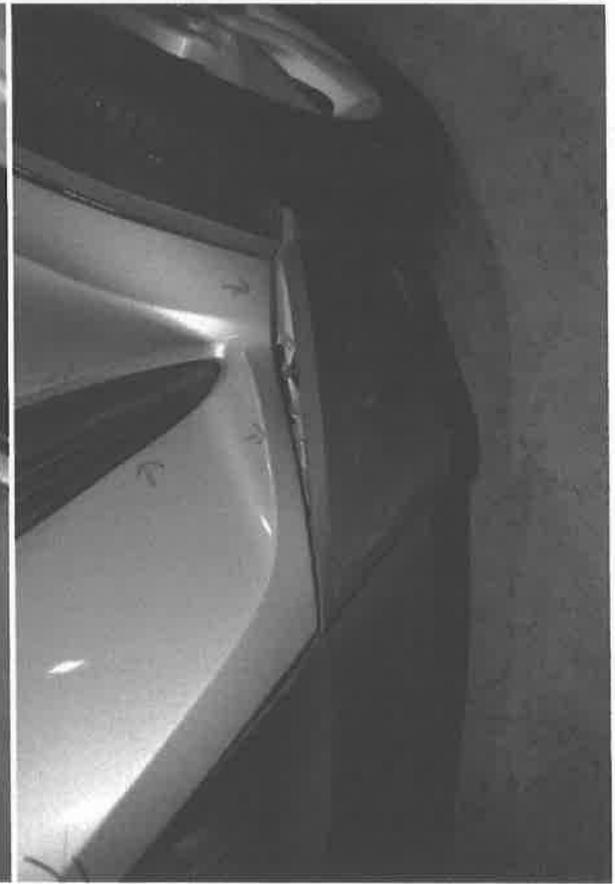
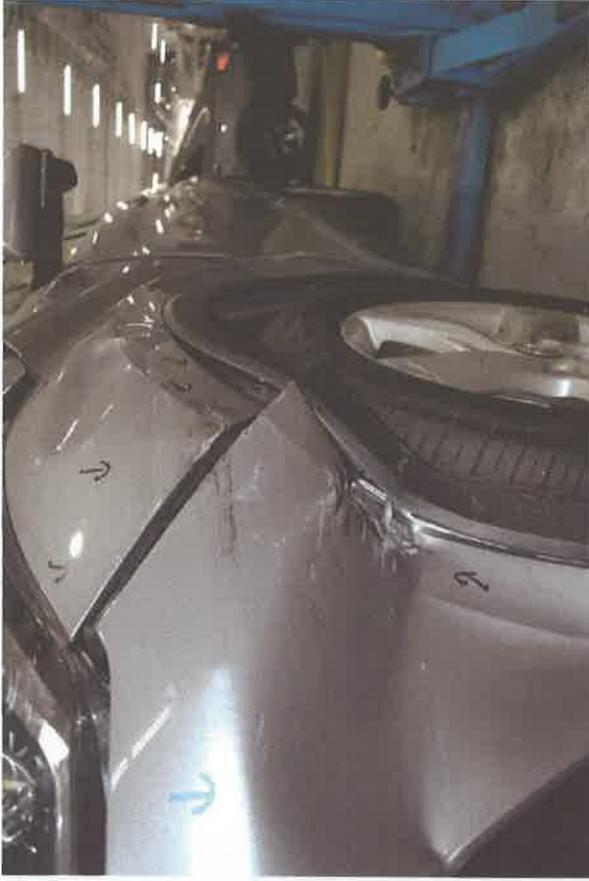
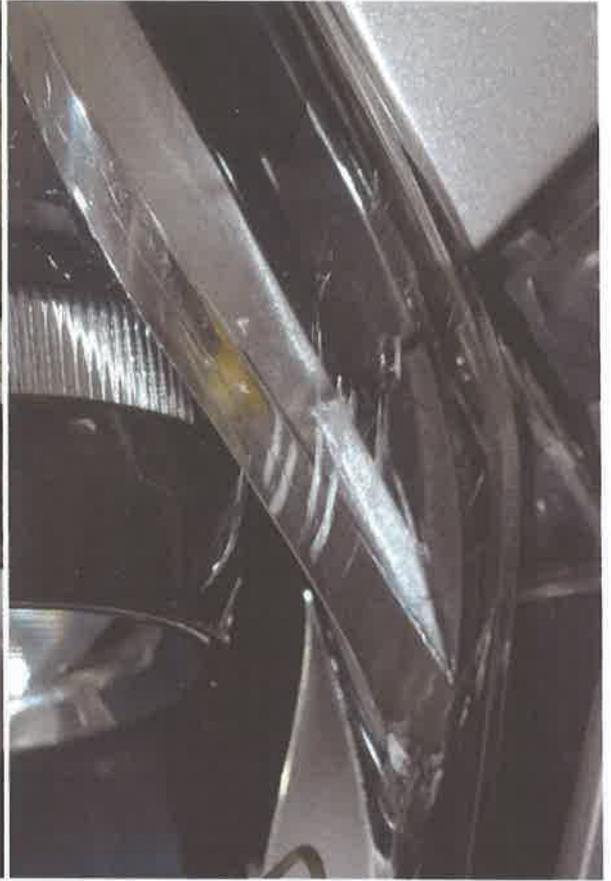
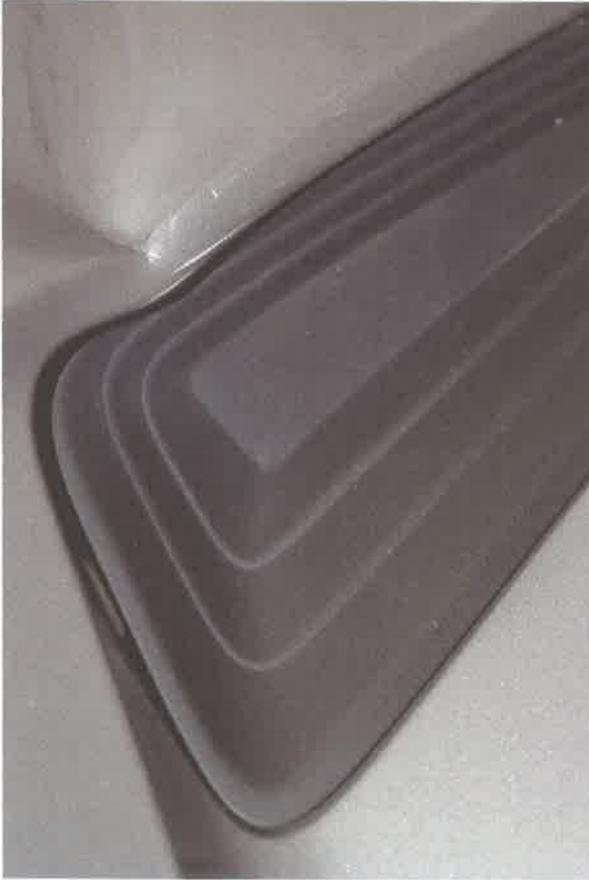
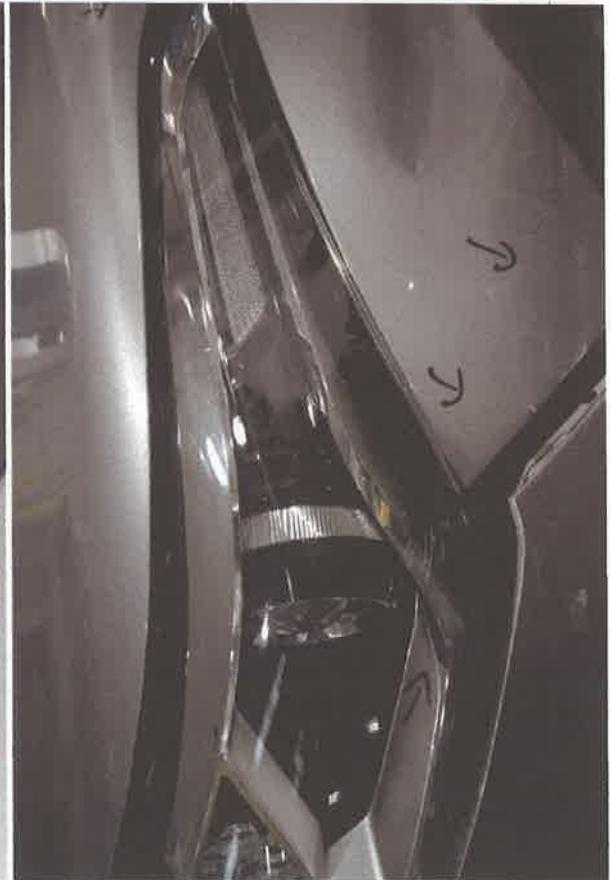
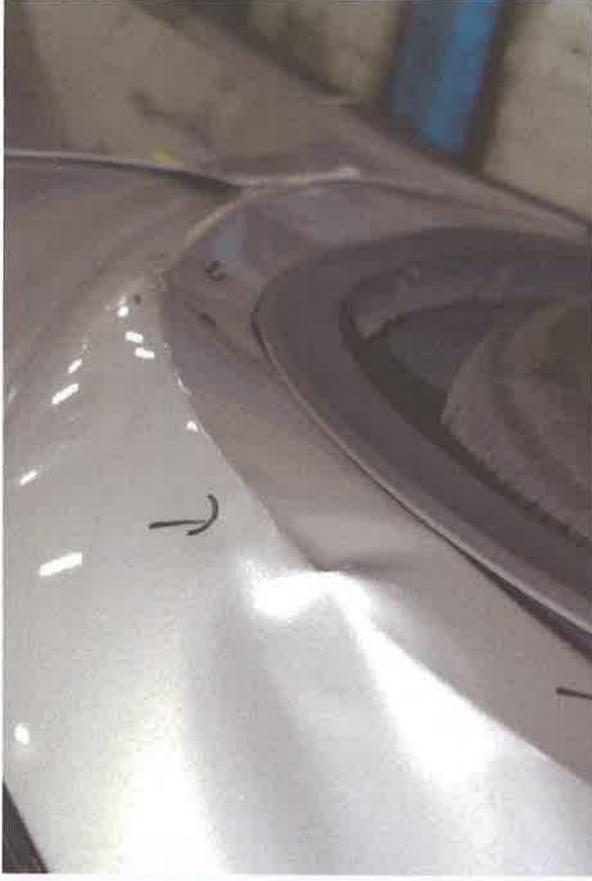
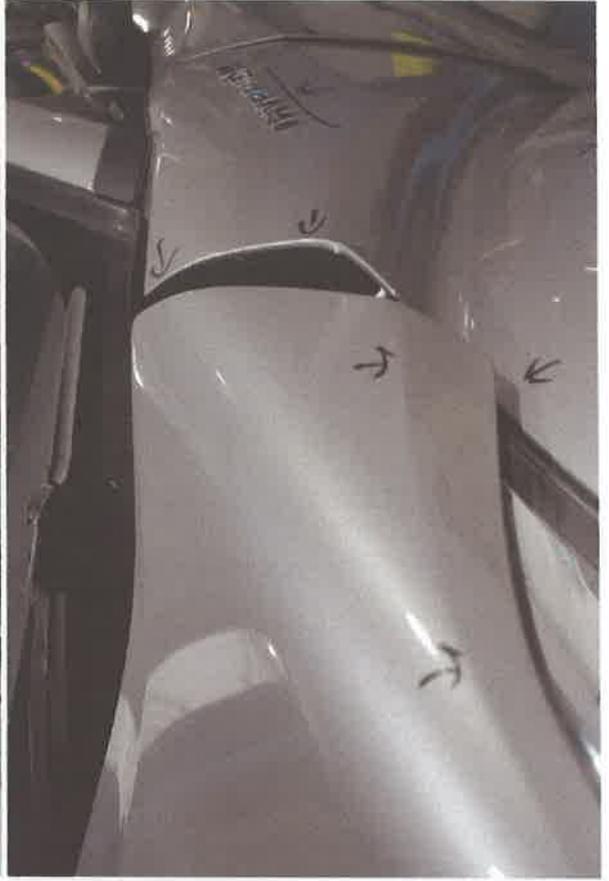
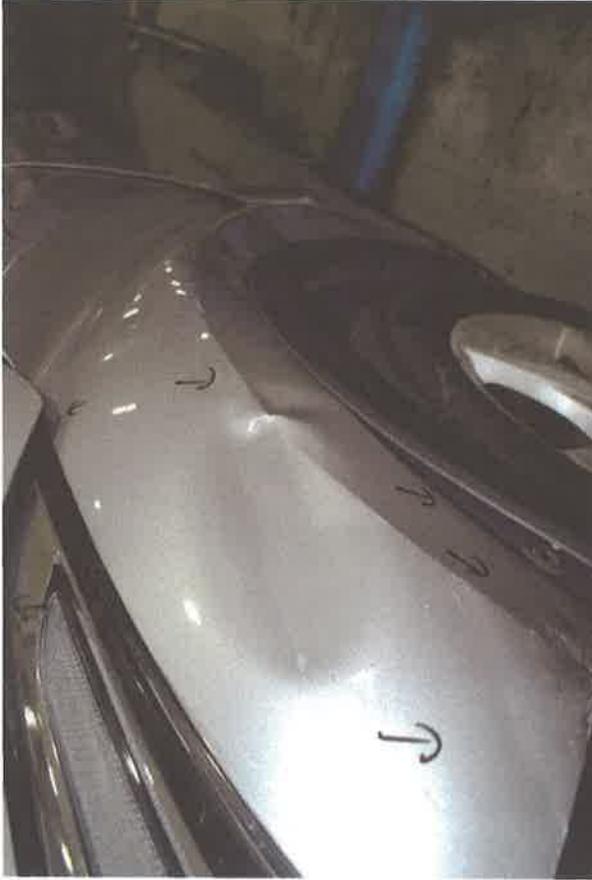
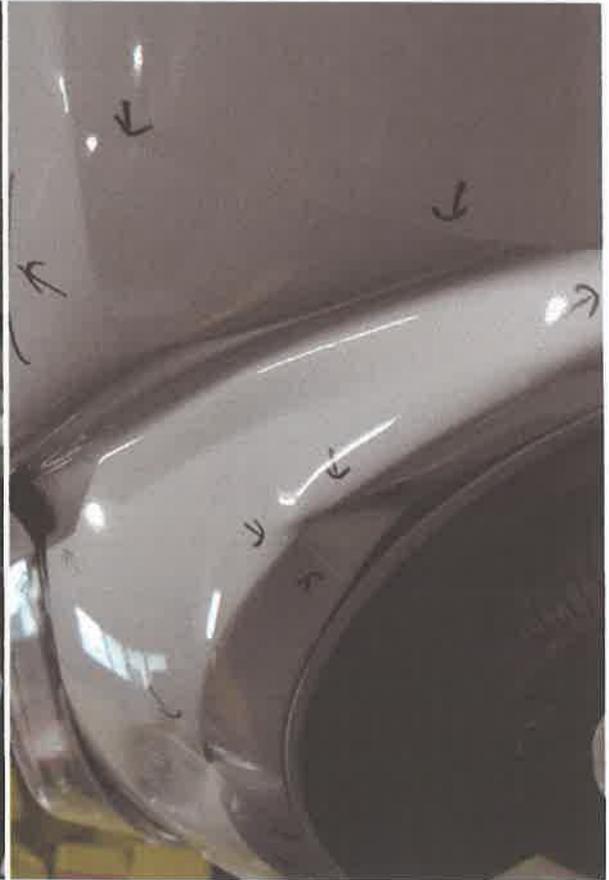
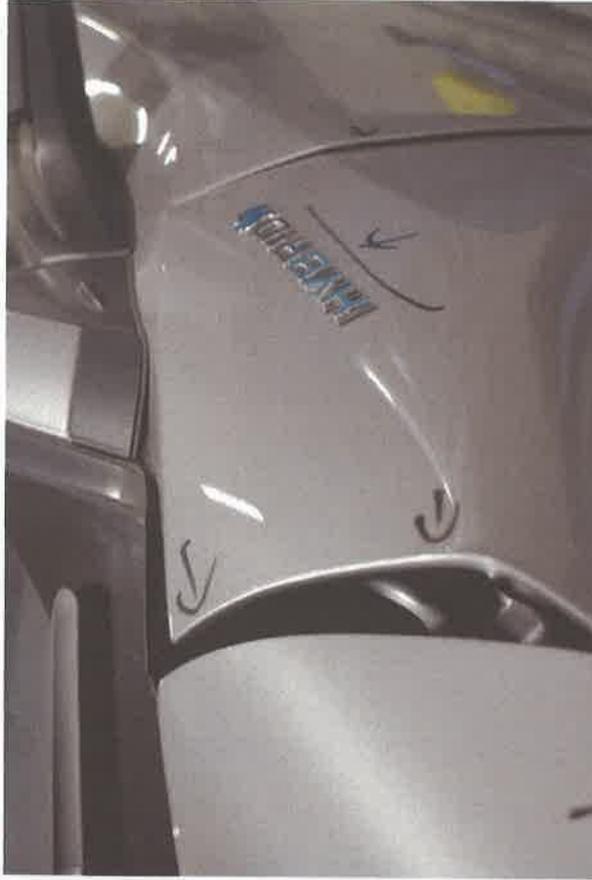
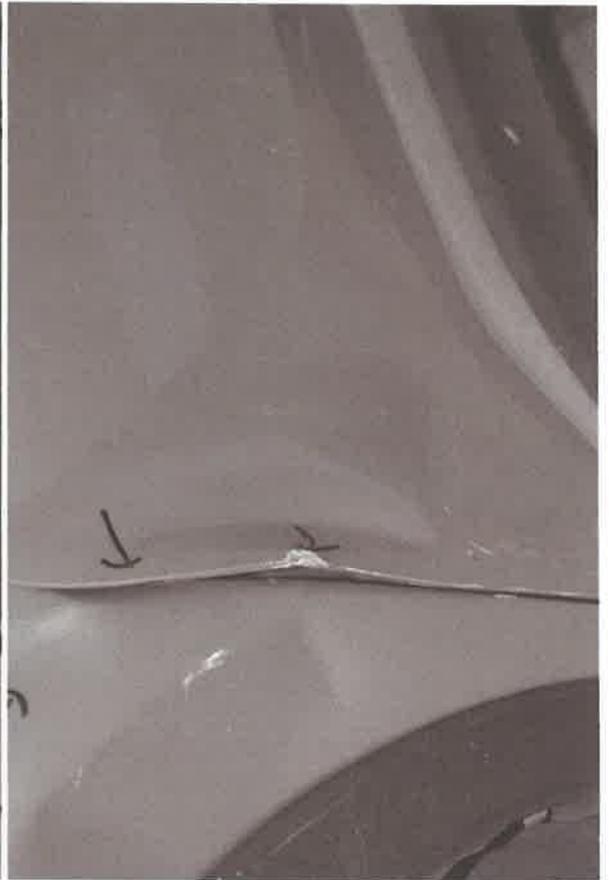
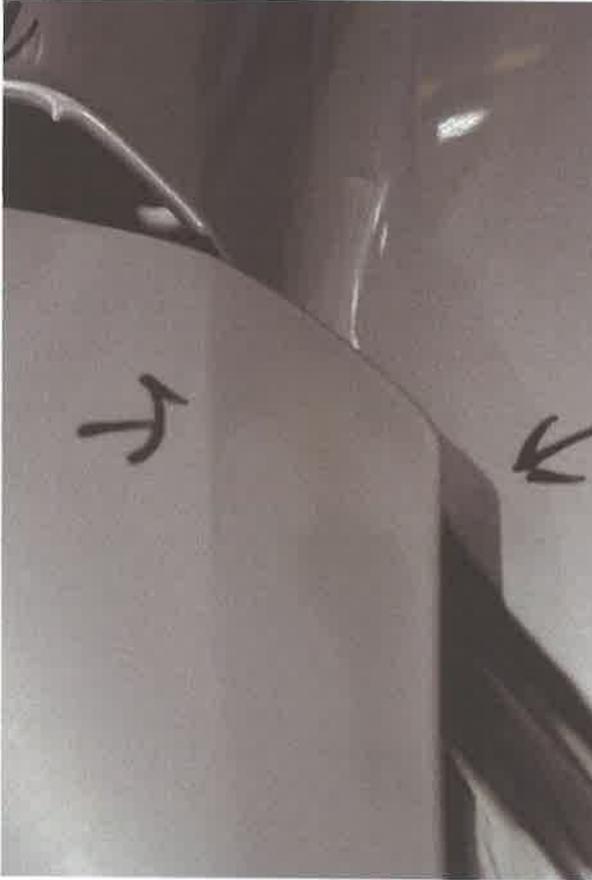
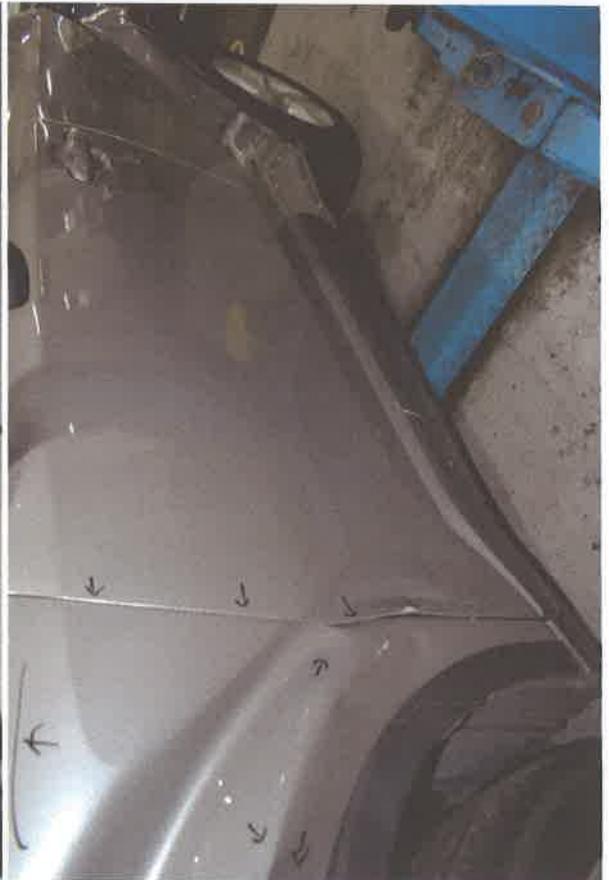
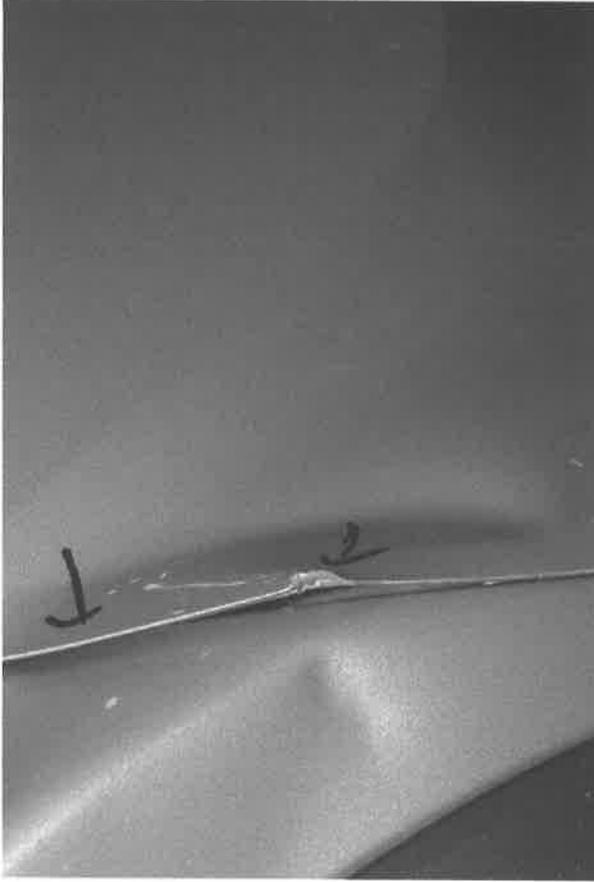
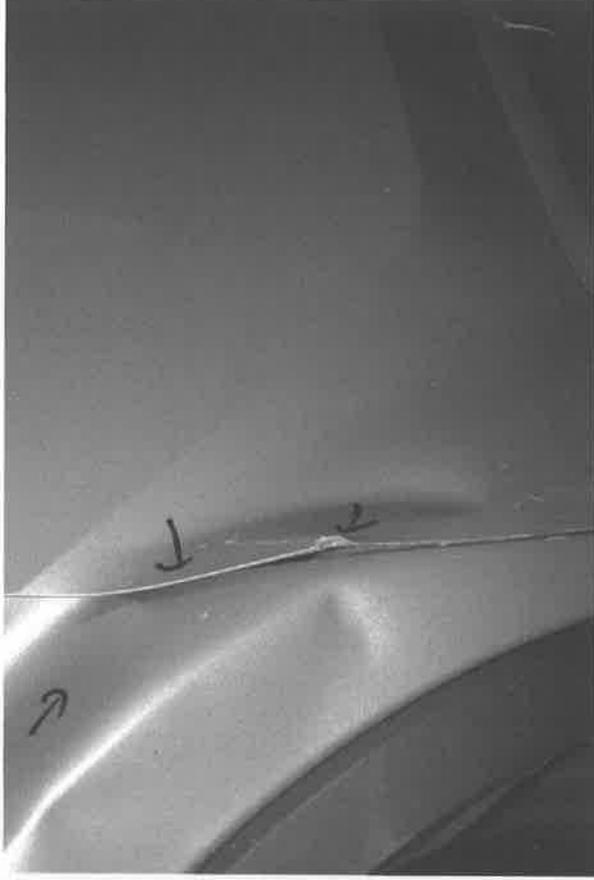
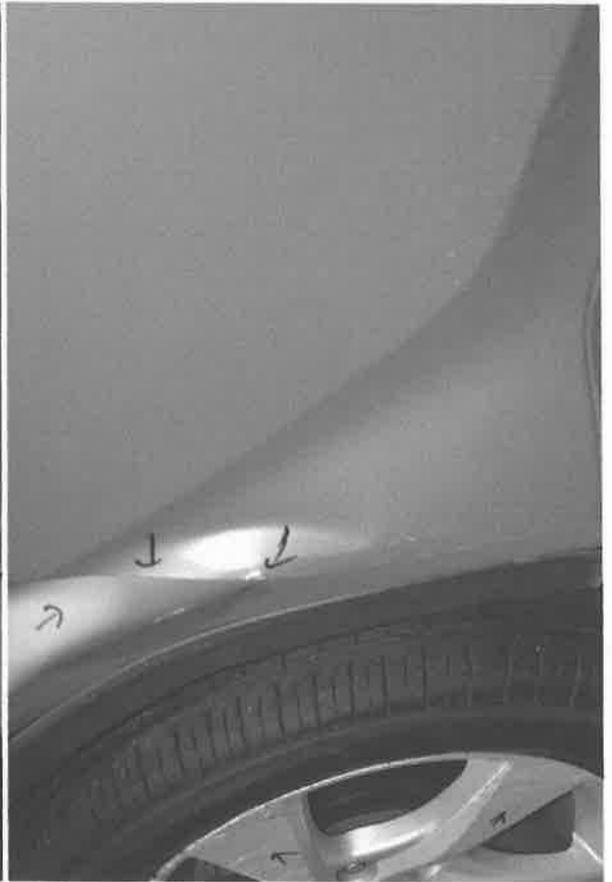
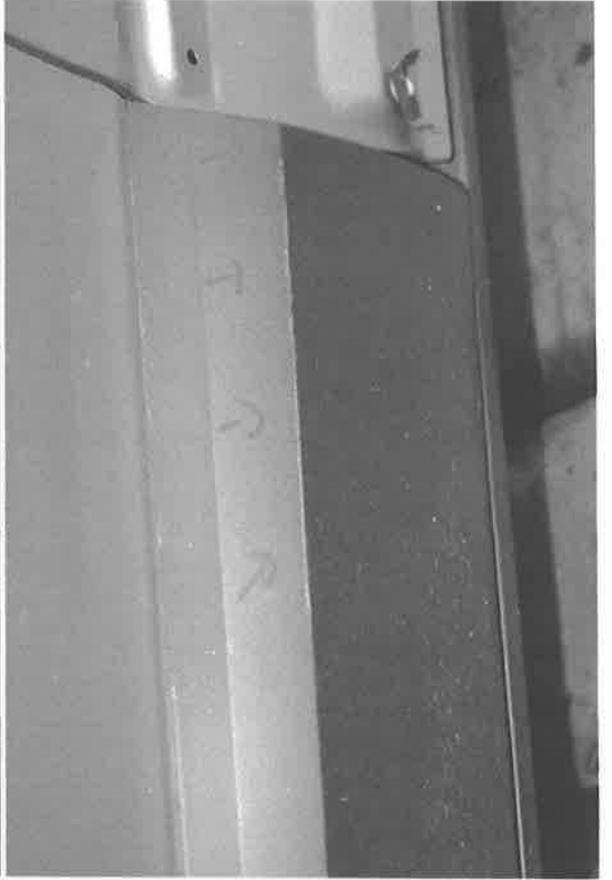
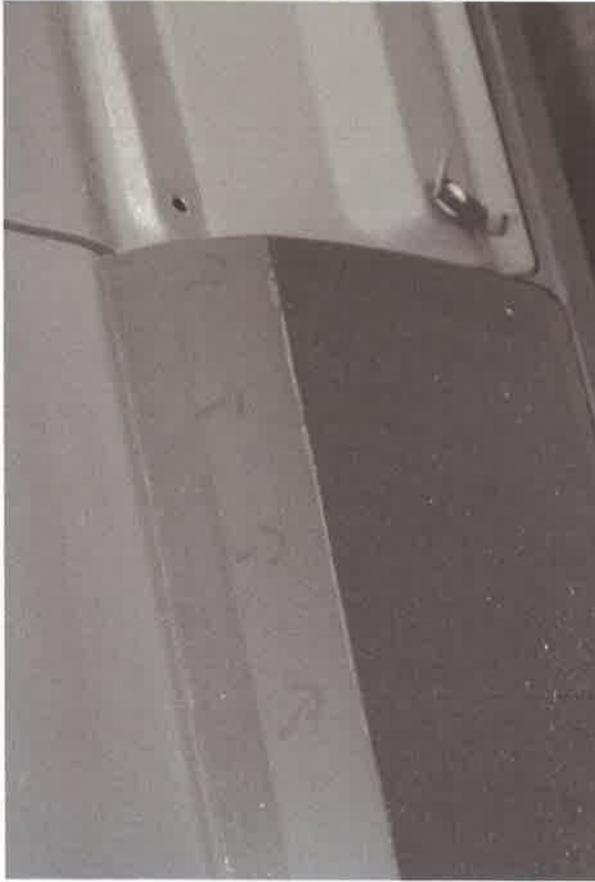
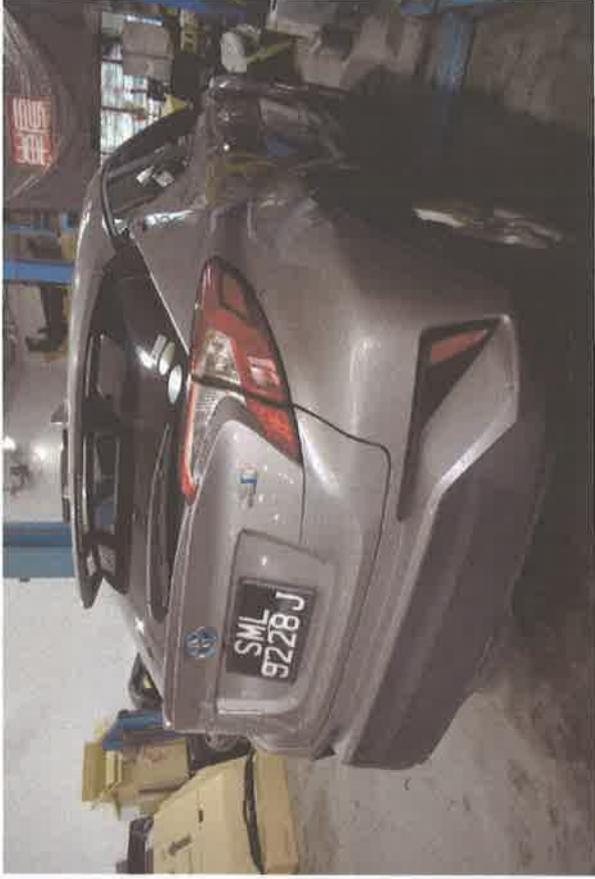
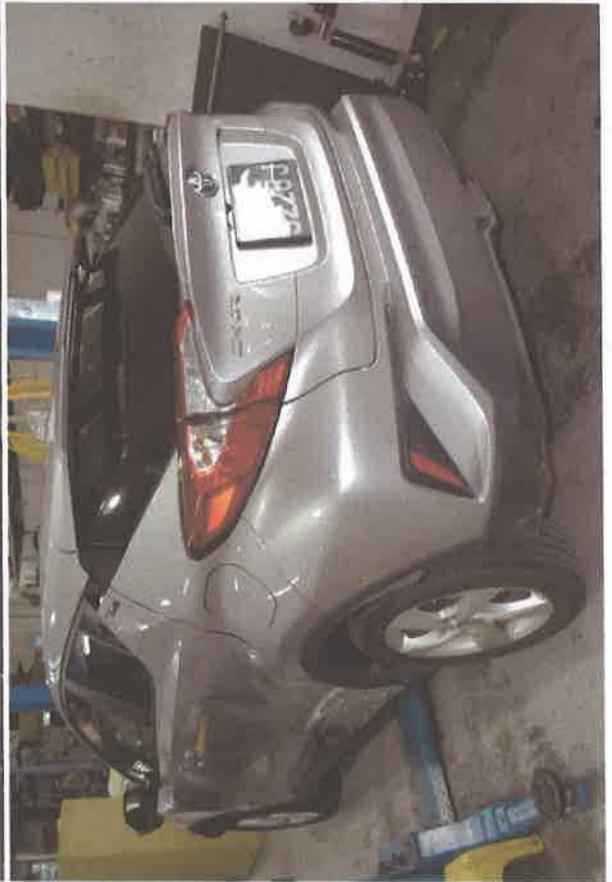
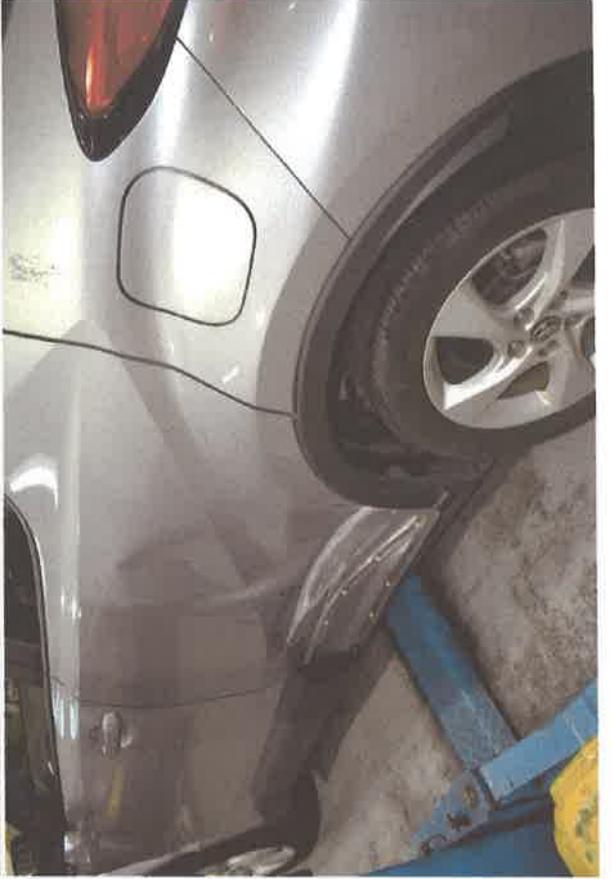
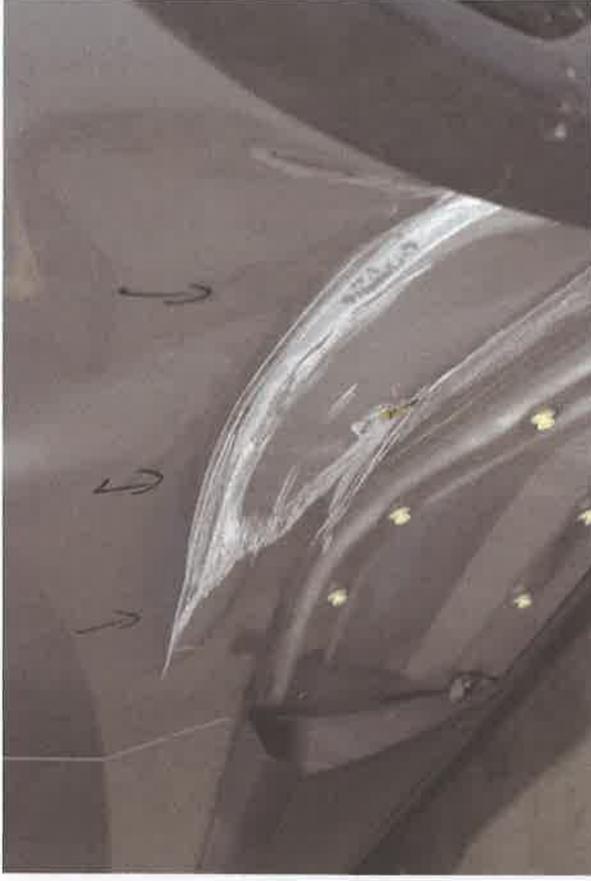
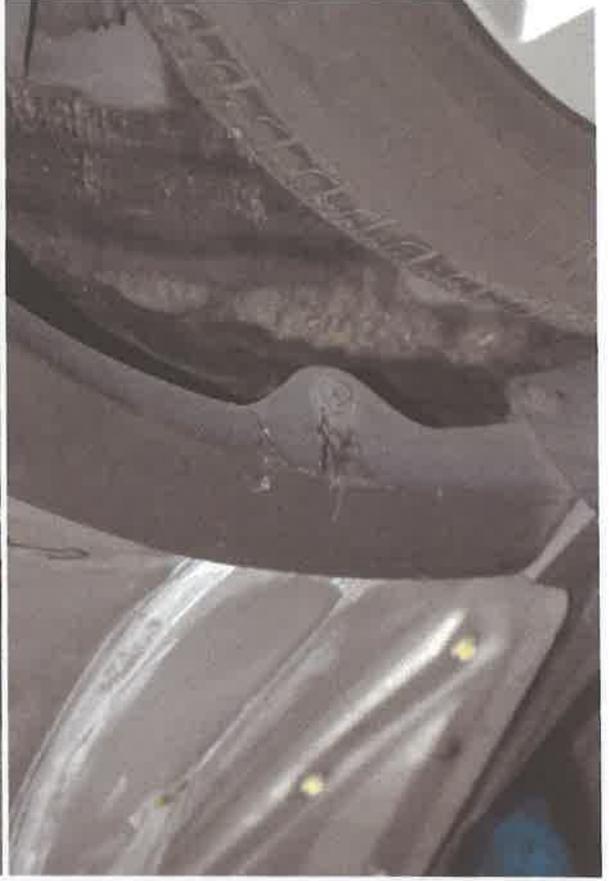
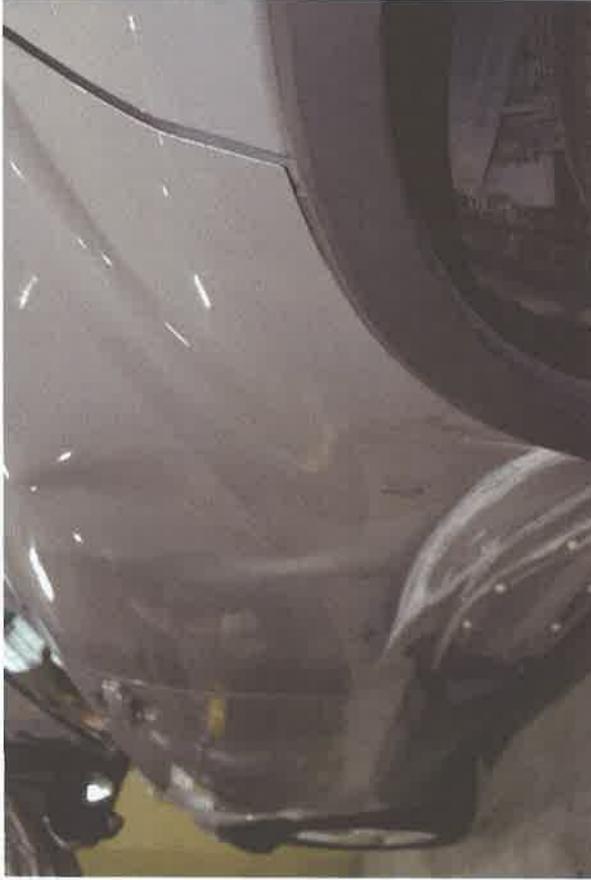
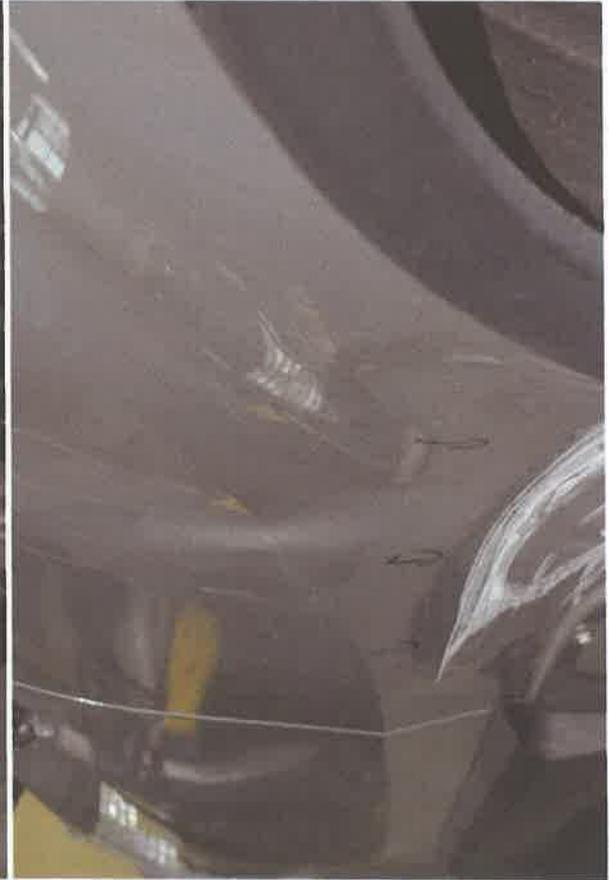
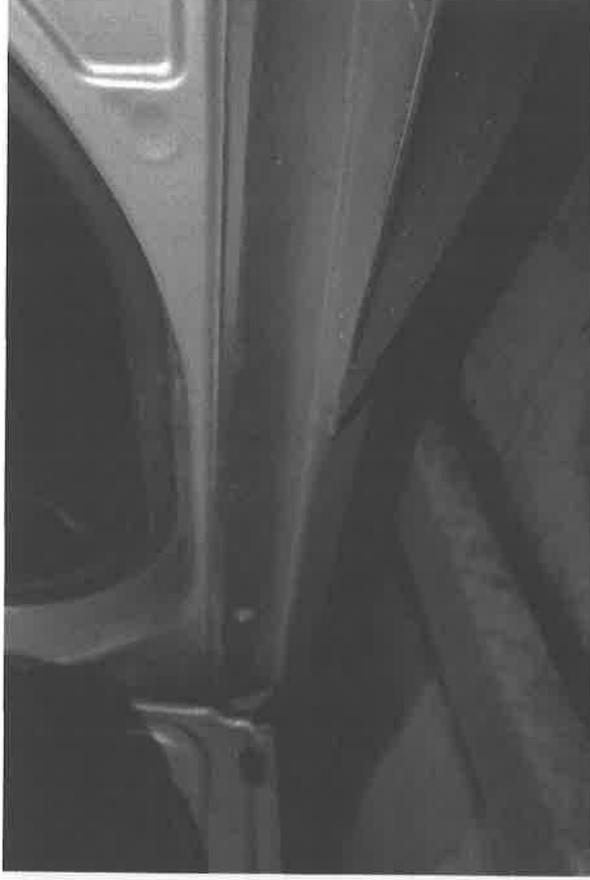
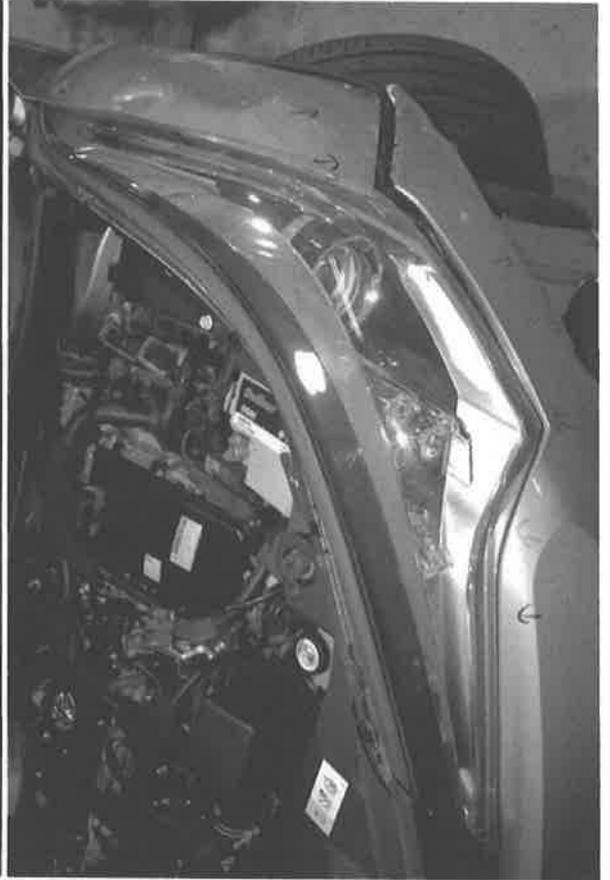
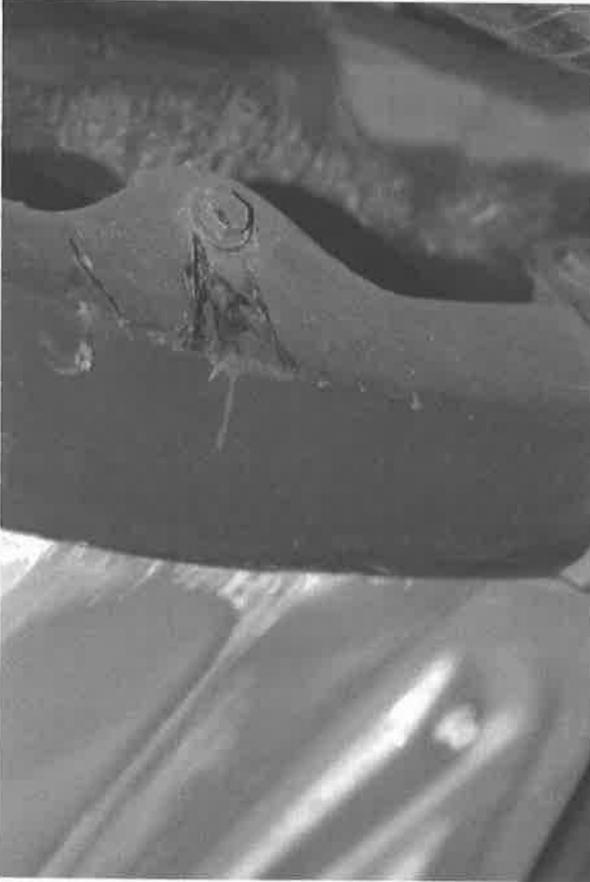
INSPECTION PHOTOS

At the time of inspection, this vehicle sustained damages to the **Lh Portion**.

Front bumper, front lh fender, front lh door, rear lh door dented, headlamp holder torn, rear lh fender dented/ torn. Front and rear lh sport rim grazed. Front and rear tyre wall torn, front and rear lh undercarriage push in etc.

We are pleased to advise that the inspection work was carried out accordingly, and hereby submit our Inspection Report and photographs.
