APPRAISER PTE LTD

Vehicle No : SKT 3771 C

Model : Toyota Corolla Altis

Report Reference : TP / 06-22001/DY / 2022

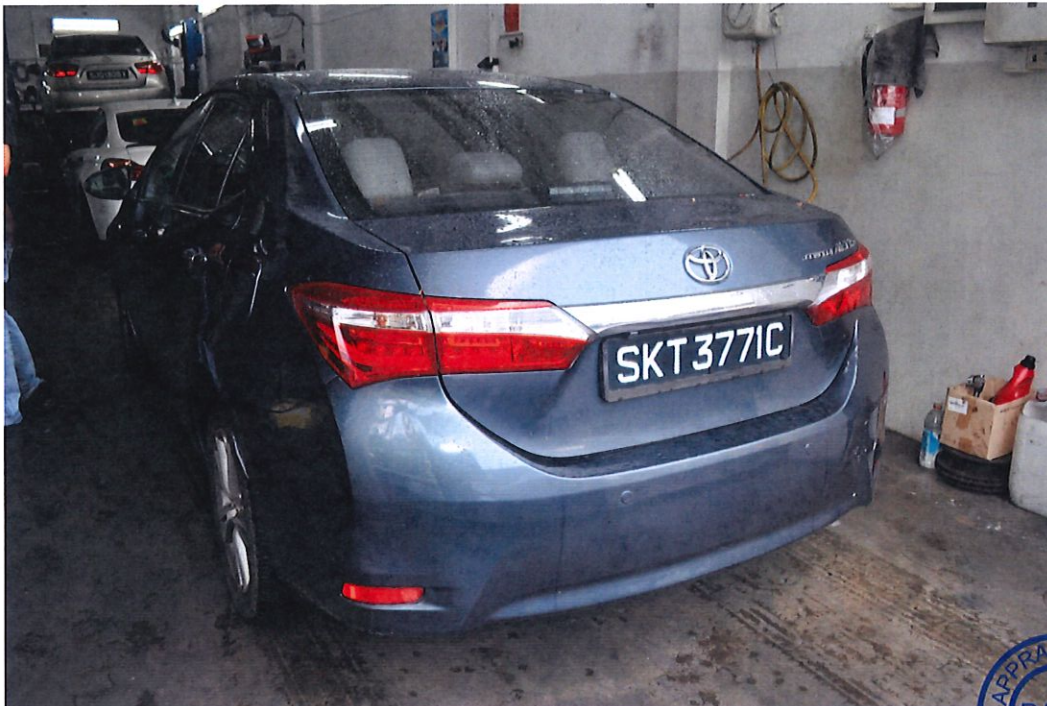
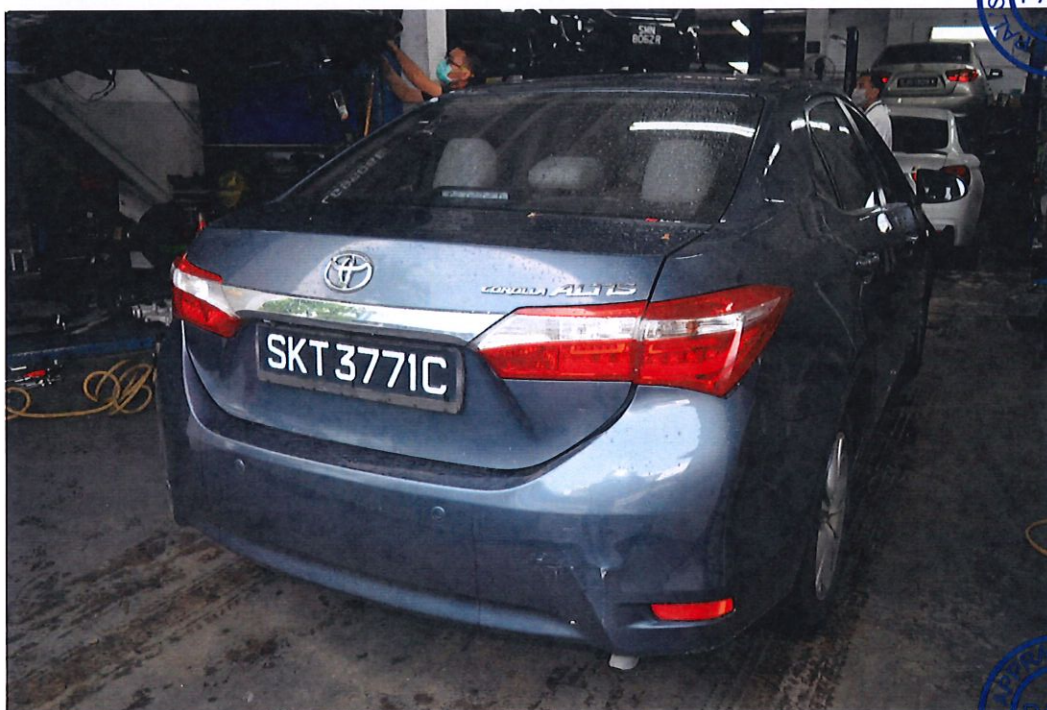
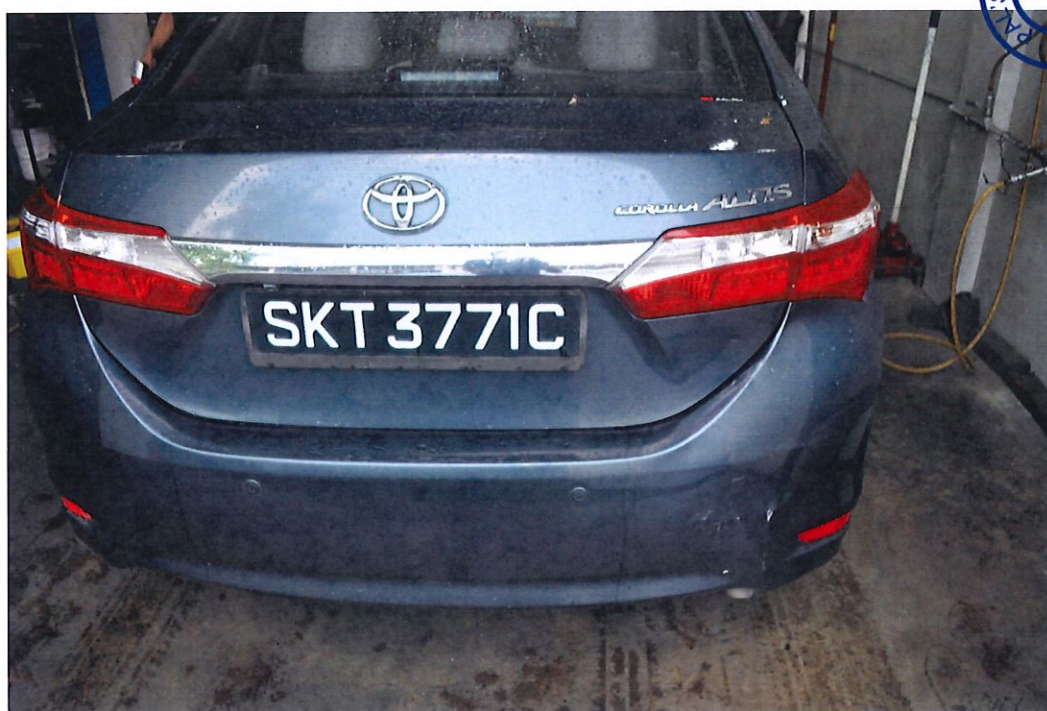
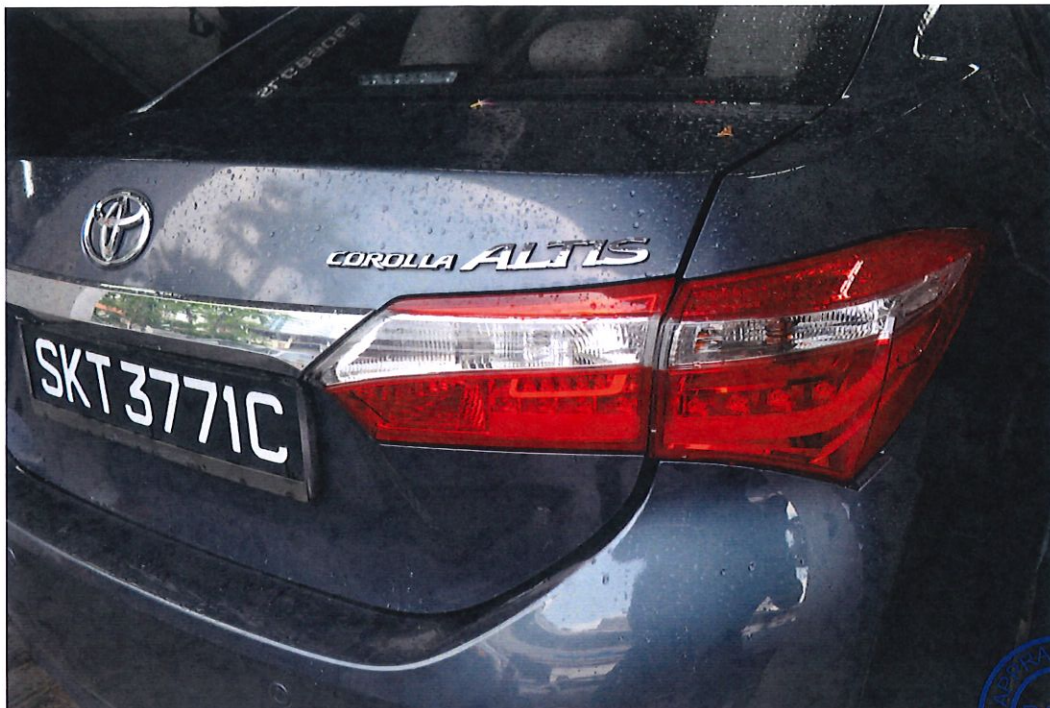
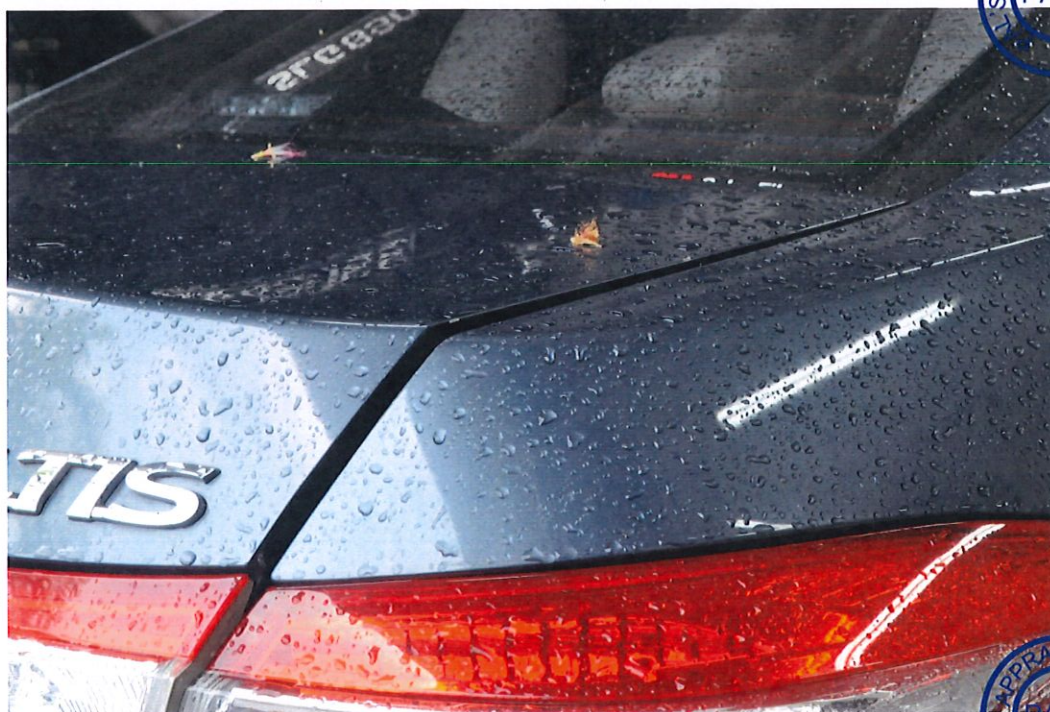
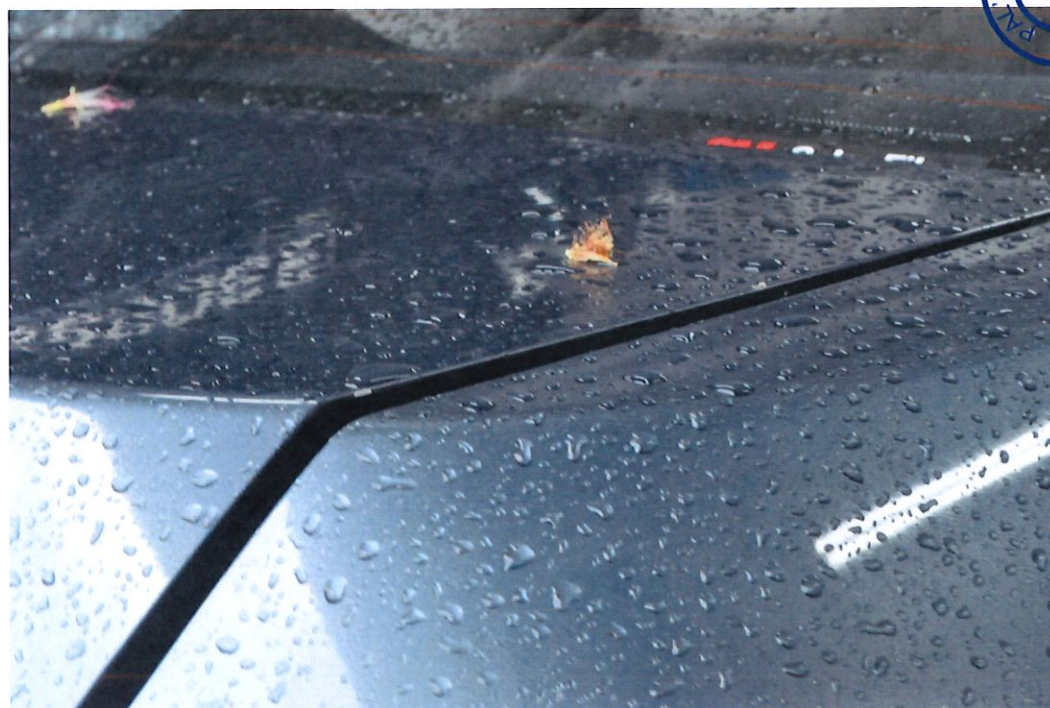
At the time of inspection, we noted that the vehicle has sustained an impact damages on the rear portion(s). For more detail of the damages, please see photograph attached.
