INVOICE	
PARTICULARS	AMOUNT
Vehicle No. : SMJ 4899R Make/Model : Honda Shuttle Hybrid 1.5(A) <input checked="" type="checkbox"/> Inspection of Vehicle <input checked="" type="checkbox"/> Appraisal Report <input checked="" type="checkbox"/> 76 Colored Photographs <input checked="" type="checkbox"/> Transport charges <input checked="" type="checkbox"/> Re-inspection <input type="checkbox"/> Others (Specify)	SGD 846.00
Total	SGD 846.00

VEHICLE APPRAISAL REPORT

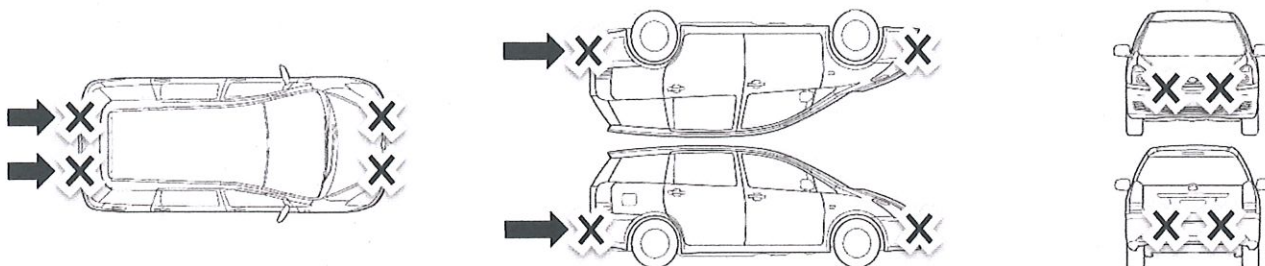
Damages sustained were consistent with the subject vehicle being involved in a collision with another vehicle and the impact was delivered **Squarely to the Rear** portion of the vehicle.

The general area of damages is at the **Front and Rear portion**
(Please refer to the parts list and photographs as attached for more information)
