Vehicle No. SMP 4527H  
Insured Veh. GBE 3889H  
Claim No. 21/22/22/VC05/025976  
Policy No. Z21VC05008636  
Accident Date 25/06/2022  
Inspection Date 29/06/2022

## ADJUSTMENT ON REPAIR COST FOR VEHICLE NO. SMP 4527H

### PHOTOGRAPHS FOR VEHICLE NO. SMP 4527H

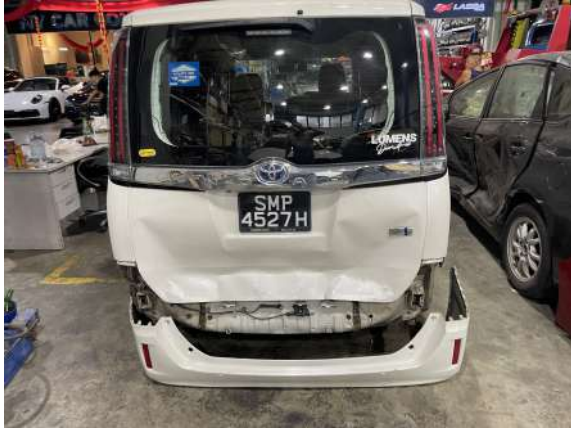
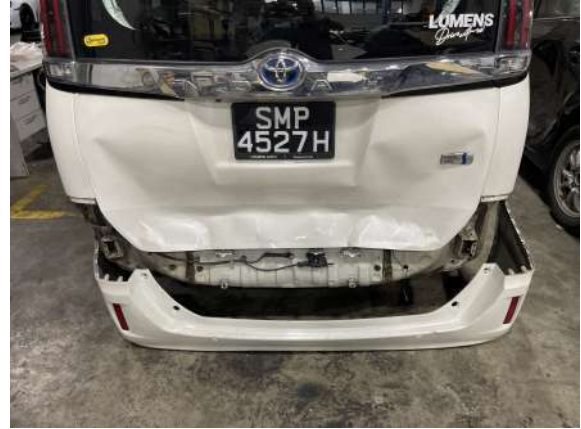
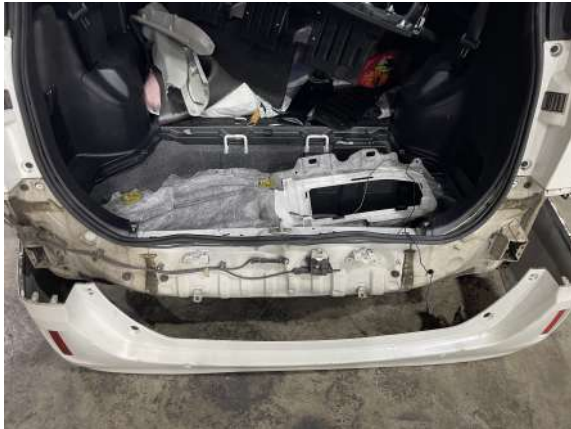
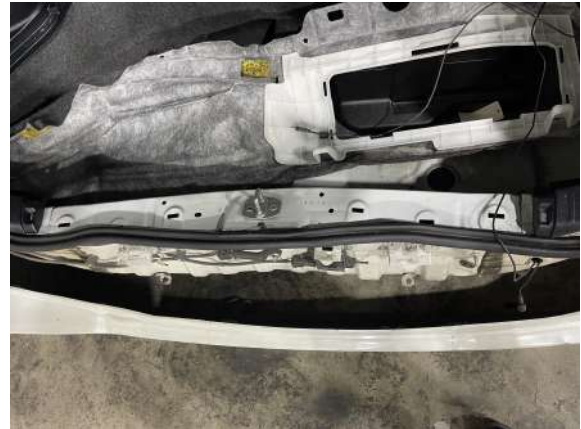
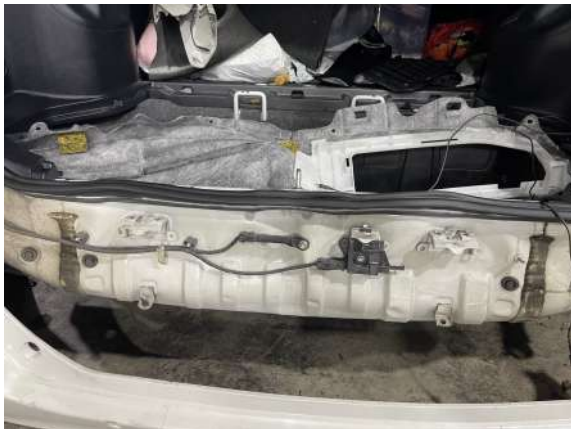
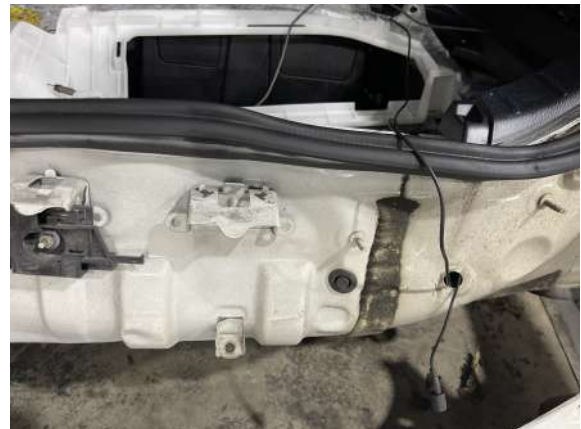
PHOTOGRAPHS FOR VEHICLE NO. SMP 4527H

RE-INSPECTION
