Vehicle No. SCY 8866Z  
Insured Veh. YP 6899D  
Claim No. 21/22/22/VC00/026007  
Policy No. Z/21/VC00/111333  
Accident Date 07/07/2022  
Inspection Date 08/07/2022

## ADJUSTMENT ON REPAIR COST FOR VEHICLE NO. SCY 8866Z

### PHOTOGRAPHS FOR VEHICLE NO. SCY 8866Z

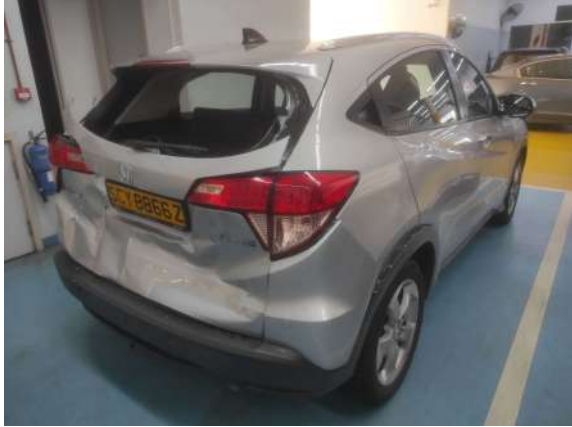
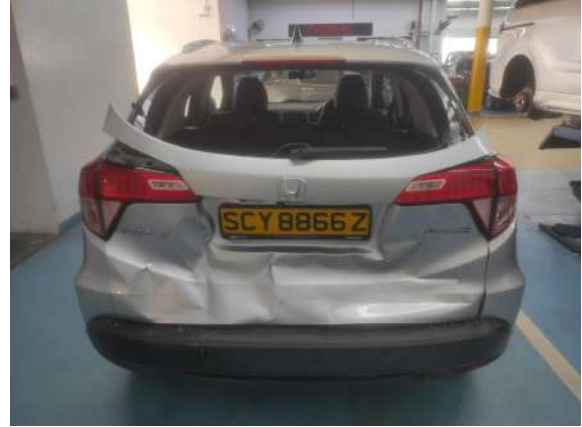
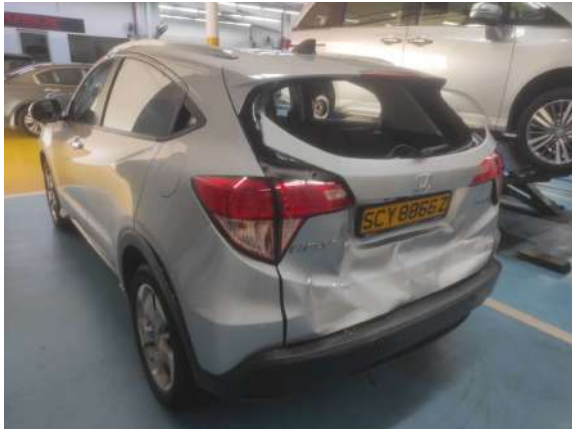
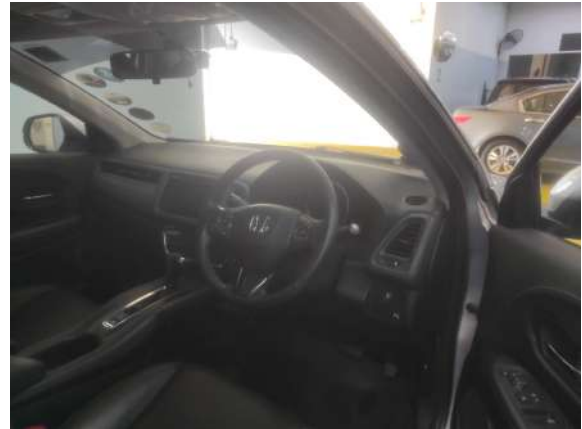
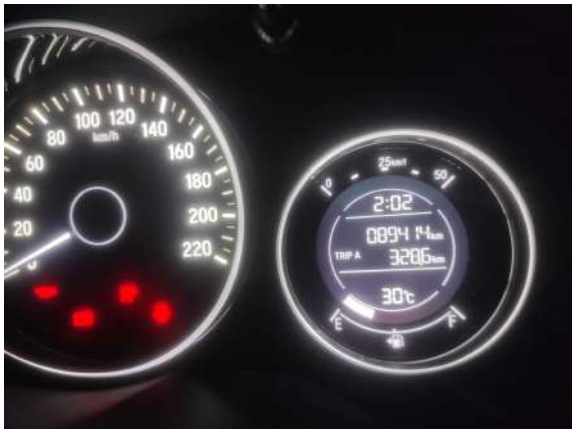
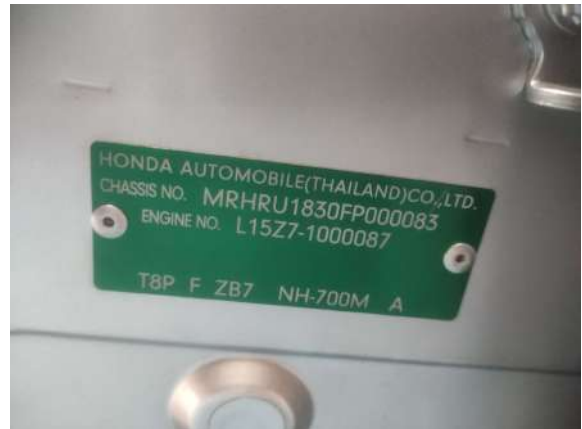
### INSPECTION

HONDA AUTOMOBILE(THAILAND)CO.,LTD.  
CHASSIS NO. MRHRU1830FP000083  
ENGINE NO. L15Z7-1000087  
T8P F ZB7 NH-700M A

| Affiliated to Federation Internationale Des Experts En Automobile | | | | |
|---|---|---|---|---|
| | THE VEHICLE SUSTAINED DAMAGES AT THE REAR PORTION.<br><br>DAMAGES SEE DETAILS. | | | |
