LKK Auto Consultants Pte Ltd

1. Policy Particulars :- THIRD PARTY CLAIM

ADJUSTMENT ON REPAIR COST FOR VEHICLE NO. SLV 9610Y

PHOTOGRAPHS FOR VEHICLE NO. SLV 9610Y

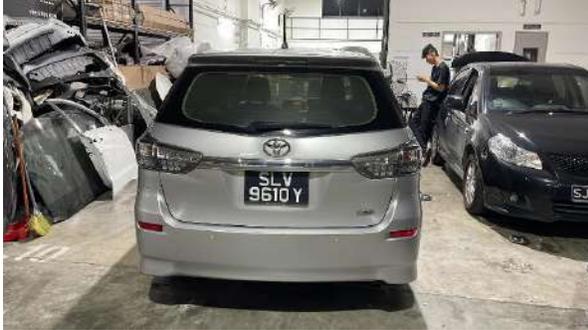
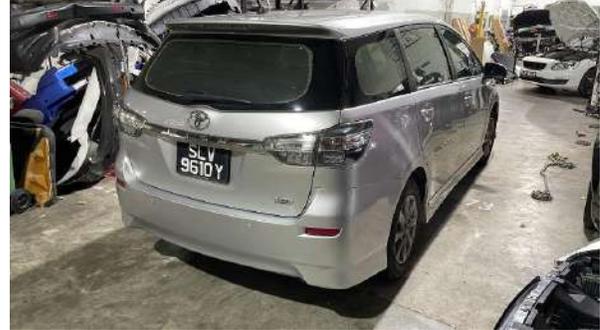
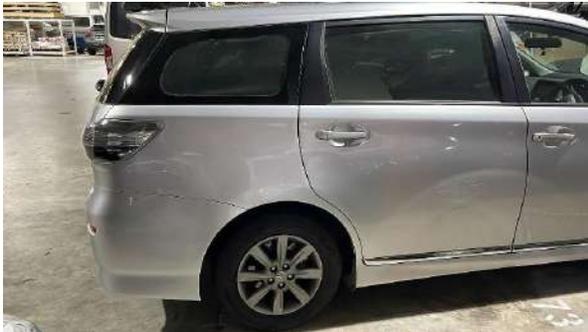
RE-INSPECTION

PHOTOGRAPHS FOR VEHICLE NO. SLV 9610Y
