# WG APPRAISAL SERVICES

## ACCIDENT DAMAGED VEHICLE INSPECTION REPORT

### REFERENCE PARTICULARS

Date of Accident : 12 January 2020  
Date of Inspection : 14 January 2020

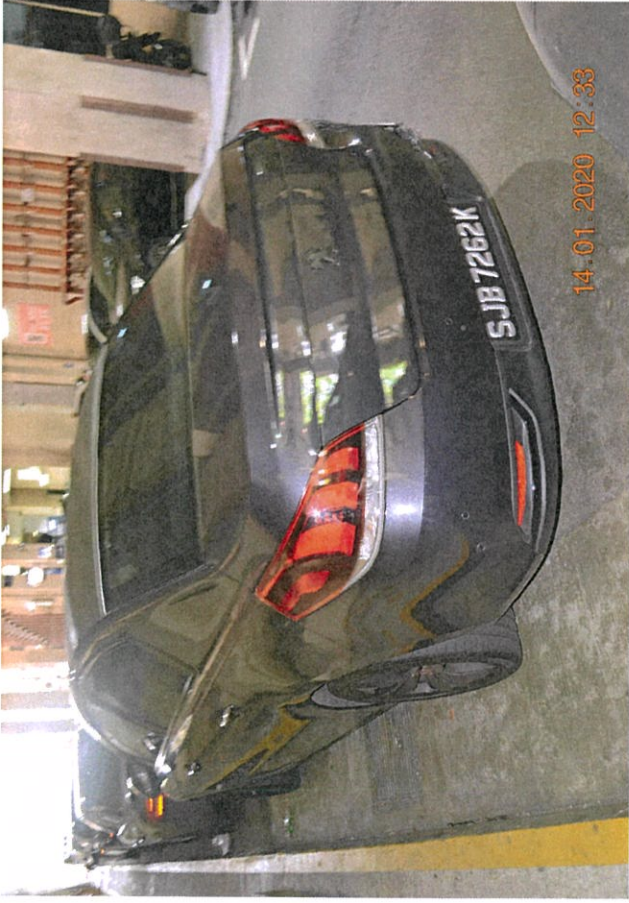
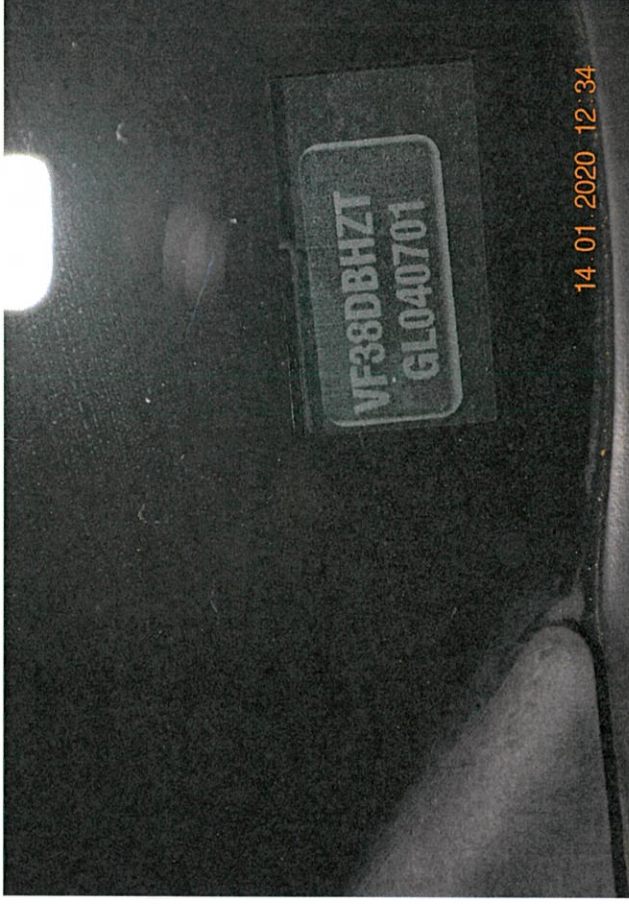
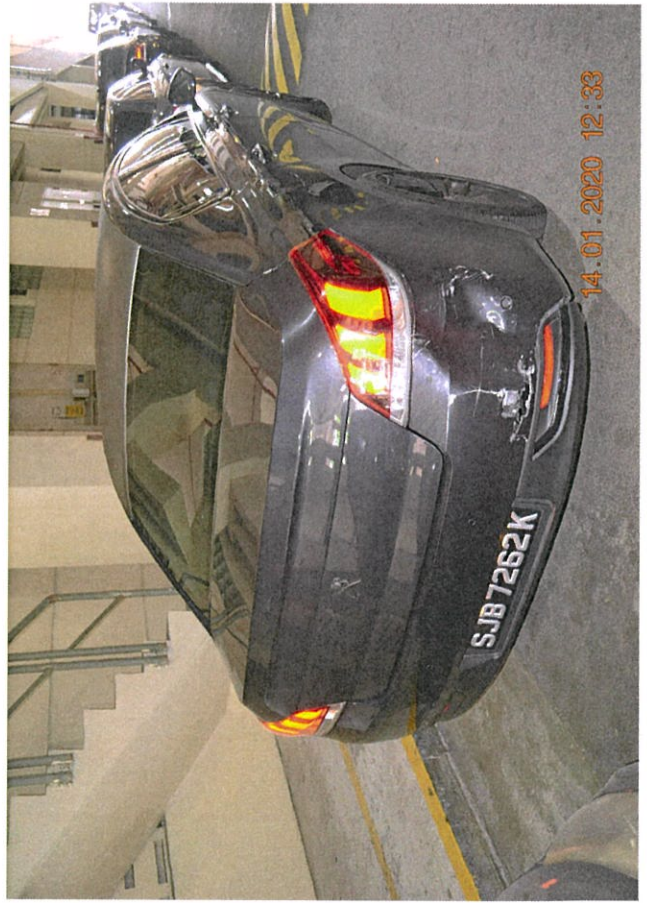
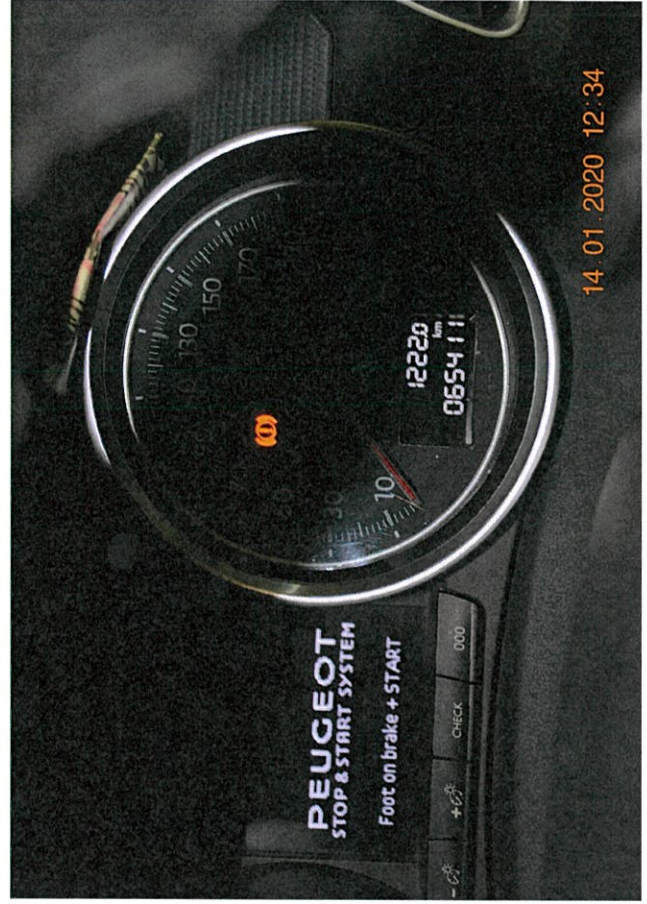
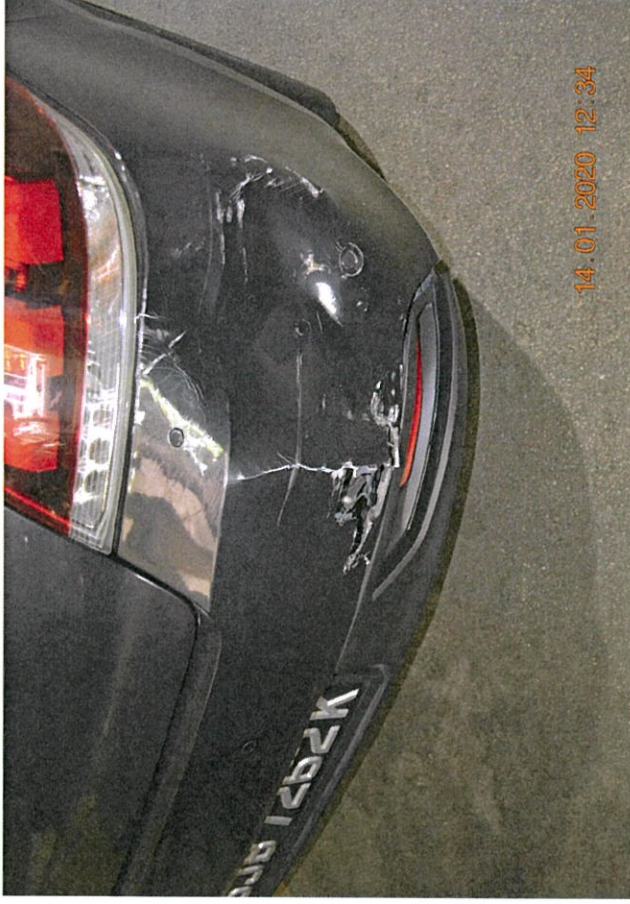
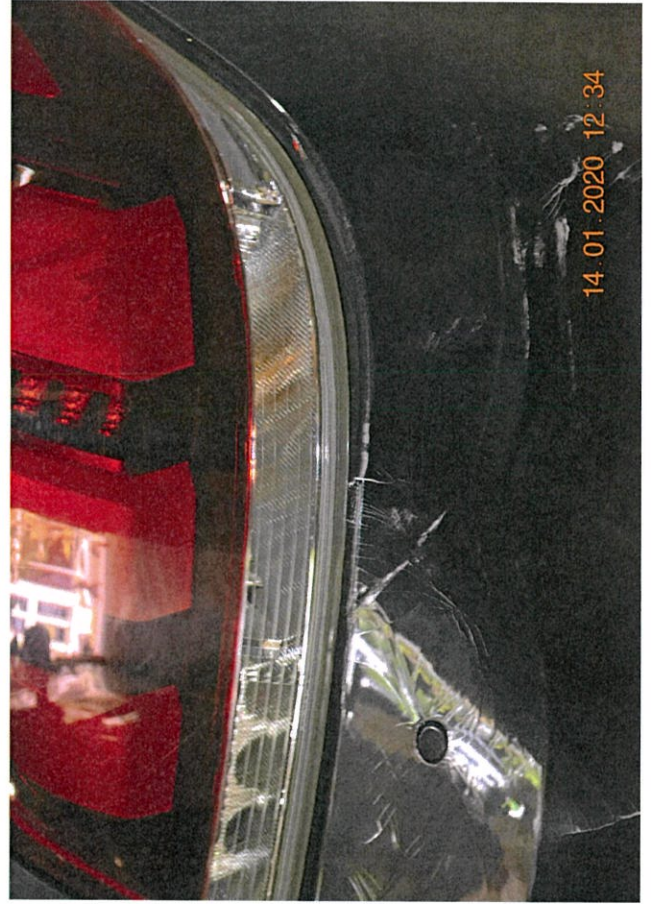
The vehicle sustained damage at the rear portion.  
For details, refer to assessment for repairs and photographs attached.

Enclosed Thirty-five ( 35 ) photographs depicting damage to the vehicle.
