## LKK Auto Consultants Pte Ltd

### PROFESSIONAL SERVICE FEE

Vehicle No. SJU 9085S  
Insured Veh. SMD 2094R  
Claim No. SNM22D205941/C02  
Policy No. DMPCSNW00182002202  
Accident Date 20/08/2022  
Inspection Date 22/08/2022

### ADJUSTMENT ON REPAIR COST FOR VEHICLE NO. SJU 9085S

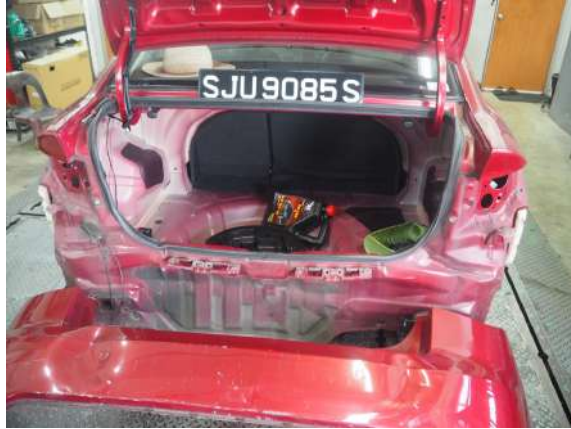
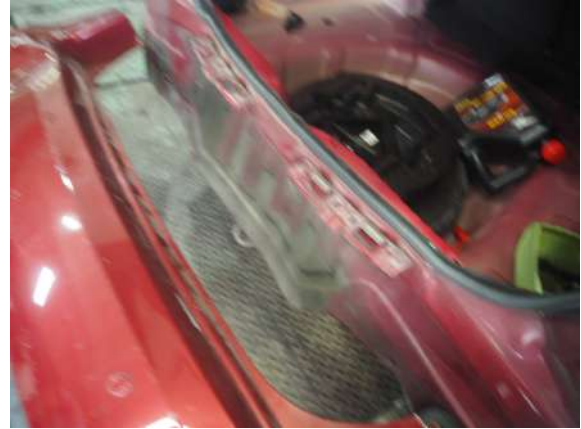
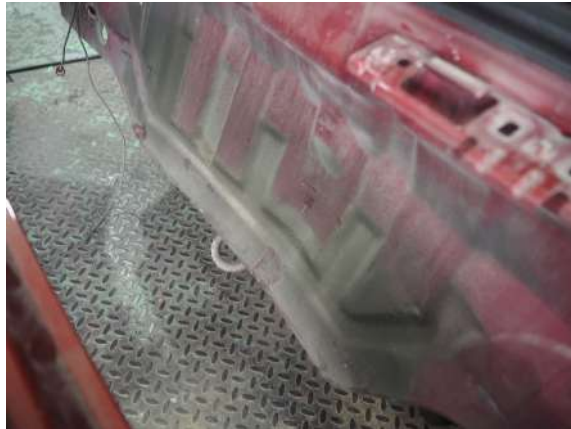
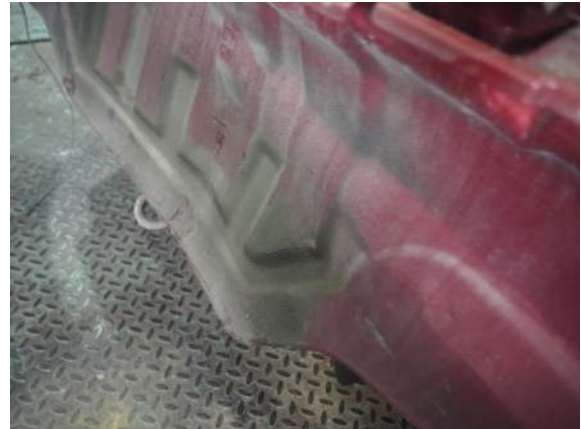
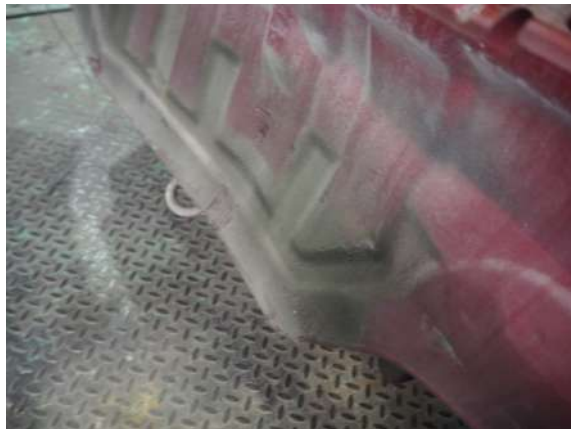
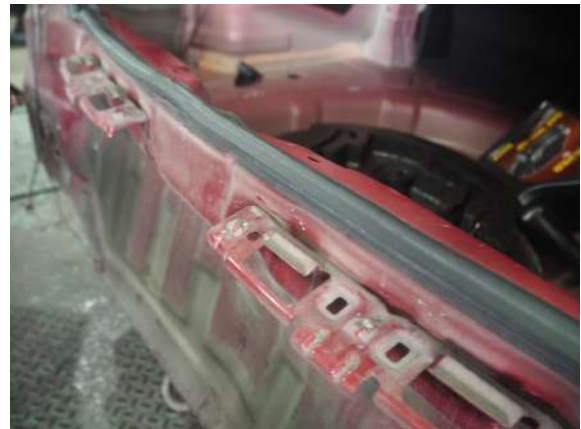
**PHOTOGRAPHS FOR VEHICLE NO. SJU 9085S**

**RE-INSPECTION**

| Affiliated to Federation Internationale Des Experts En Automobile | | | | |
|---|---|---|---|--|
| THE VEHICLE SUSTAINED DAMAGES AT THE REAR PORTION.<br>DAMAGES SEE DETAILS. | | | | |
