## LKK Auto Consultants Pte Ltd

## ADJUSTMENT ON REPAIR COST FOR VEHICLE NO. SMH 525G

### PHOTOGRAPHS FOR VEHICLE NO. SMH 525G

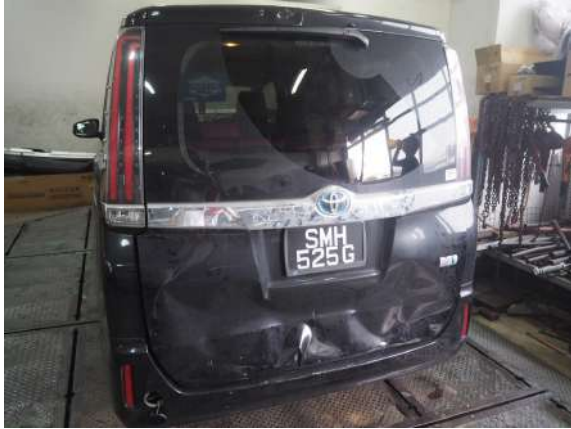
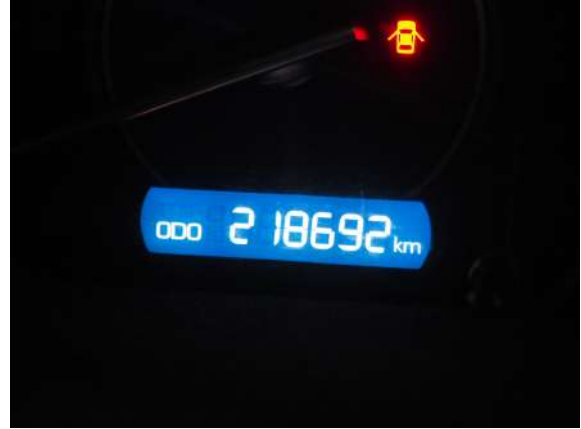
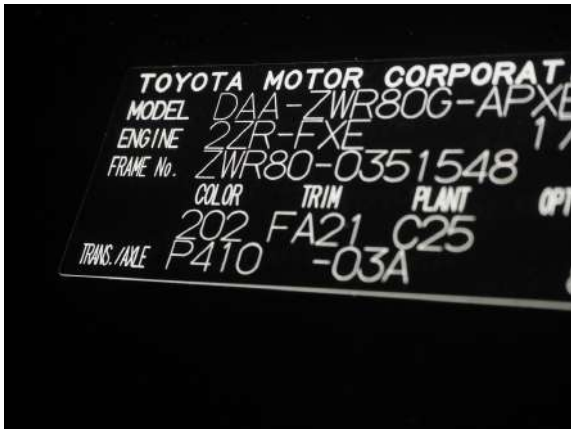
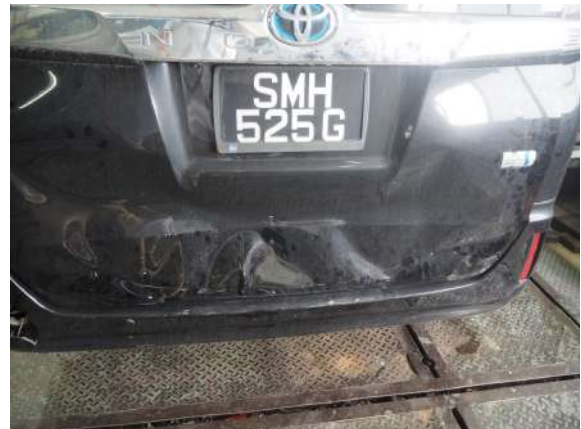
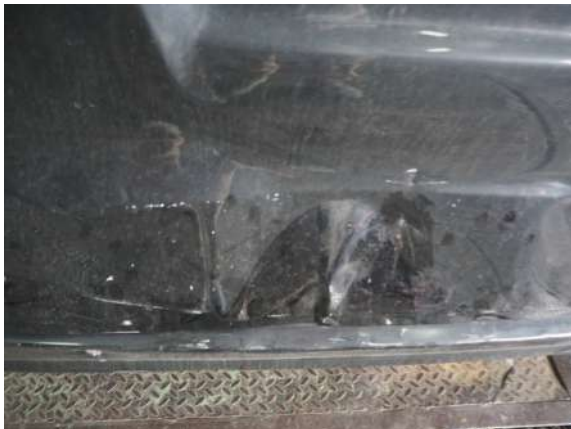
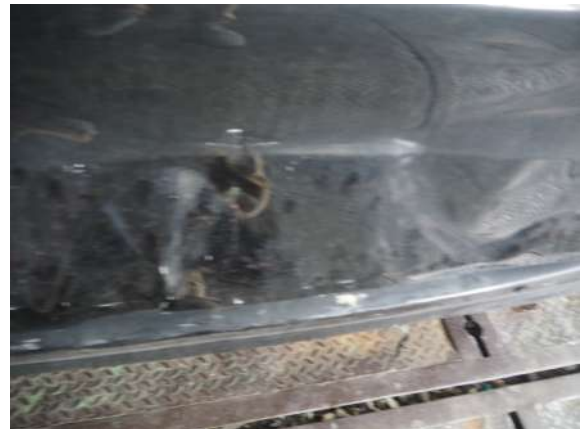
### INSPECTION

| Affiliated to Federation Internationale Des Experts En Automobile | | | | |
|---|---|---|---|--|
| THE VEHICLE SUSTAINED DAMAGES AT THE REAR PORTION.<br>DAMAGES SEE DETAILS. | | | | |

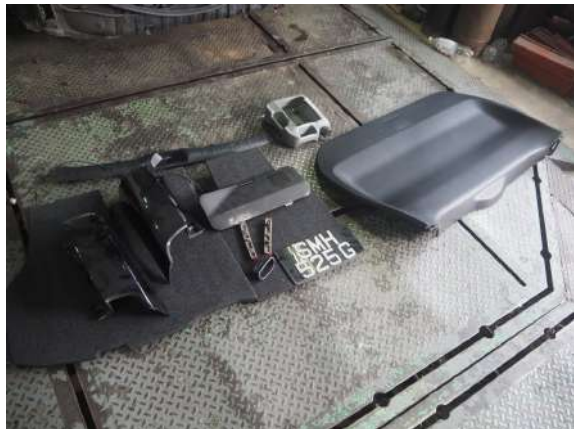
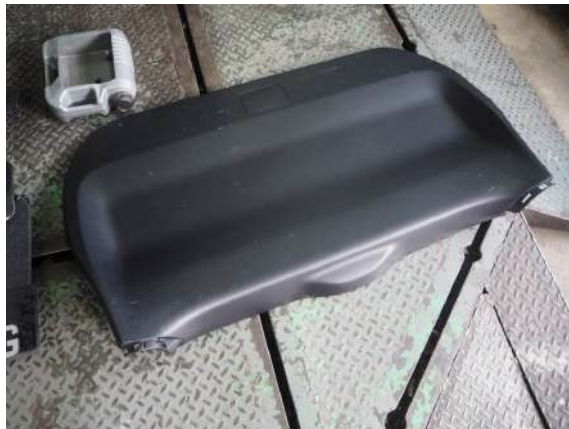
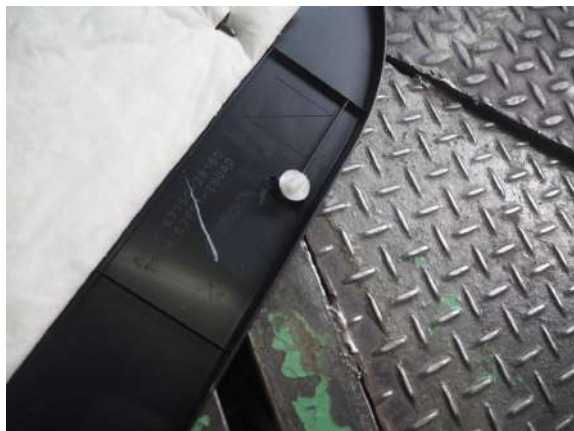
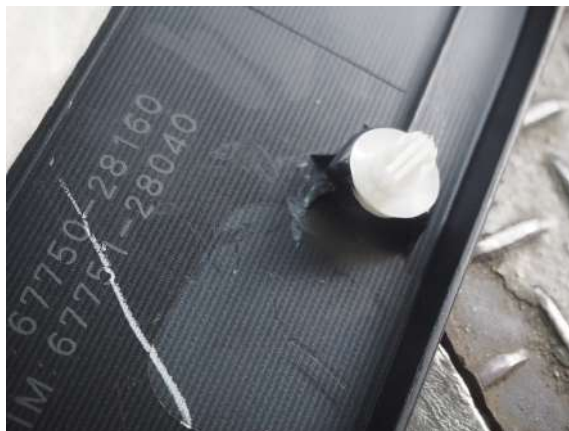
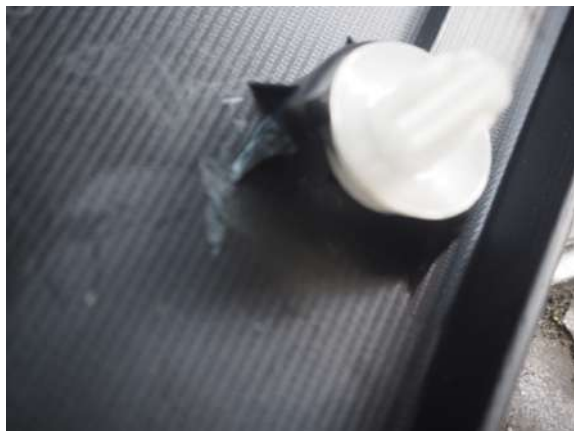
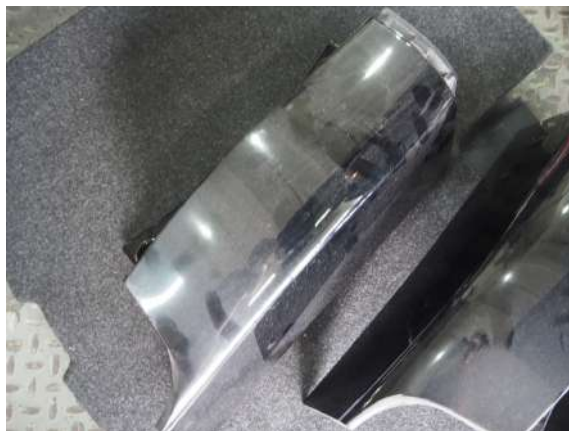
RE-INSPECTION

PHOTOGRAPHS FOR VEHICLE NO. SMH 525G
