PREMIER APPRAISER SERVICES

**Re: Third Party Claim / Workshop :- Hong Huat Motor Services (HQ)
Vehicle Regn. No. : YM 9547 R**

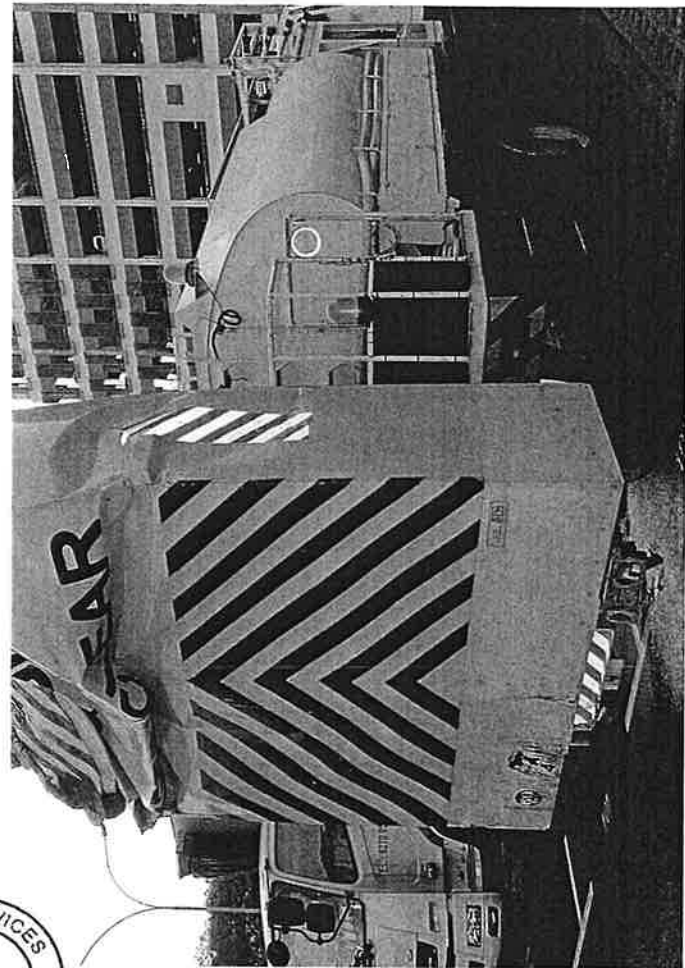
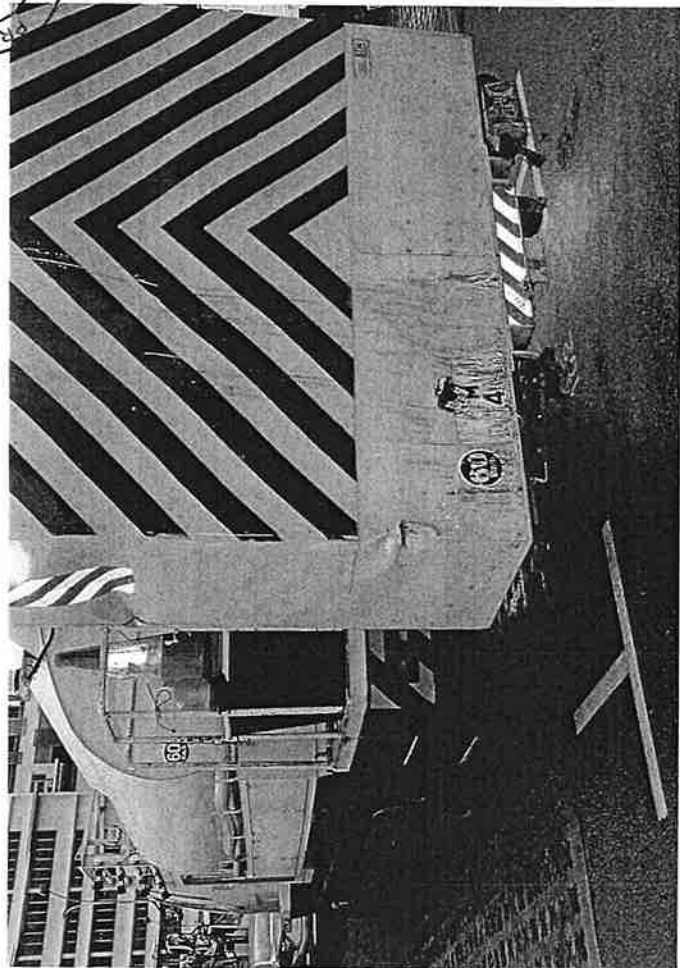
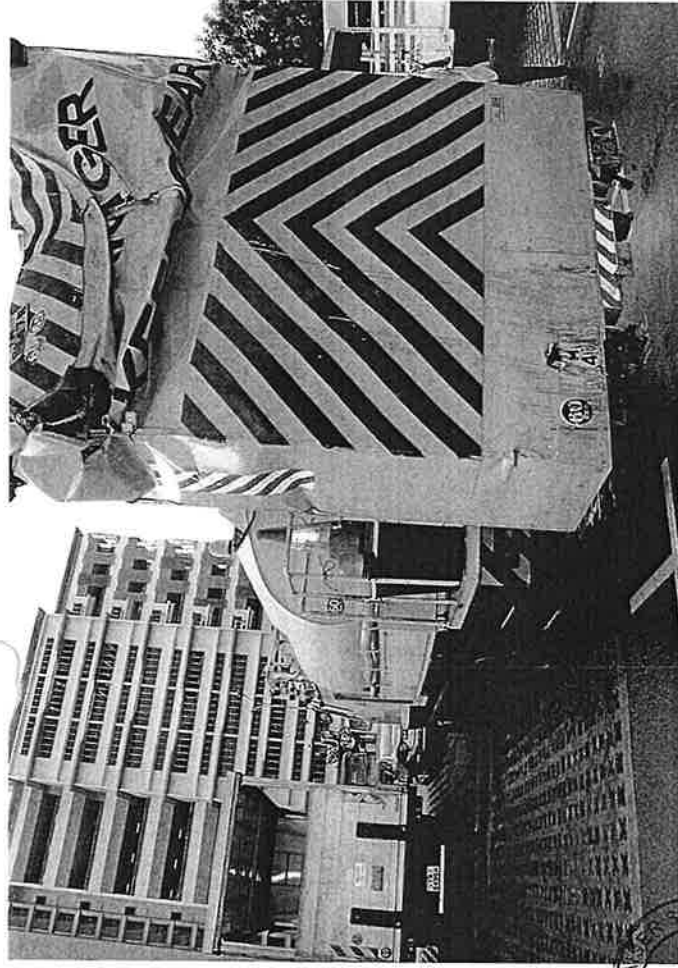
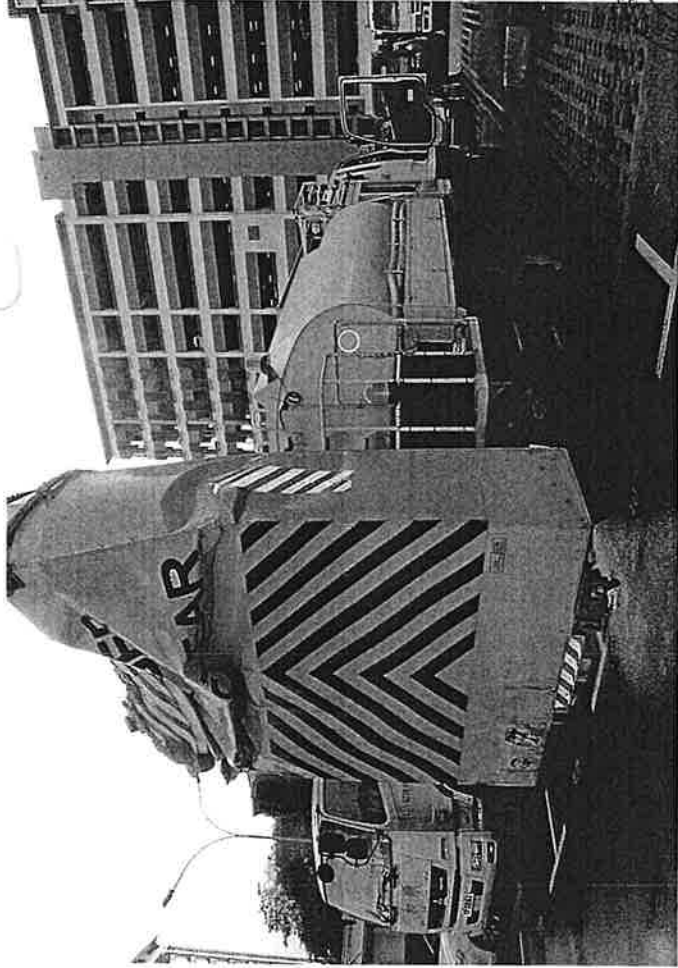
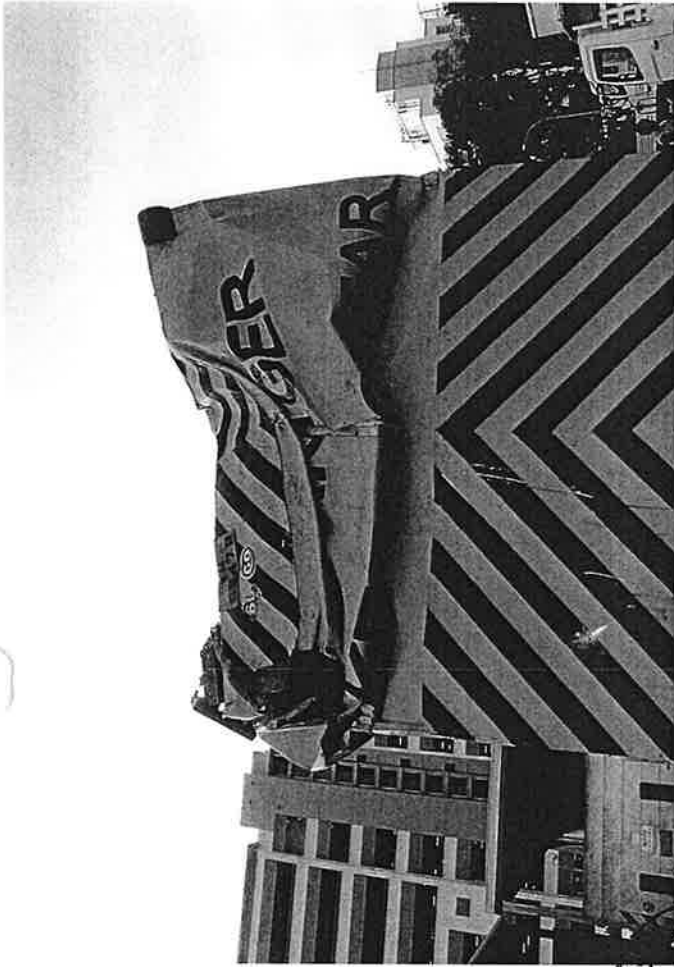
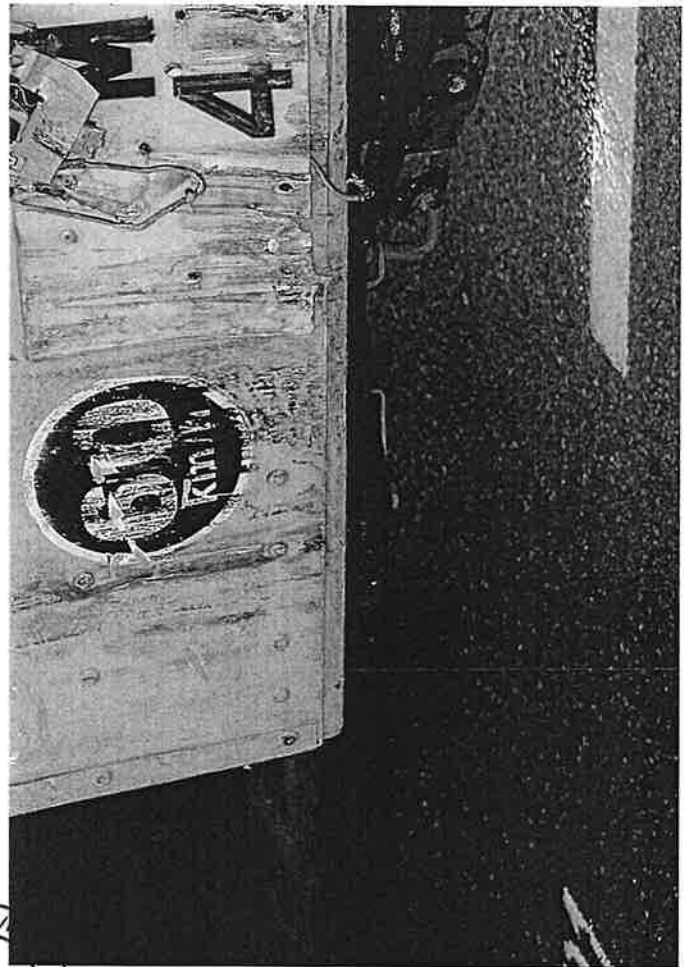
The entire Truck Mounted Attenuator (TMA) was badly crushed/ destroyed. The tail lamps, number plate lamp were cracked/ broken. The TMA quick mount bracket was bent/ distorted.

Under normal circumstances the estimated period of repairs is **SEVEN (7) Days**. Photographs of the damaged vehicle taken by us during our inspection are enclosed.
