### PROFESSIONAL SERVICE FEE

Vehicle No. SLH 7000U  
Insured Veh. YQ 3662J  
Claim No. SNM22D206995/C02  
Policy No. DMCVSNW00041142201  
Accident Date 29/09/2022  
Inspection Date 04/10/2022

## ADJUSTMENT ON REPAIR COST FOR VEHICLE NO. SLH 7000U

### PHOTOGRAPHS FOR VEHICLE NO. SLH 7000U

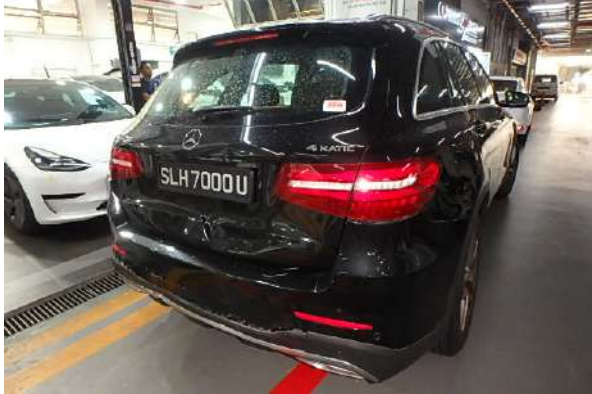
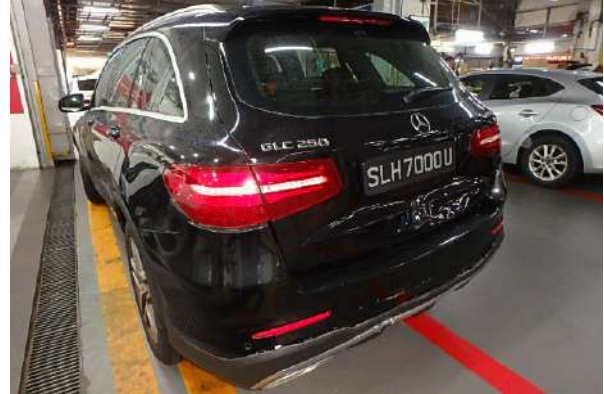
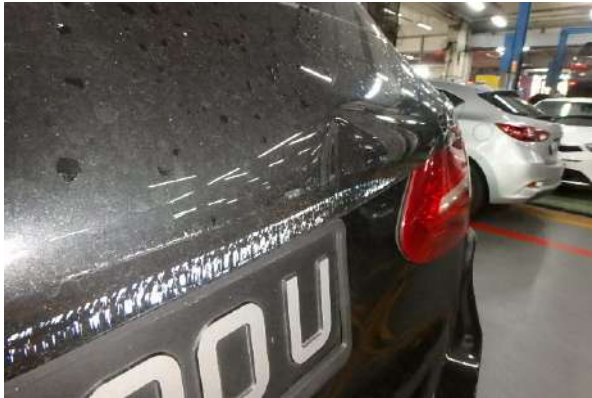
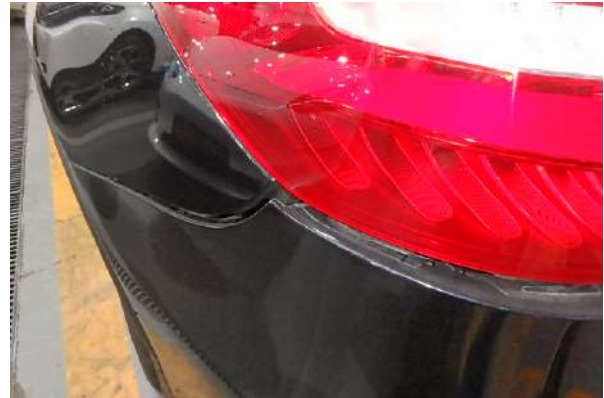
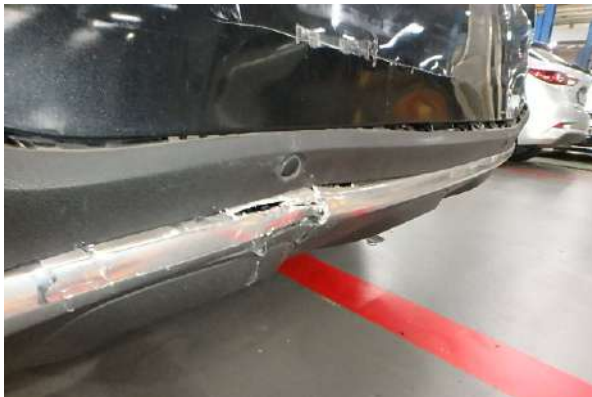
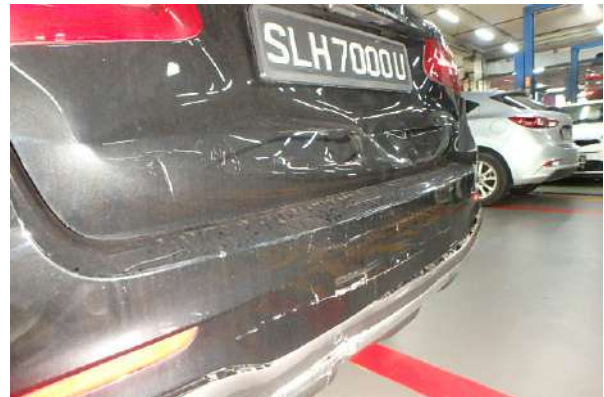
### INSPECTION

| Affiliated to Federation Internationale Des Experts En Automobile | | | | |
|---|---|---|---|--|
| THE VEHICLE SUSTAINED DAMAGES AT THE REAR & FRONT PORTION.<br>DAMAGES SEE DETAILS. | | | | |

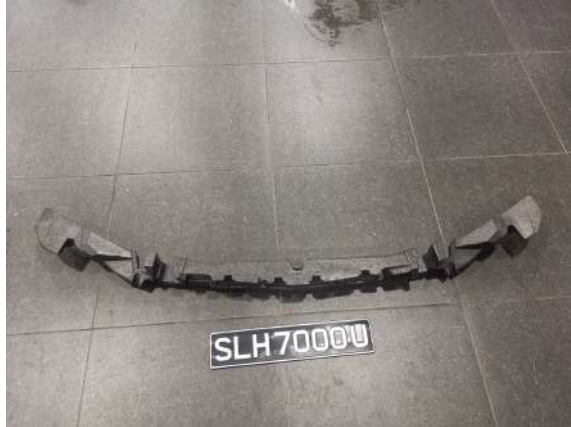
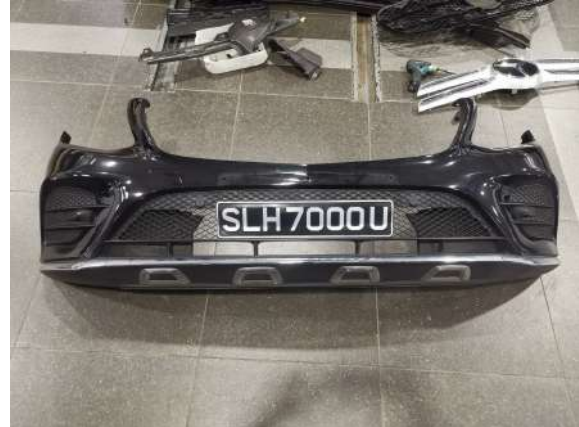
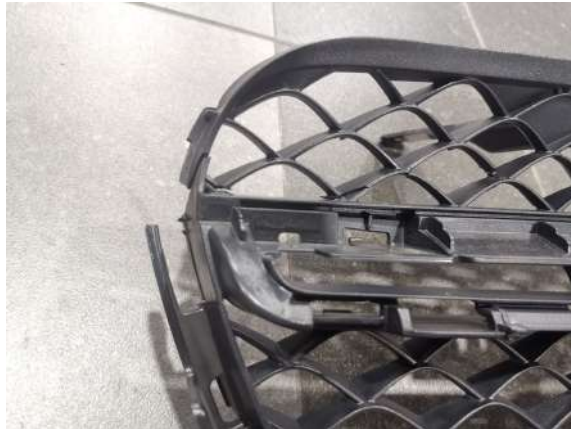
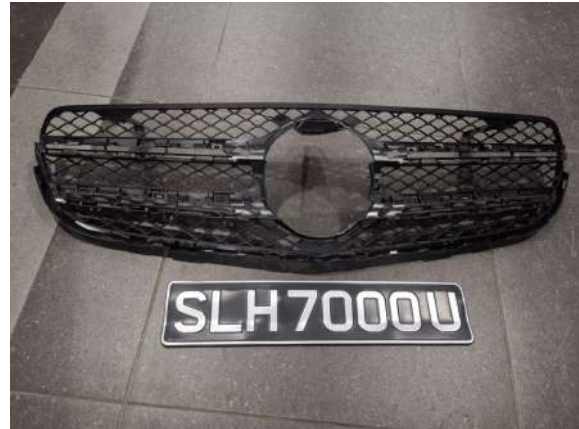
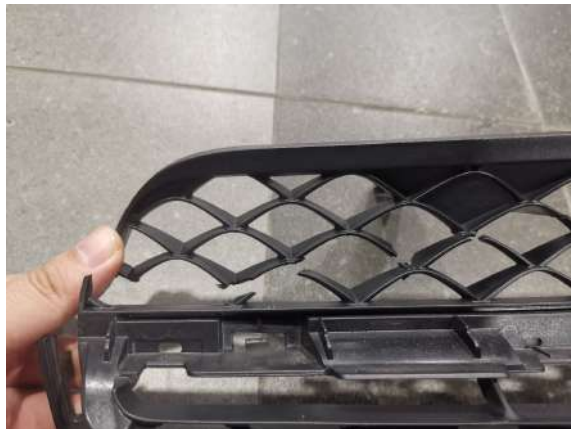
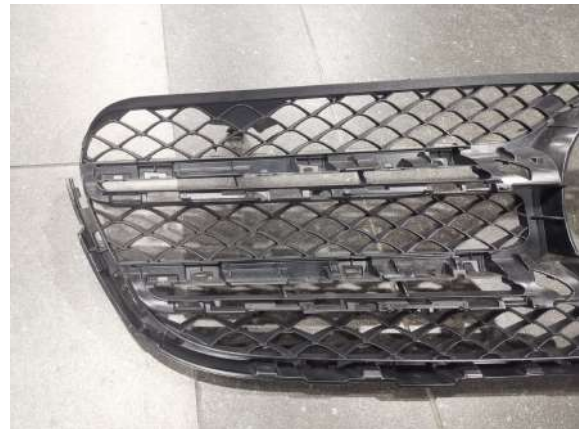
RE-INSPECTION

PHOTOGRAPHS FOR VEHICLE NO. SLH 7000U
