2. Vehicle Particulars & Condition				
Make & Model	TESLA MODEL 3 (A)	c.c	0	
Engine No.	HIDDEN	Year of Reg.	2021	
Chassis No.	LRW3F7FJXMC263263	Colour	METALLIC PEARL WHITE	
Odometer	21189 KM	Steering	IN ORDER	
Brakes	IN ORDER	Modification	STANDARD ALLOY RIM	
General	GOOD

4. Description of Damages				
THE VEHICLE SUSTAINED DAMAGES AT THE O/S REAR PORTION. DAMAGES SEE DETAILS.				
5. General Information				
Accident Date	29/09/2022	Inspection Date	04/10/2022	
Survey held at	OPTIMA WERKZ PTE LTD 10 ANG MO KIO INDUSTRIAL PARK 2A #01-05 AMK AUTOPOINT SINGAPORE 568047			
5a. Remarks				
A)THE INSPECTION WAS CONDUCTED ON A"WITHOUT PREJUDICE" BASIS. B)IN ACCORDANCE TO YOUR INSTRUCTIONS, WE HAVE NOT AUTHORISED REPAIRS.				
5b. Estimate Days of Repair				
ESTIMATED NORMAL PERIOD FOR REPAIR:			5 Working Days

ADJUSTMENT ON REPAIR COST FOR VEHICLE NO. SJH 8966A

PHOTOGRAPHS FOR VEHICLE NO. SJH 8966A

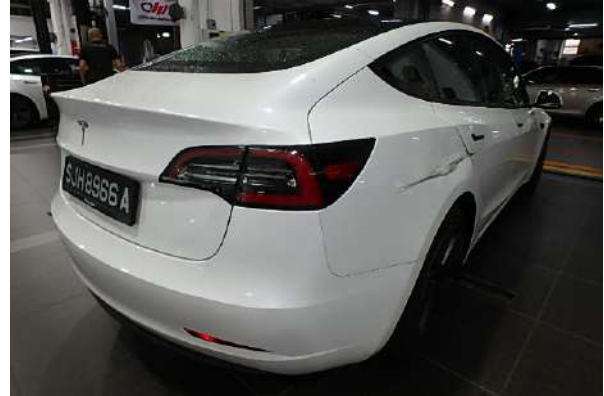
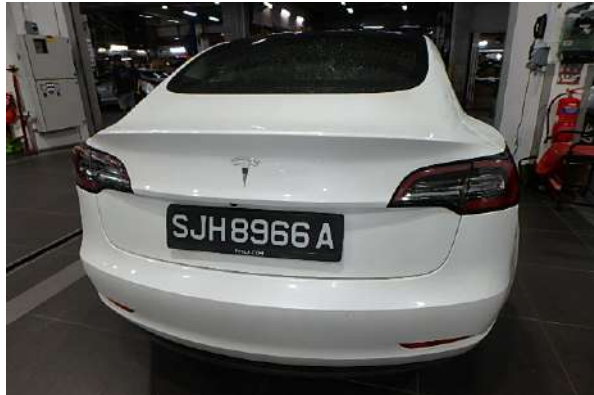
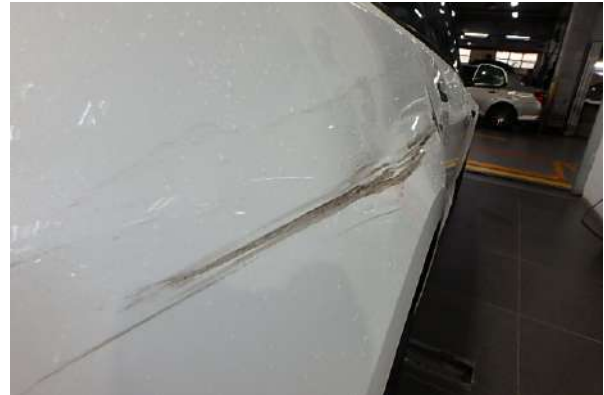
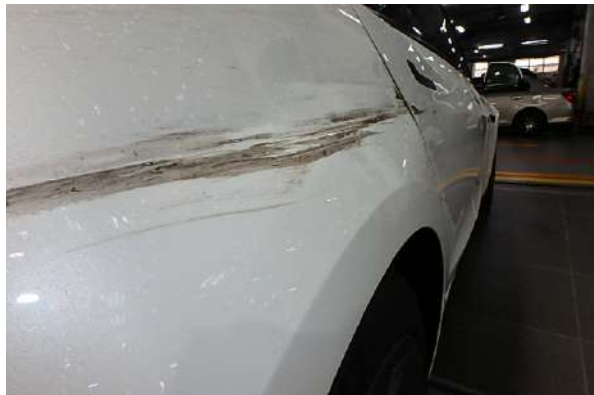
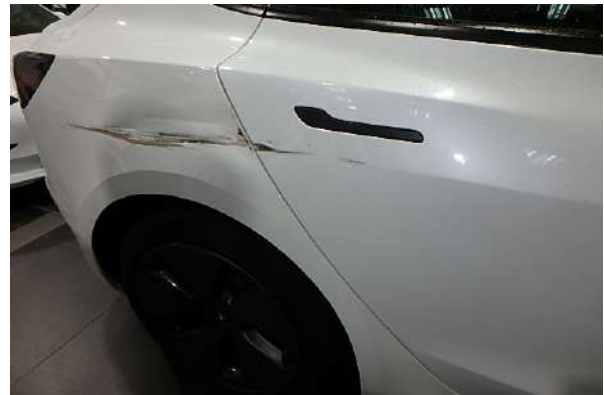
INSPECTION

Qty	Description of Parts	Condition	Estimate By Workshop (\$)	Our Adjusted (\$)
	<u>REPLACEMENT OF PARTS</u>			
1	REAR DOOR RH	TO REPAIR SEE LABOUR	953.27	-
1	REAR DOOR WEATHERSTRIP RH	SERVICEABLE	88.79	-
1	REAR FENDER RH	BENT	1,345.79	1,345.79
1	REAR FENDER QUARTER GLASS RH	MTG NECESSARY	280.37	280.37
	LESS 10% DISCOUNT		-266.82	-162.62
			2,401.40	1,463.54
	<u>SPECIAL NETT ITEMS</u>			
1	REAR DOOR INNER TRIM BOARD CLIPS (SN)	NOT NECESSARY	50.00	-
1	REAR FENDER QUARTER GLASS SEALANT RH (SN)	NECESSARY	80.00	40.00
