2. Vehicle Particulars & Condition			
Make & Model	TOYOTA PRIUS	c.c	1798
Engine No.	HIDDEN	Year of Reg.	2018
Chassis No.	JTDKB3FU903076118	Colour	M. P. WHITE / RED
Odometer	570505 KM	Steering	IN ORDER
Brakes	IN ORDER	Modification	STANDARD ALLOY RIM
General	GOOD

ADJUSTMENT ON REPAIR COST FOR VEHICLE NO. SHD 9070Y

PHOTOGRAPHS FOR VEHICLE NO. SHD 9070Y

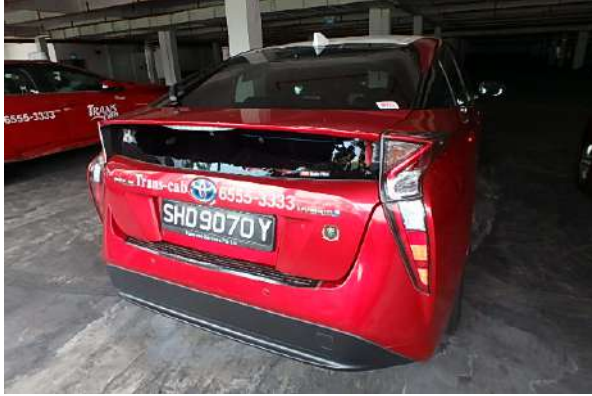
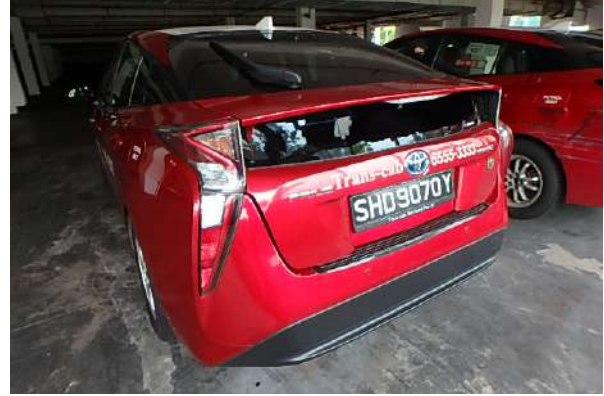
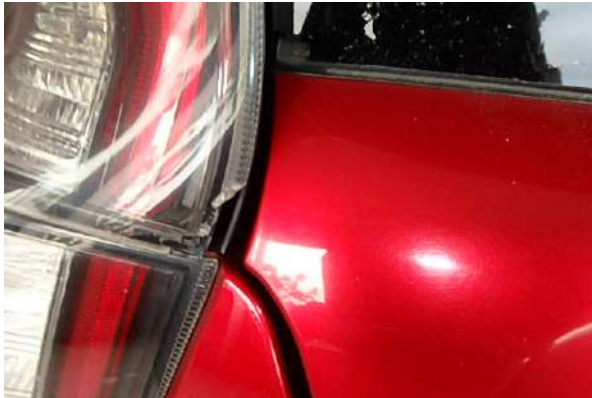
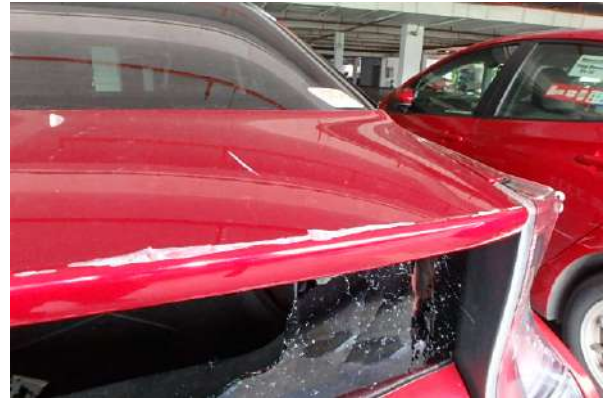
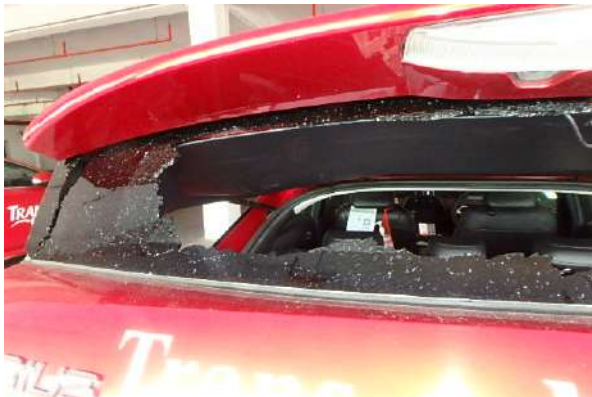
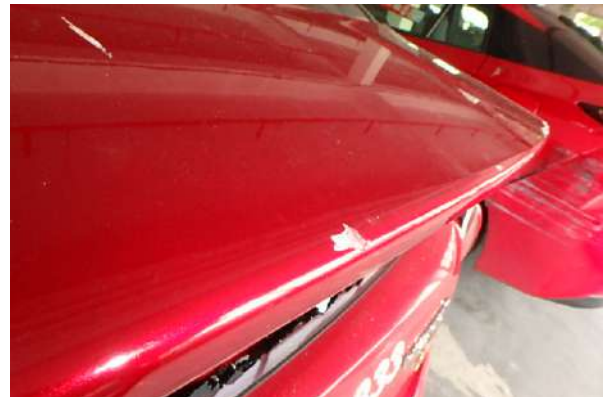
4. Description of Damages			
THE VEHICLE SUSTAINED DAMAGES AT THE REAR PORTION. DAMAGES SEE DETAILS.			
5. General Information			
Accident Date	06/10/2022	Inspection Date	10/10/2022
Survey held at	TRANS-CAB AUTO SERVICES PTE LTD NO.2 ANG MO KIO ST 63 SINGAPORE 569111		
5a. Remarks			
A)THE INSPECTION WAS CONDUCTED ON A"WITHOUT PREJUDICE" BASIS. B)IN ACCORDANCE TO YOUR INSTRUCTIONS, WE HAVE NOT AUTHORISED REPAIRS.			
5b. Estimate Days of Repair			
ESTIMATED NORMAL PERIOD FOR REPAIR:		4 Working Days

INSPECTION
