RE: **Road Traffic Accident on 29-04-2022**  
**Foong Khai Weng**

In accordance with your instructions received in this office on **29-04-2022**, we made arrangements to examine the vehicle on **29-04-2022** at above-mentioned address. The following data was recorded:

**Vehicle details**

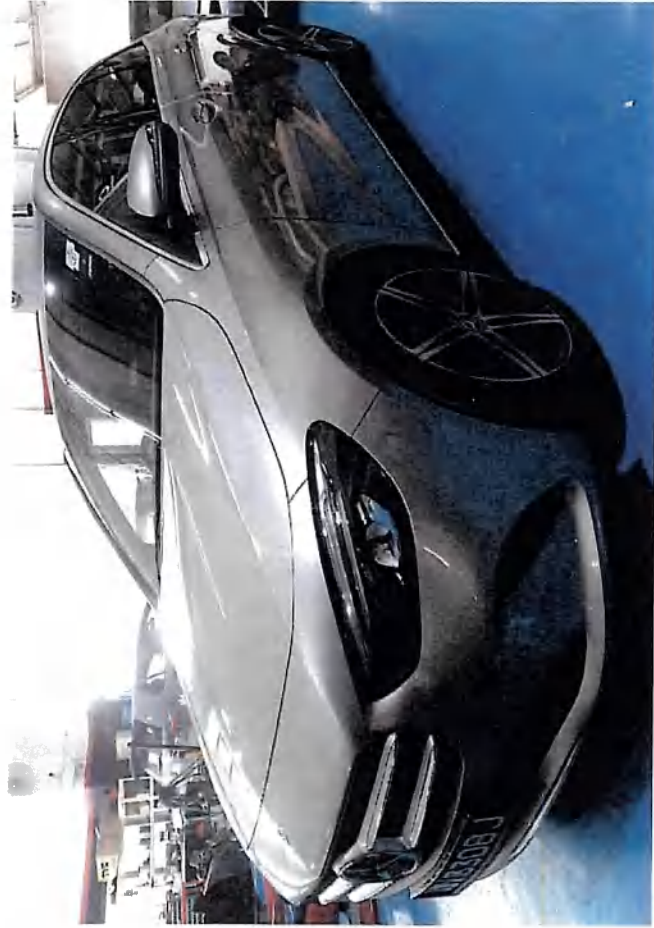
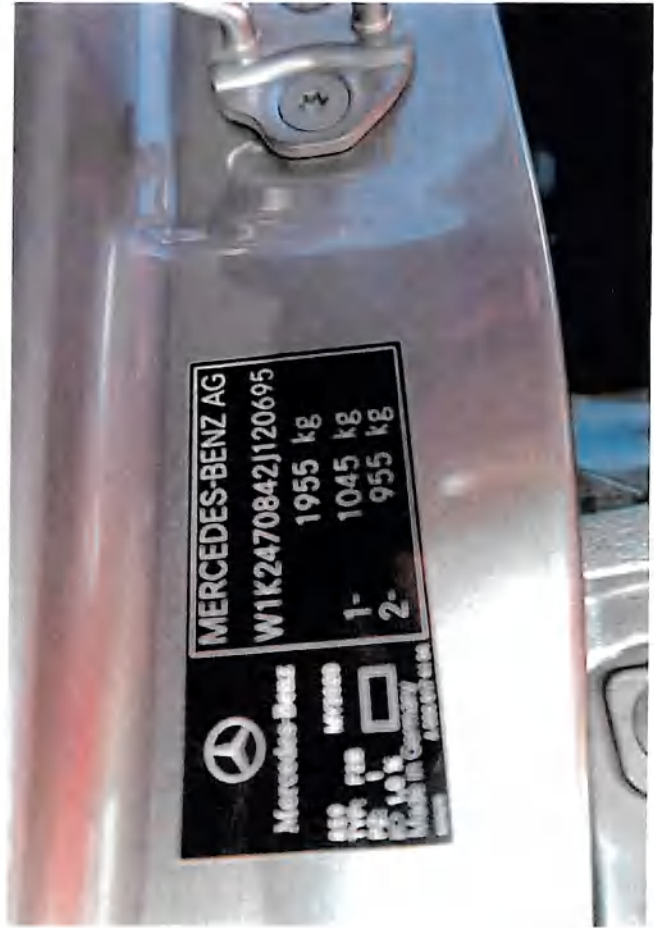
MERCEDES-BENZ AG  
W1K2470842J120695  
1955 kg  
1045 kg  
955 kg  
1- 2-  
Mercedes-Benz  
W1K2470842J120695  
1955 kg  
1045 kg  
955 kg  
Made in Germany  
1.600.000.000
