LKK Auto Consultants Pte Ltd

Ref: CC4/LPC22010153/Kpa3q2

ADJUSTMENT ON REPAIR COST FOR VEHICLE NO. SJM 728Y

PHOTOGRAPHS FOR VEHICLE NO. SJM 728Y

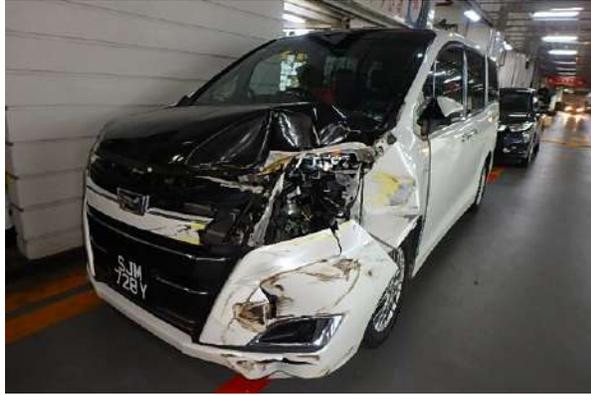
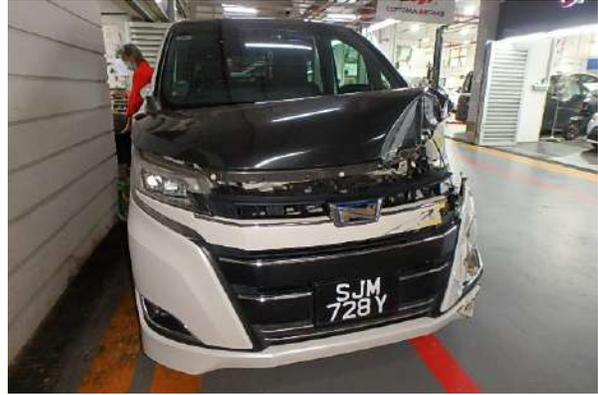
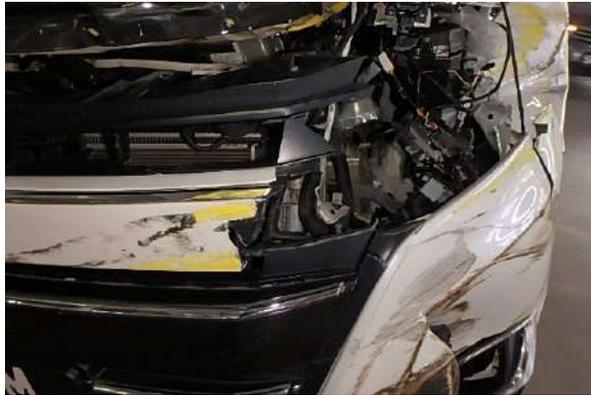
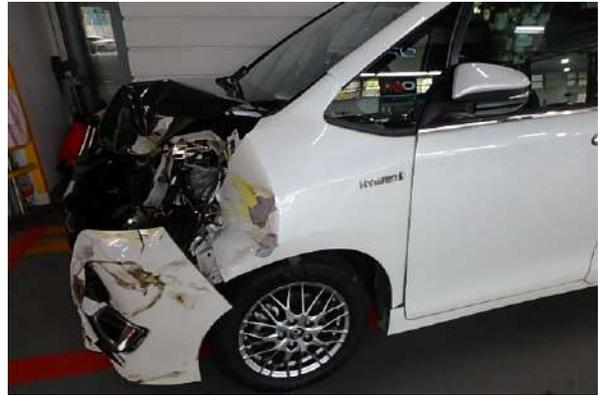
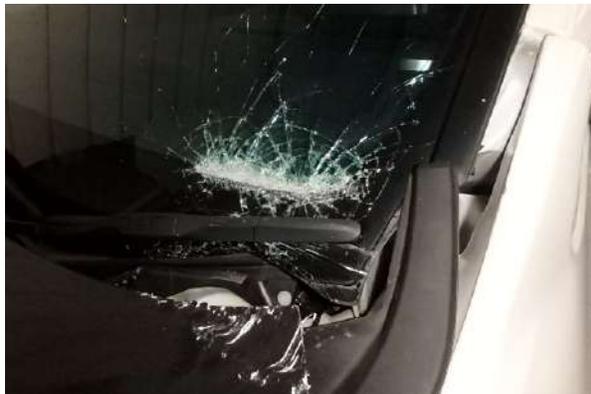
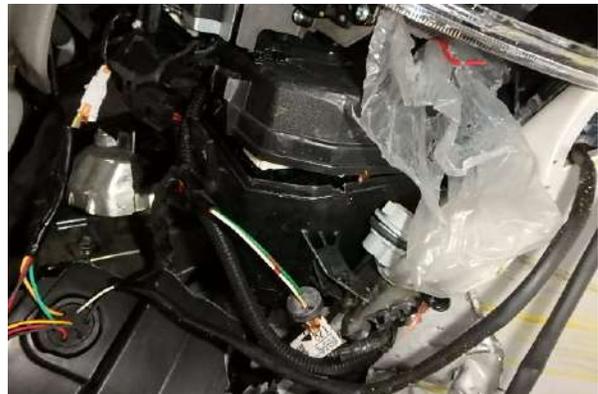
INSPECTION

THE VEHICLE SUSTAINED DAMAGES AT THE FRONT N/S PORTION.
DAMAGES SEE DETAILS.

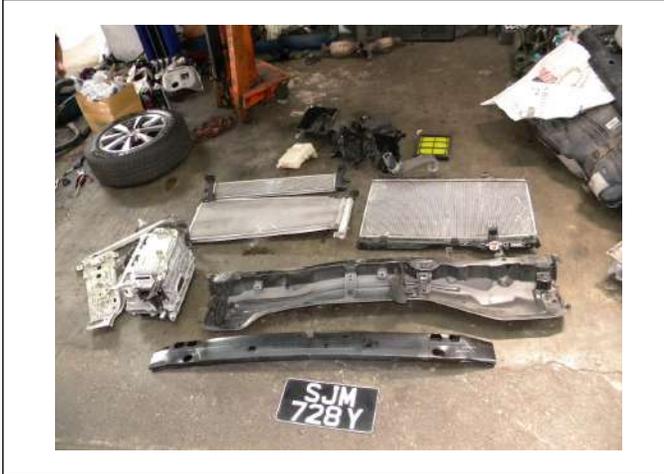
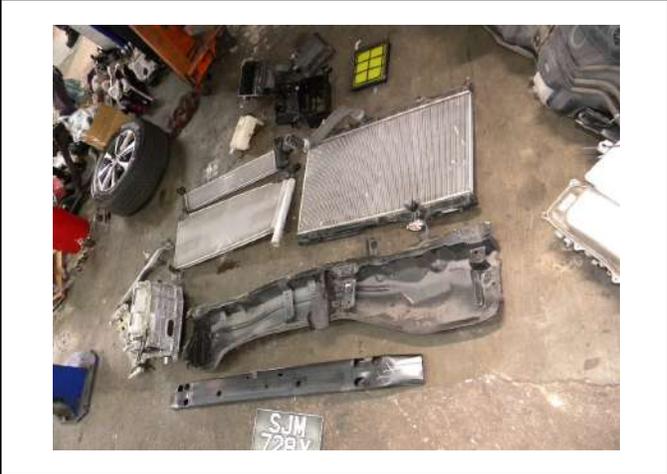
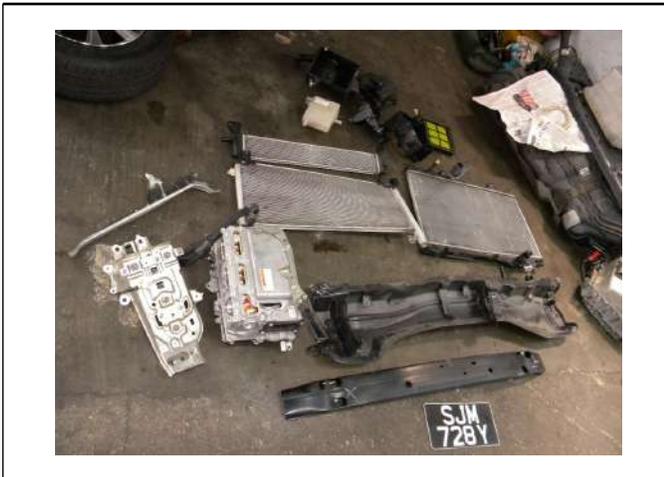
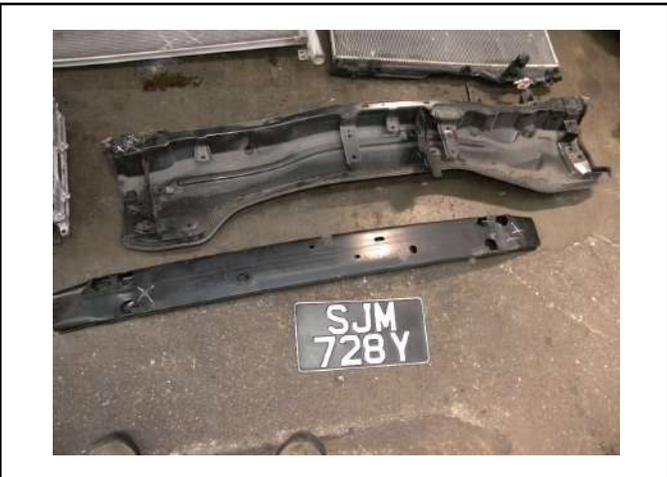
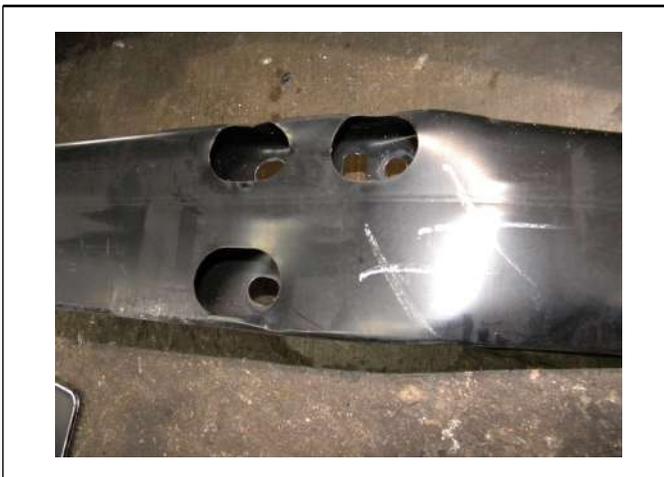
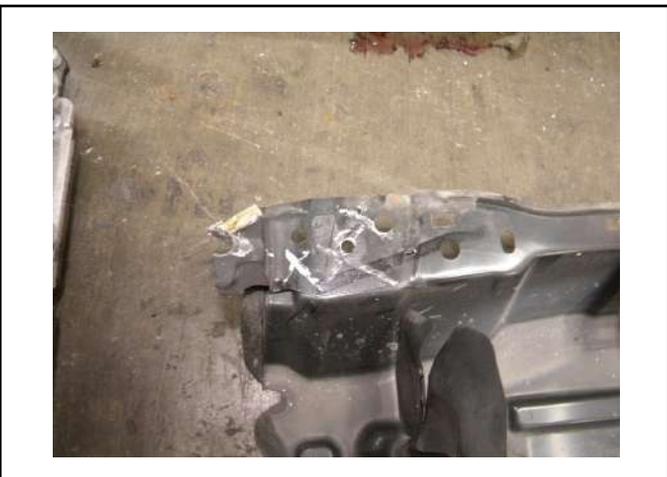
RE-INSPECTION

PHOTOGRAPHS FOR VEHICLE NO. SJM 728Y
