## LKK Auto Consultants Pte Ltd

### PROFESSIONAL SERVICE FEE

Vehicle No. SKZ 4822B

## ADJUSTMENT ON REPAIR COST FOR VEHICLE NO. SKZ 4822B

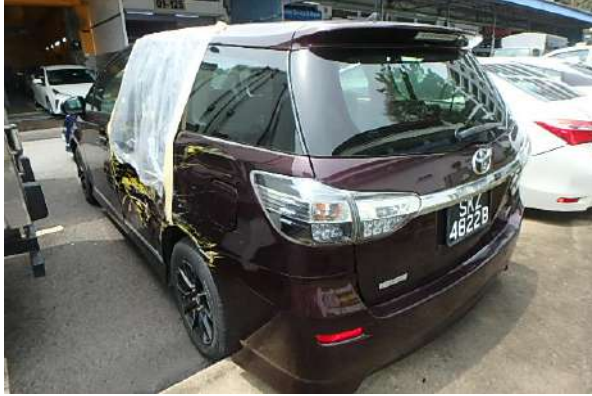
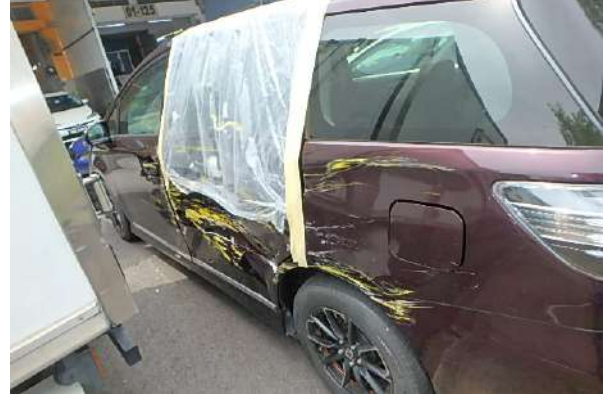
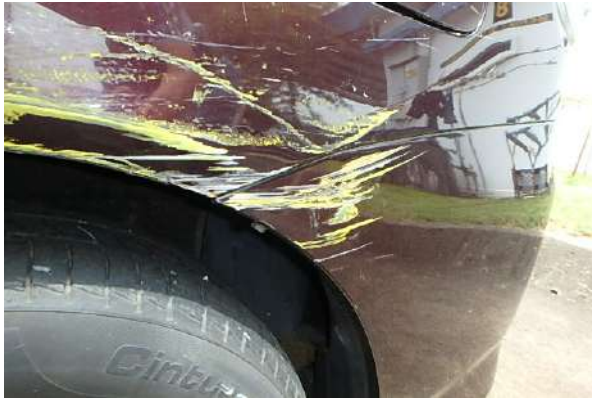
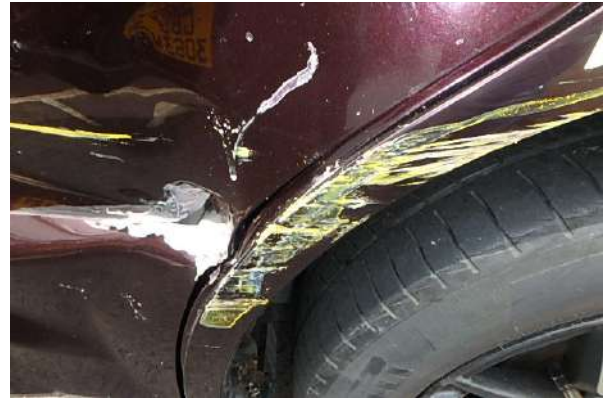
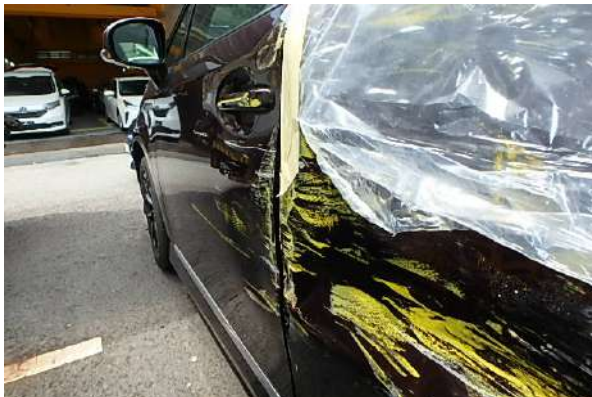
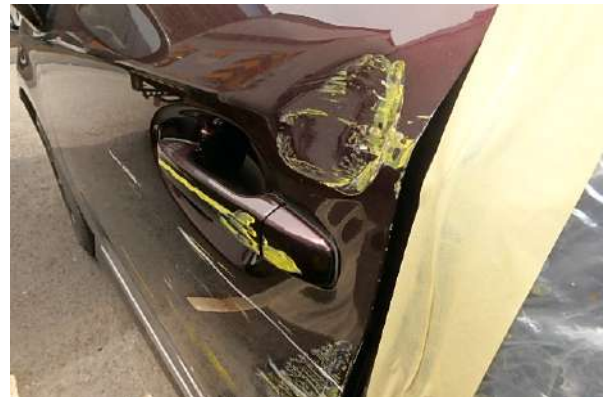
**PHOTOGRAPHS FOR VEHICLE NO. SKZ 4822B**

| Affiliated to Federation Internationale Des Experts En Automobile | | | | |
|---|---|---|---|--|
| THE VEHICLE SUSTAINED DAMAGES AT THE FRONT PORTION & N/S BODY.<br>DAMAGES SEE DETAILS. | | | | |

**INSPECTION**

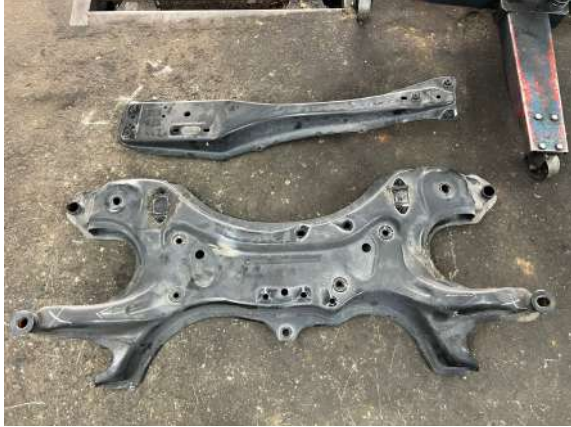
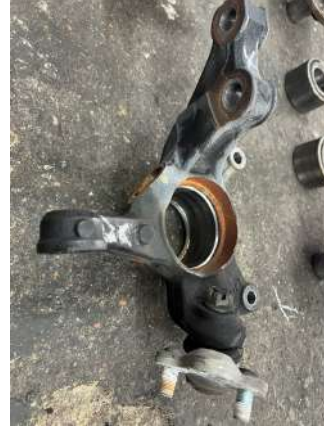
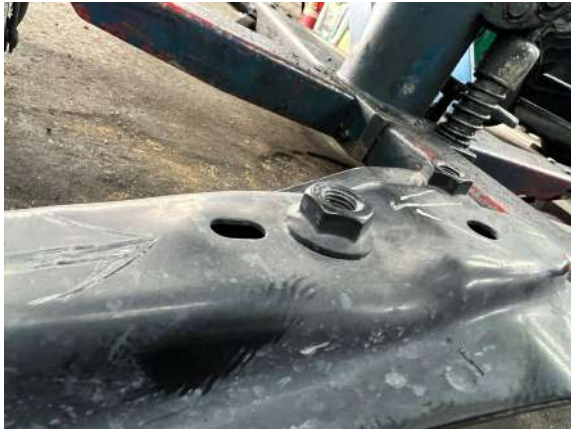
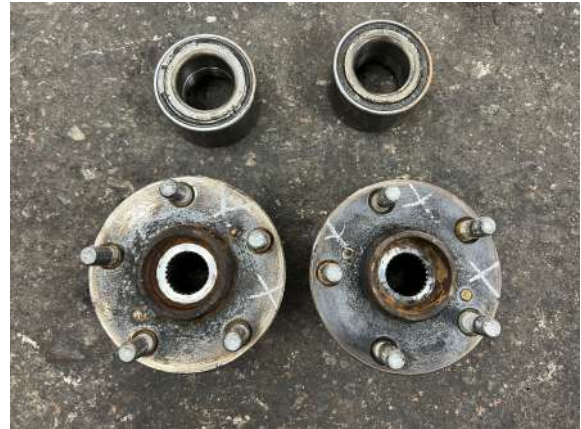
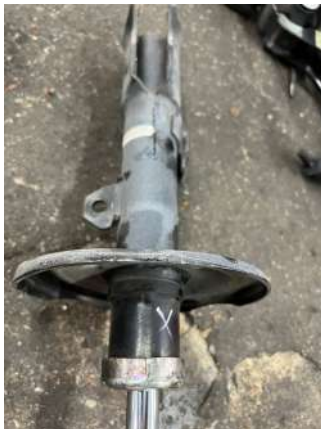
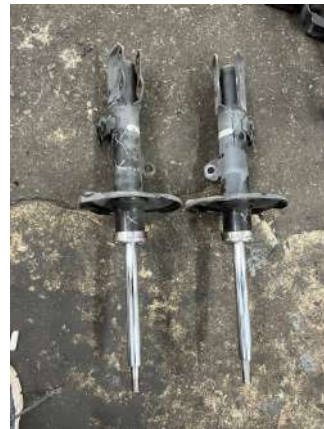
**PHOTOGRAPHS FOR VEHICLE NO. SKZ 4822B**

**RE-INSPECTION**
