Description		Amount
Vehicle No:	PA87E	
Make & Model:	Isuzu LT134P (Bus) 49 Seater	
Our reference:	AAS/2021/030	
Services rendered for appraiser / inspection report		
Survey Fee		
Photographs		
Transport Fees		
Re-inspection Fees		
SGD Dollar : Four hundred thirty nine dollar only	Total:	SGD \$ 439.00

**ABSOLUTE APPRAISAL SERVICES PTE LTD
LOSS ADJUSTERS & MOTOR APPRAISERS**

Vehicle Inspection Report

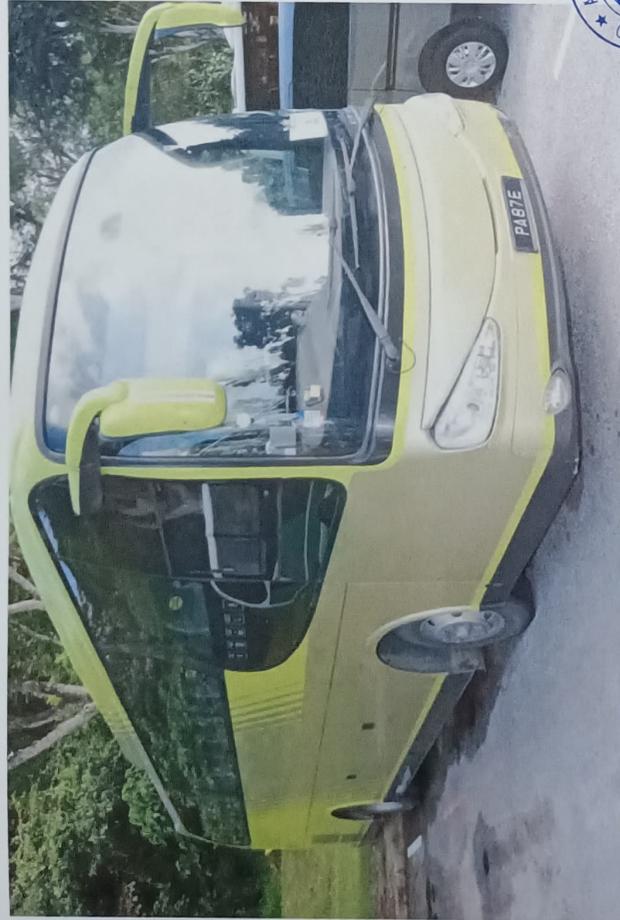
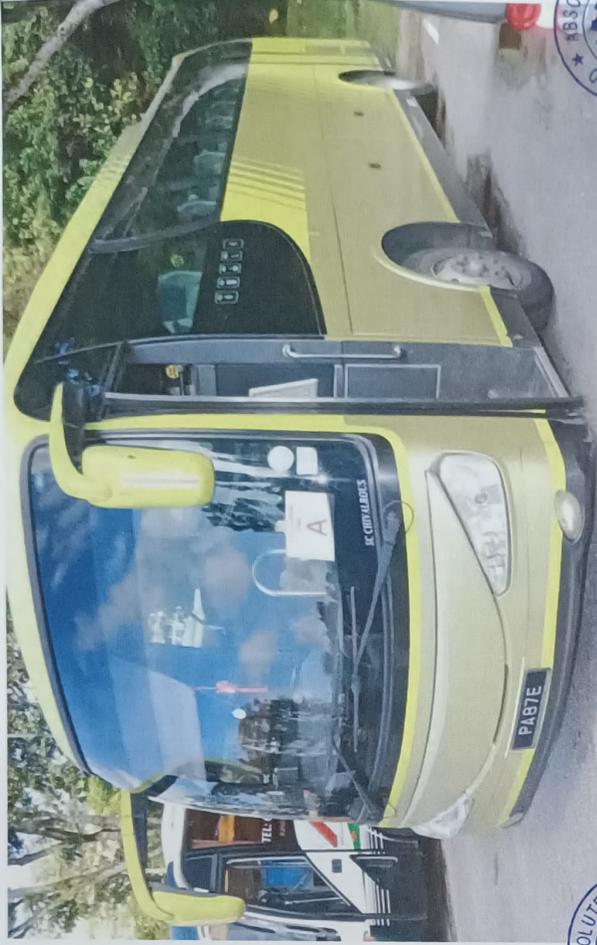
CHASSIS NO.: JALLT134PA7000118
U.W. : 10720 KG
M.L.W. : 15200 KG
TYRE SIZE : F.11R-22.5-14
: R.11R-22.5-14(D)
PASS. CAP. : 1 DRIVER ONLY
: 49 PASSENGERS
