## VEHICLE INSPECTION REPORT

Registration No : SJM 2387 J

Make / Model : Chevrolet/ Chevy Aveo

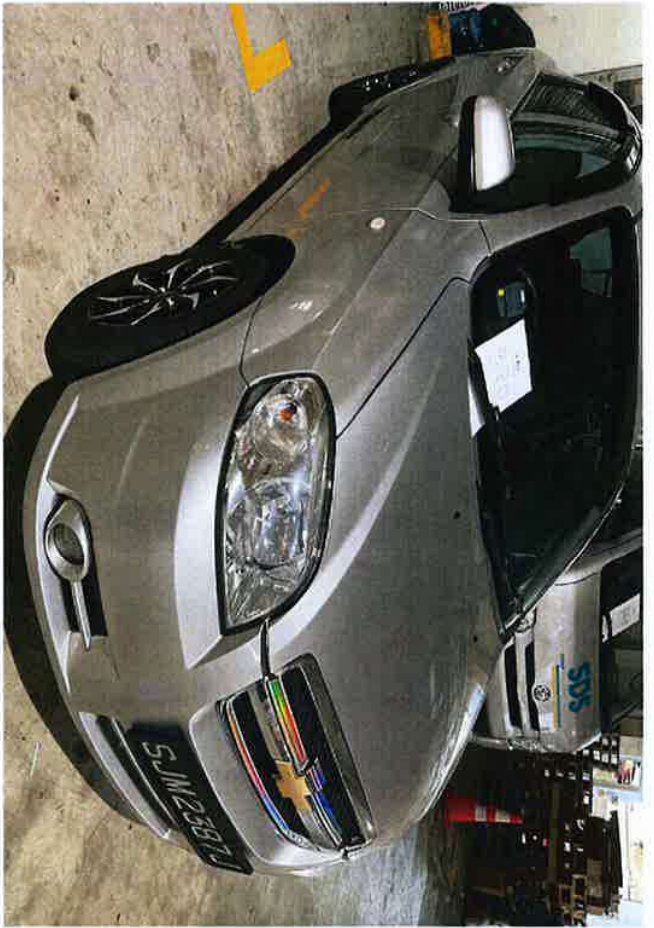
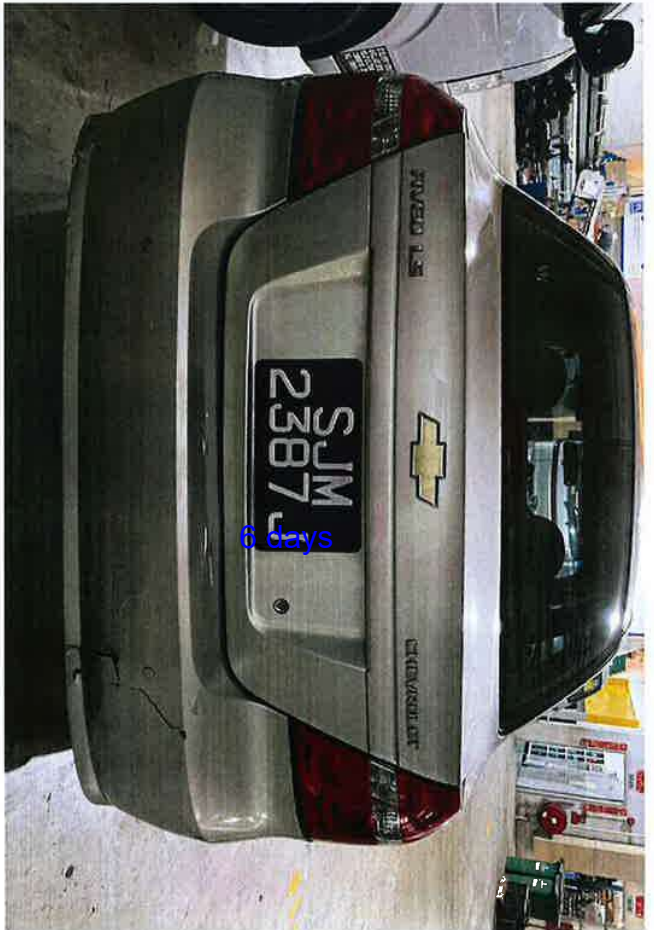
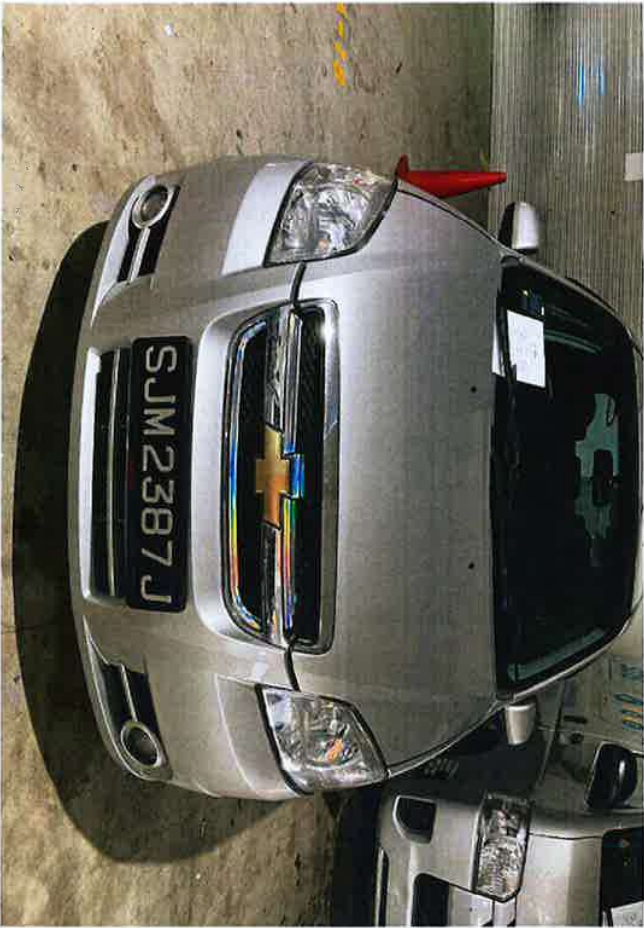
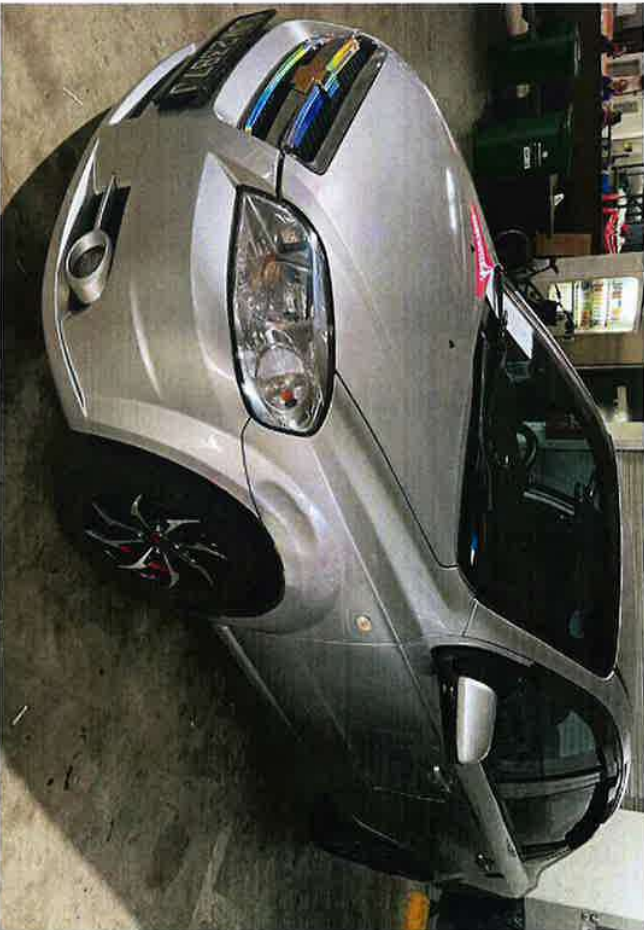
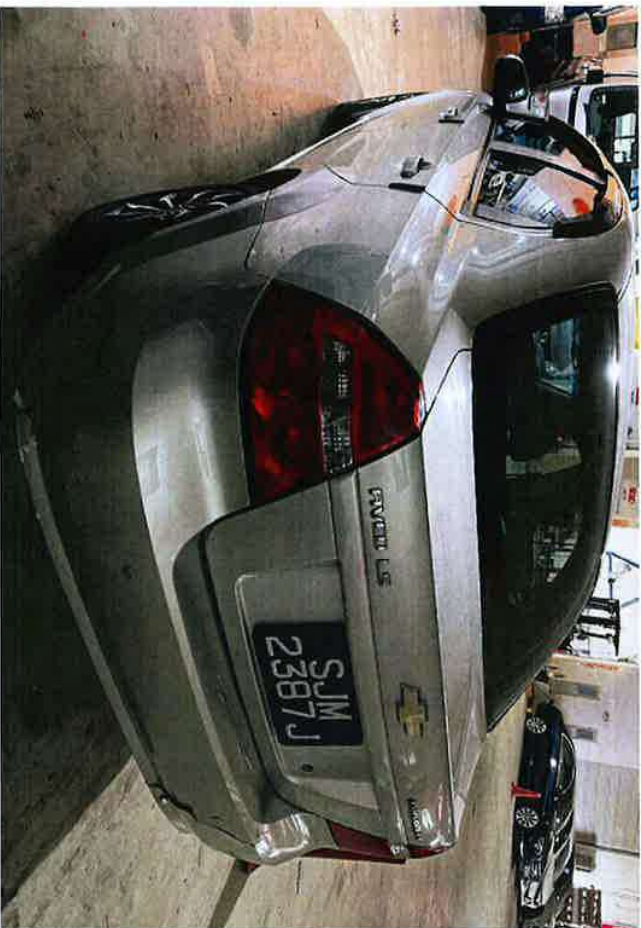
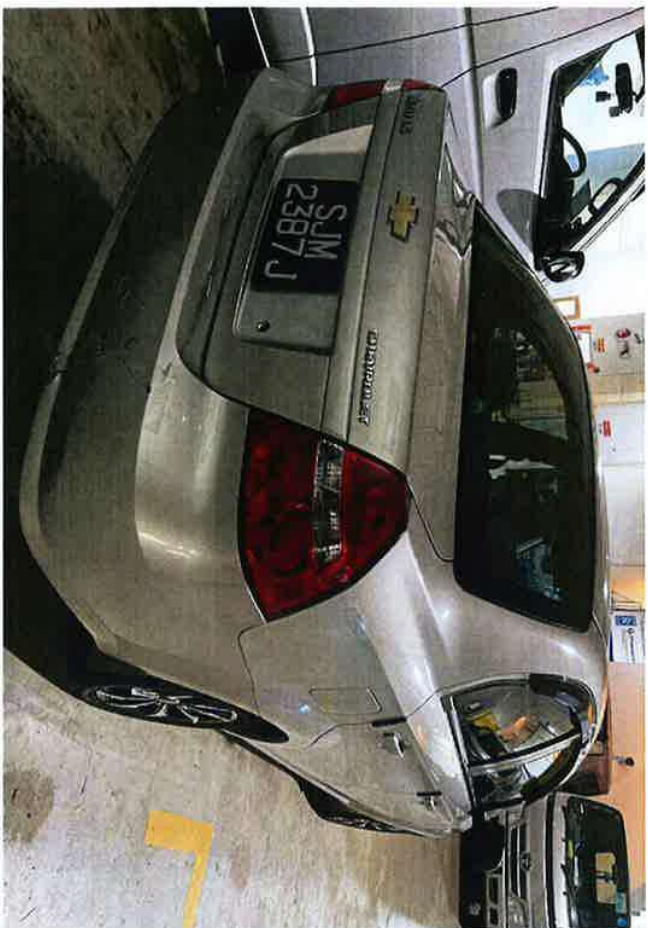
The impact damages sustained on the vehicle at the time of inspection is on the rear bumper portion.

*(Details refer to the photographs attached)*
