### PROFESSIONAL SERVICE FEE

Vehicle No. SJT 9195M  
Insured Veh. GBB 8704R  
Claim No. 22/22/22/VC05/026622  
Policy No. Z22VC05012093  
Accident Date 23/11/2022  
Inspection Date 01/12/2022

## ADJUSTMENT ON REPAIR COST FOR VEHICLE NO. SJT 9195M

### PHOTOGRAPHS FOR VEHICLE NO. SJT 9195M

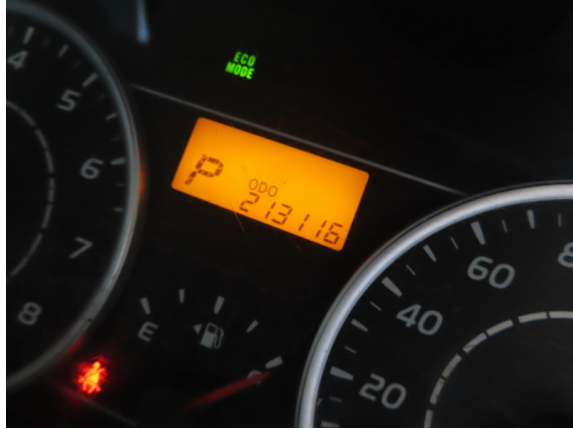
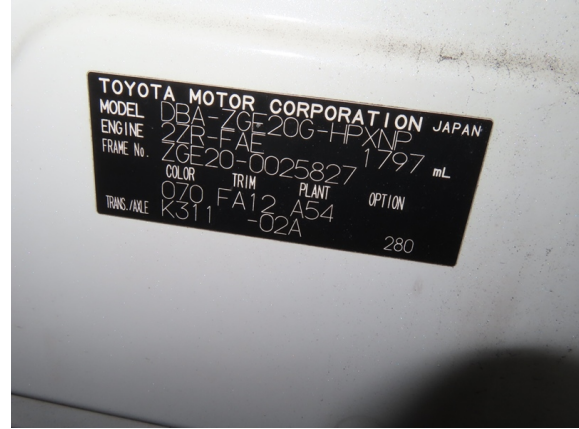
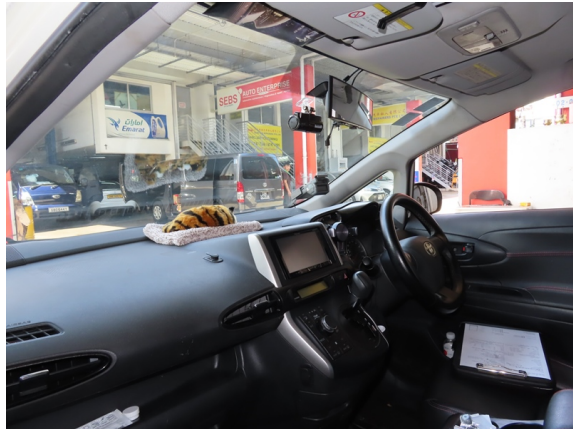
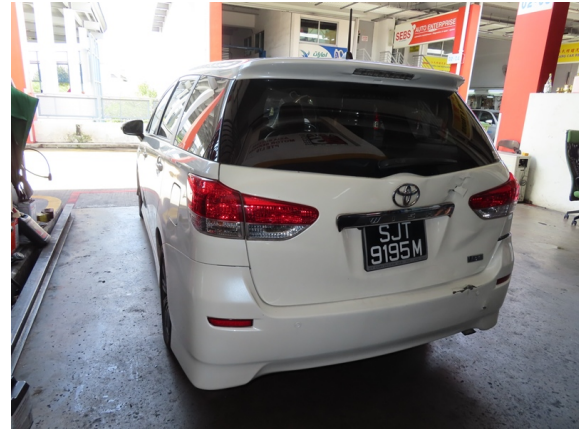
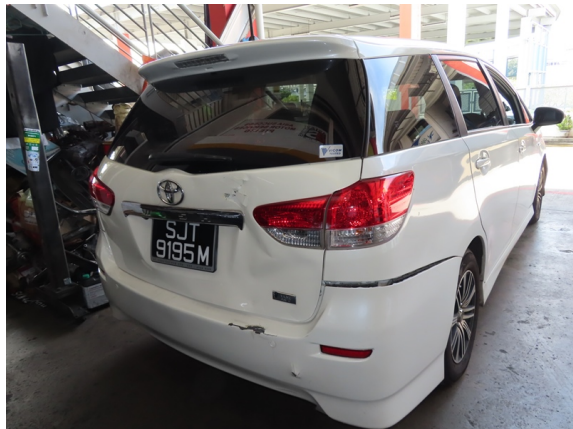
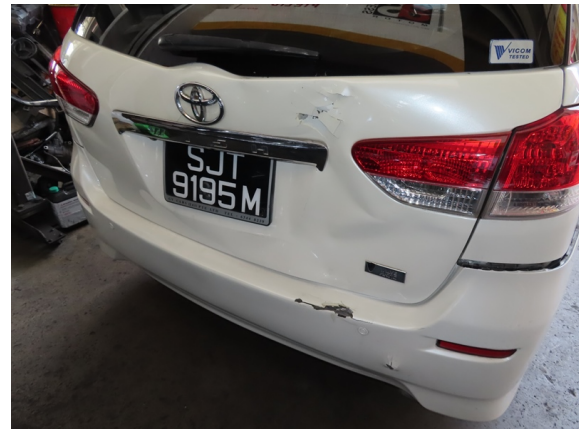
### INSPECTION

| Affiliated to Federation Internationale Des Experts En Automobile | | | | |
|---|---|---|---|--|
| THE VEHICLE SUSTAINED DAMAGES AT THE REAR PORTION.<br>DAMAGES SEE DETAILS. | | | | |

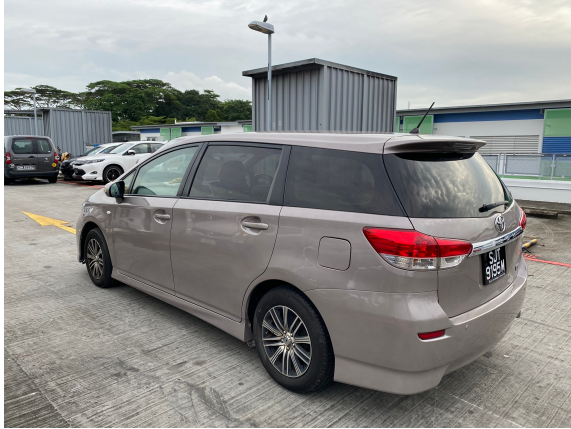
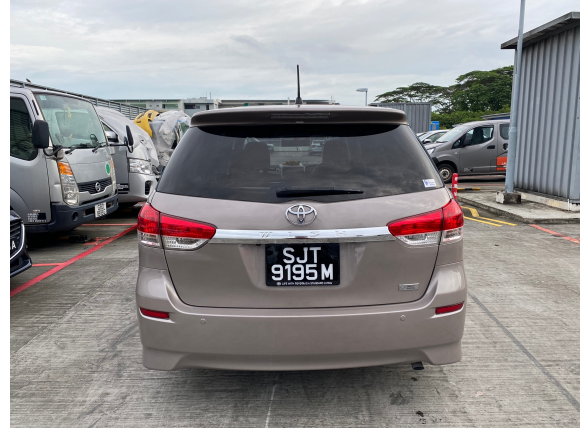
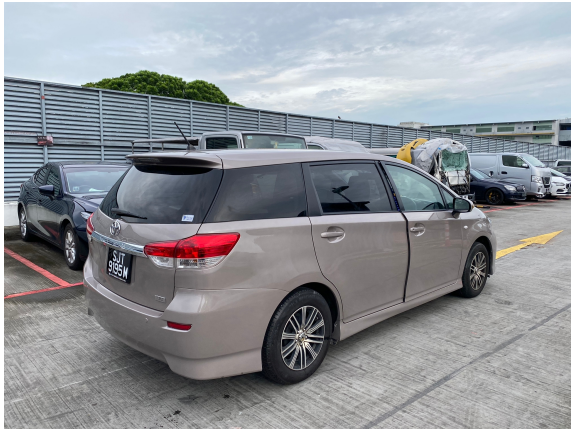
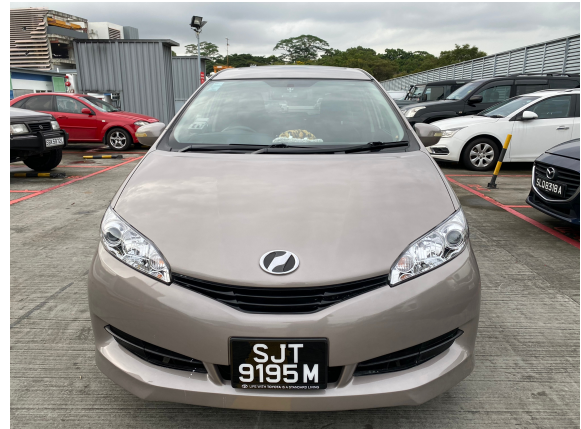
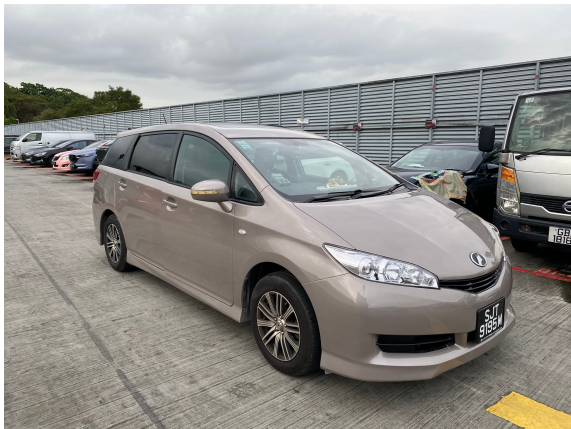
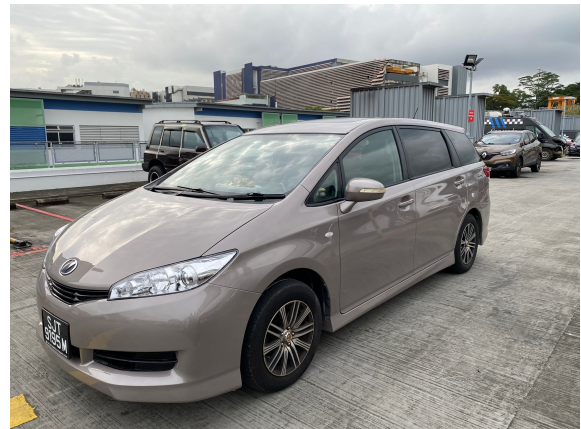
**PHOTOGRAPHS FOR VEHICLE NO. SJT 9195M**

**RE-INSPECTION**
