## Enquire Vehicle Owner Details ( As At 10 Dec 2020 / 16:30:00 )

**IVECO / TRAKKER AUTO AT260T41  
(MY2013, EURO V)**

**SYNOPSIS OF DAMAGES RESULTANT FROM THE ACCIDENT**

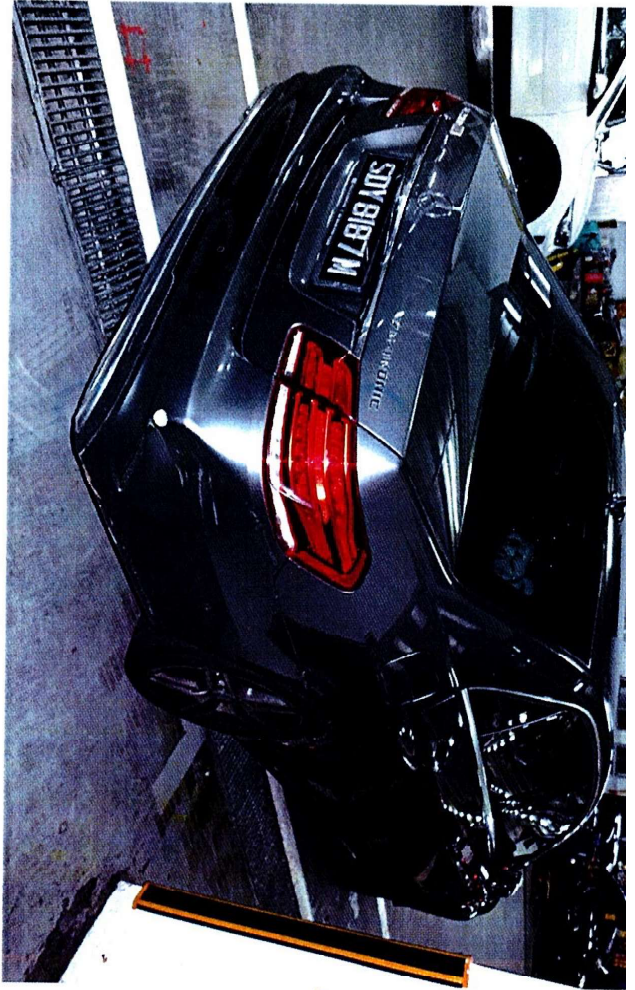
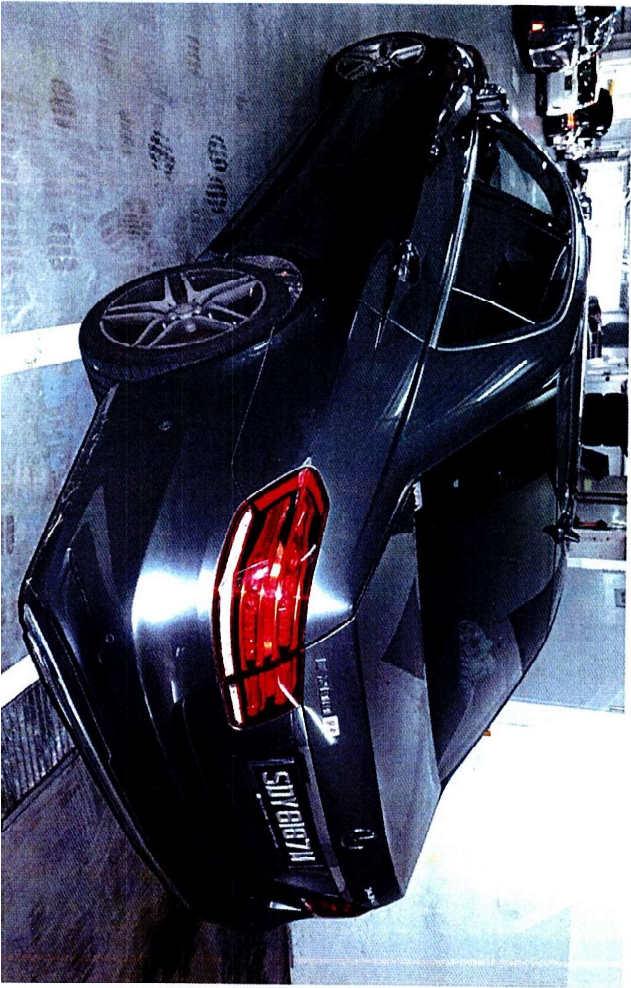
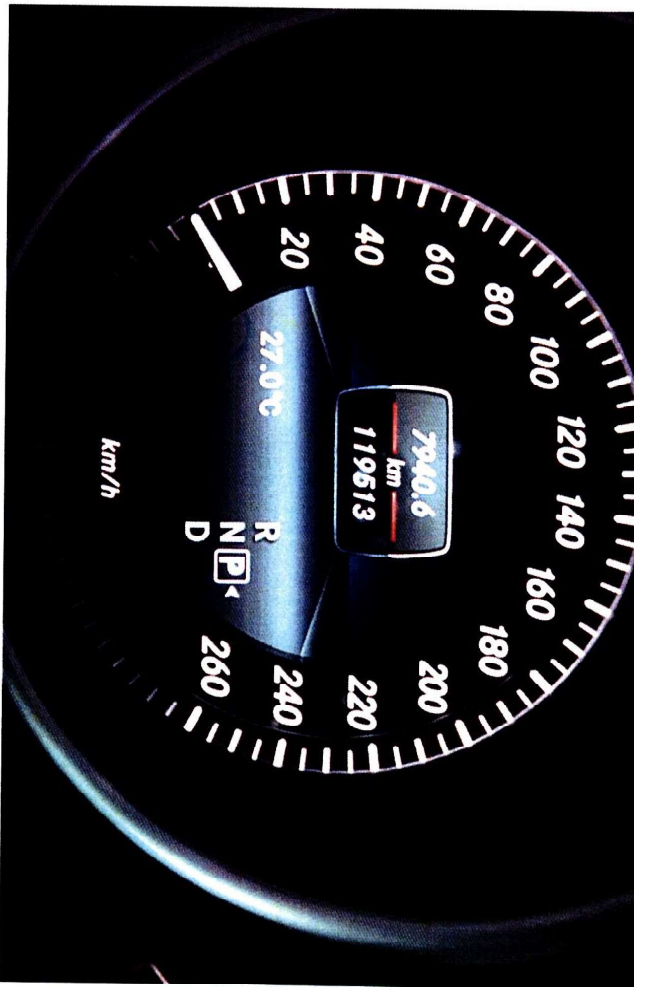
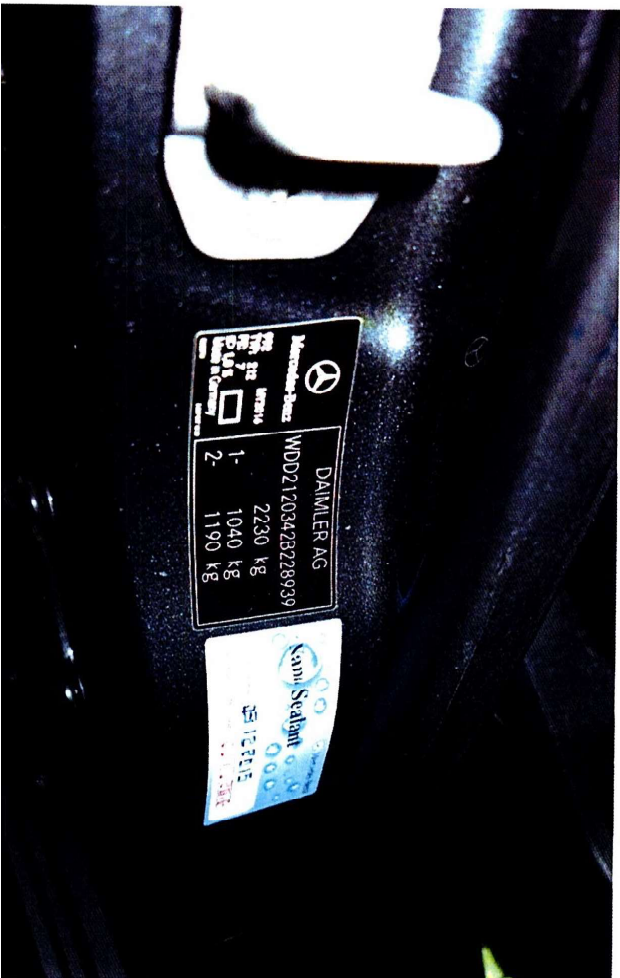
The impact of the collision has damaged / affected the rear bumper, rear end panel, taillamp, o/s rear ender, rear undercarriage and etc...

Please refer to Annex A (Appraisal Schedule) for a detailed account of the damages and photographs taken.
