VEHICLE DAMAGE INSPECTION REPORT

Reg No	: SJT3166L	Make	: Toyota
Reg Year	: 2015	Model	: Corolla Altis 1.6
Chassis No	: MR053REH104546296	Engine No	: 1ZR554881
Engine Cap	: 1598 cc	Colour	: Silver
Type of Claim	: Third Party Claim	Odometer	: 277267

POINT OF IMPACT

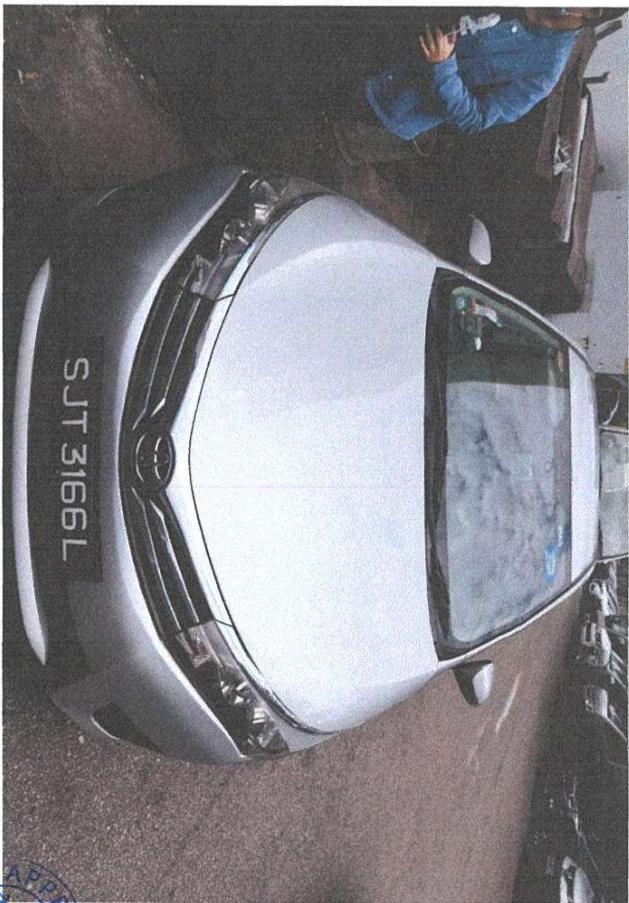
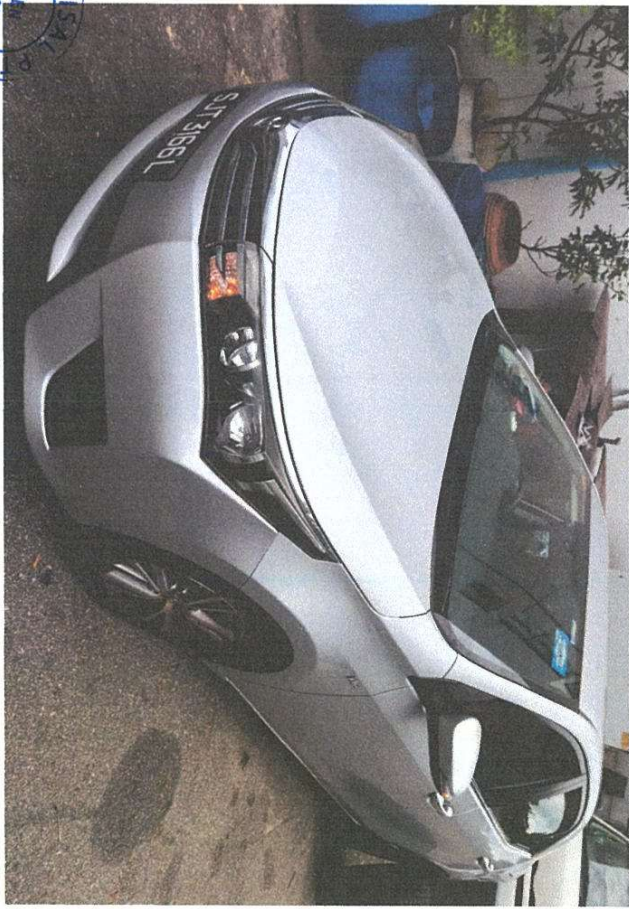
TOYOTA MOTOR CORPORATION
MODEL ZRE171R-GE XGKZ
ENGINE 1ZR-FE
FILE NO. MR053REH1045462296
COLOR 1D4-FB21 Z35
TRIM 1D4-FB21 Z35
PLANT 09A DEC 15
GVM (kg) 1598 mL
MADE IN THAILAND
MADE IN THAILAND
MADE IN THAILAND
