### PROFESSIONAL SERVICE FEE

Vehicle No.	SLF 7601X
Insured Veh.	YQ 2920X
Claim No.	SNM23D200849/C02
Policy No.	DMCVSNW00114892202
Accident Date	31/01/2023
Inspection Date	01/02/2023

## ADJUSTMENT ON REPAIR COST FOR VEHICLE NO. SLF 7601X

## PHOTOGRAPHS FOR VEHICLE NO. SLF 7601X

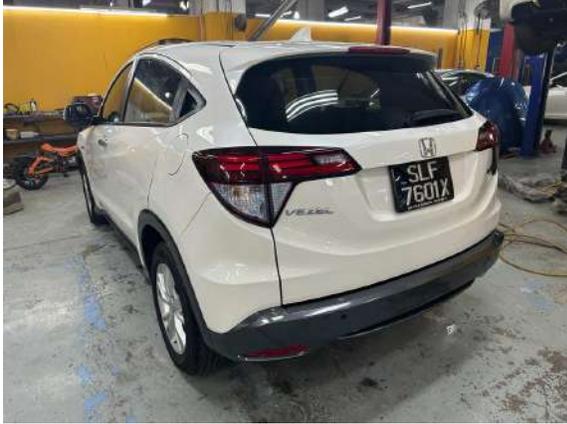
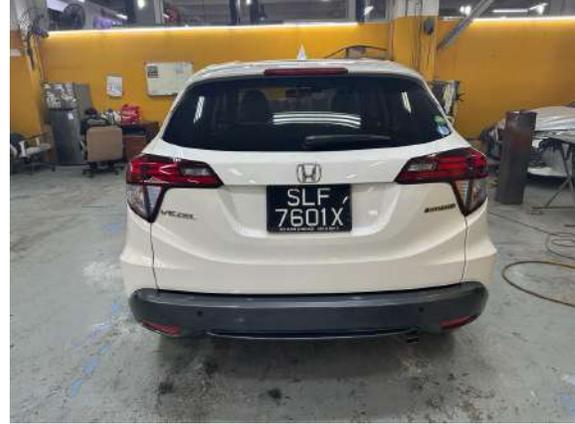
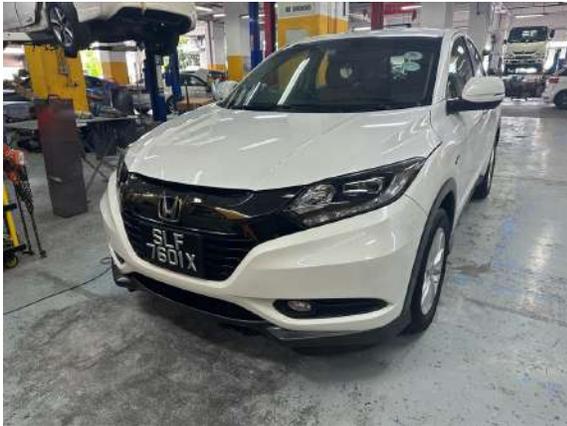
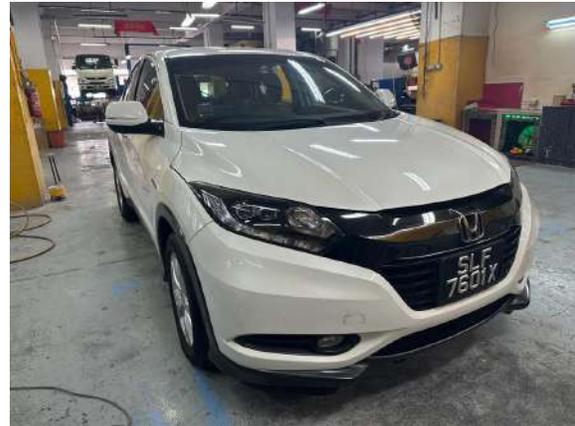
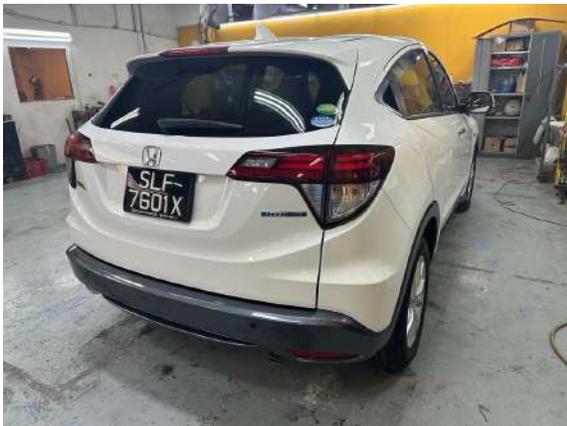
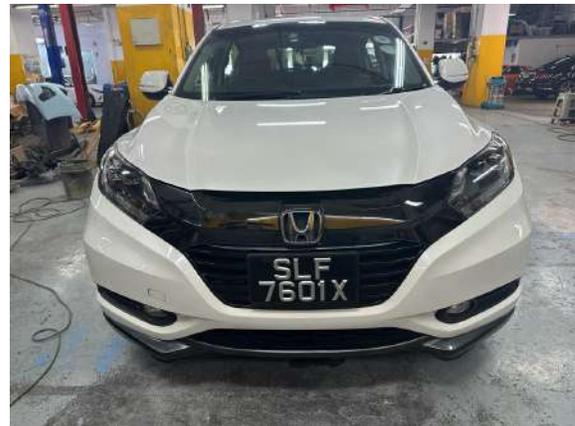
**PHOTOGRAPHS FOR VEHICLE NO. SLF 7601X**

**RE-INSPECTION**

4. Description of Damages			
THE VEHICLE SUSTAINED DAMAGES AT THE REAR PORTION. DAMAGES SEE DETAILS.			
5. General Information			
Accident Date	31/01/2023	Inspection Date	01/02/2023
Survey held at	ADVANCE AUTO GARAGE 23 KAKI BUKIT AVENUE 4, #04-01 VICOM KAKI BUKIT INSPECTION CENTER, SINGAPORE 415933.		
5a. Remarks			
A)THE INSPECTION WAS CONDUCTED ON A"WITHOUT PREJUDICE" BASIS. B)IN ACCORDANCE TO YOUR INSTRUCTIONS, WE HAVE NOT AUTHORISED REPAIRS.			
5b. Estimate Days of Repair			
ESTIMATED NORMAL PERIOD FOR REPAIR:		6 Working Days
