### **DAMAGED VEHICLE (SMM 4558 J) INSPECTION REPORT (WITHOUT PREJUDICE)**

Registration No	: SMM 4558 J	Mileage	: 256131 Km
Make & Model	: TOYOTA COROLLA 1.6	Engine No	: 1ZR0D95733
Date of Registration	: 28 <sup>th</sup> Jun 2019	Chassis No.	: MR053REH604598029
Colour	: White	Engine Capacity	: 1,598 cc

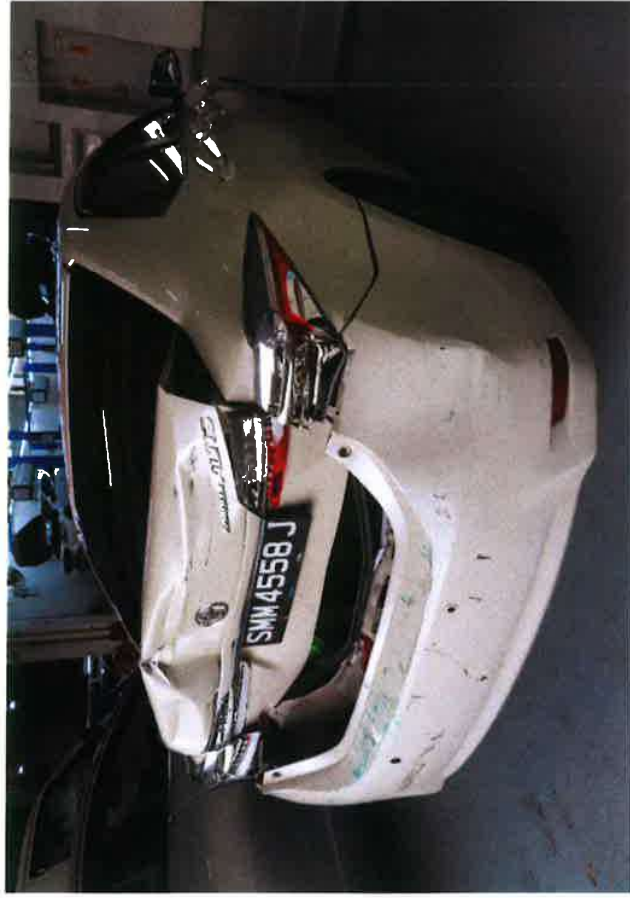
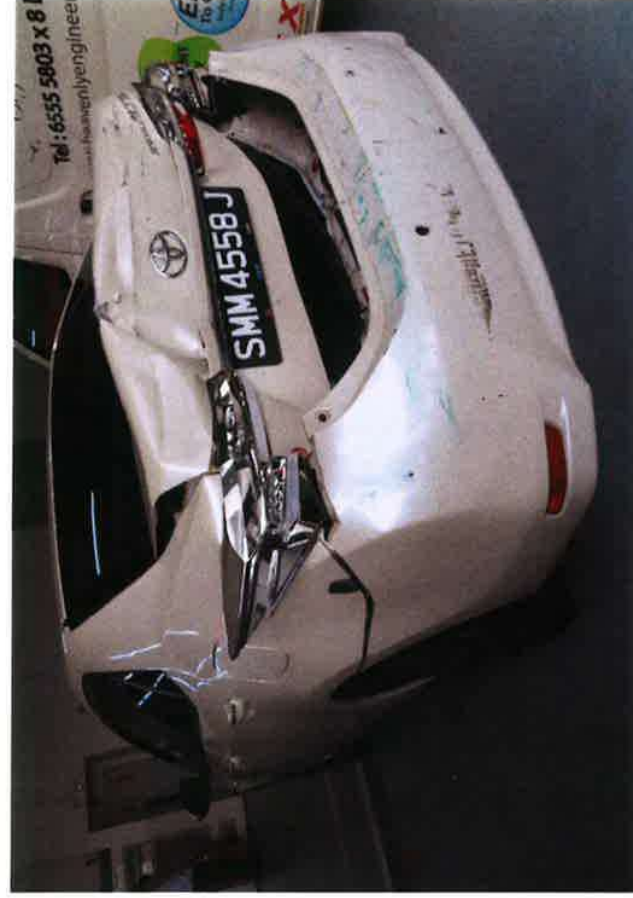
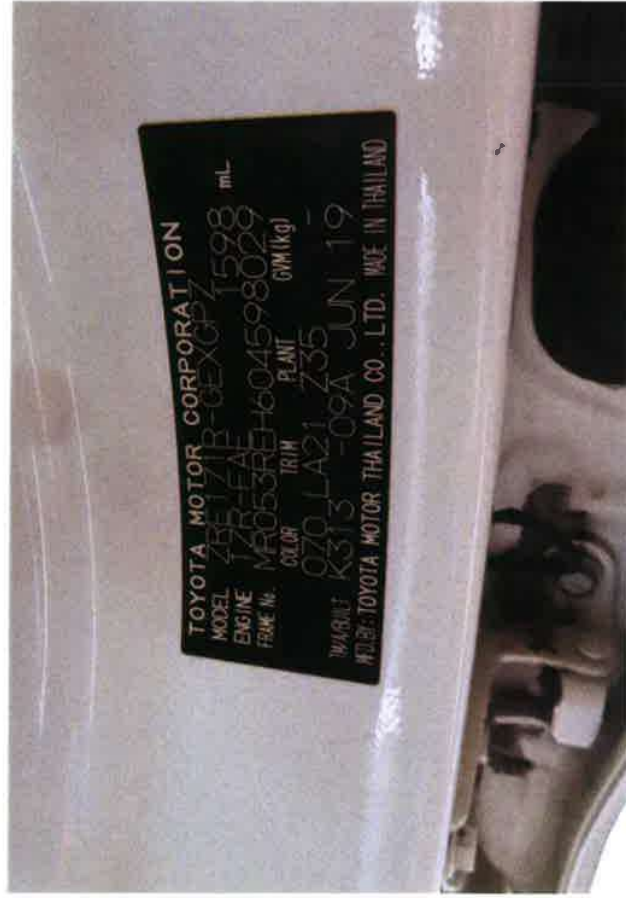
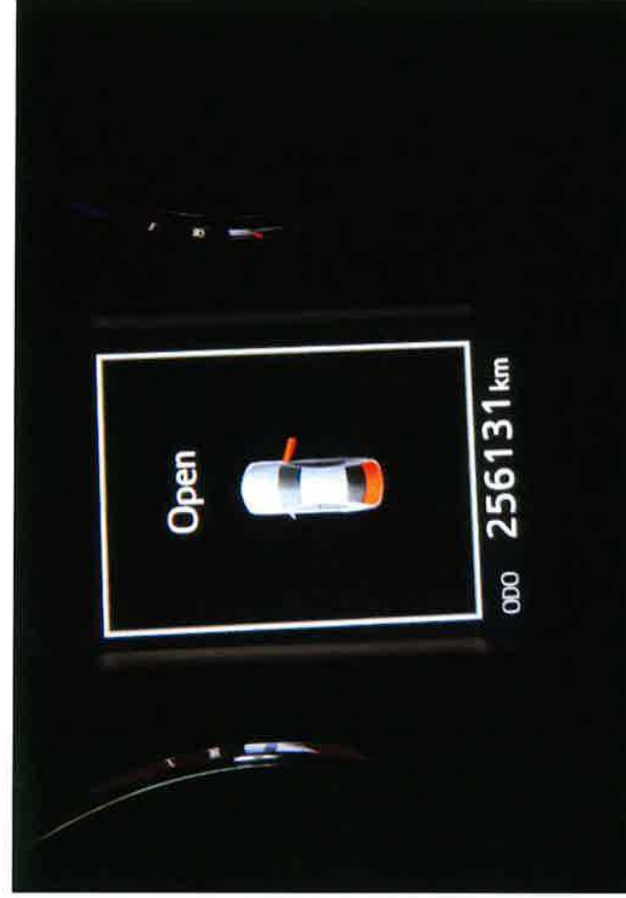
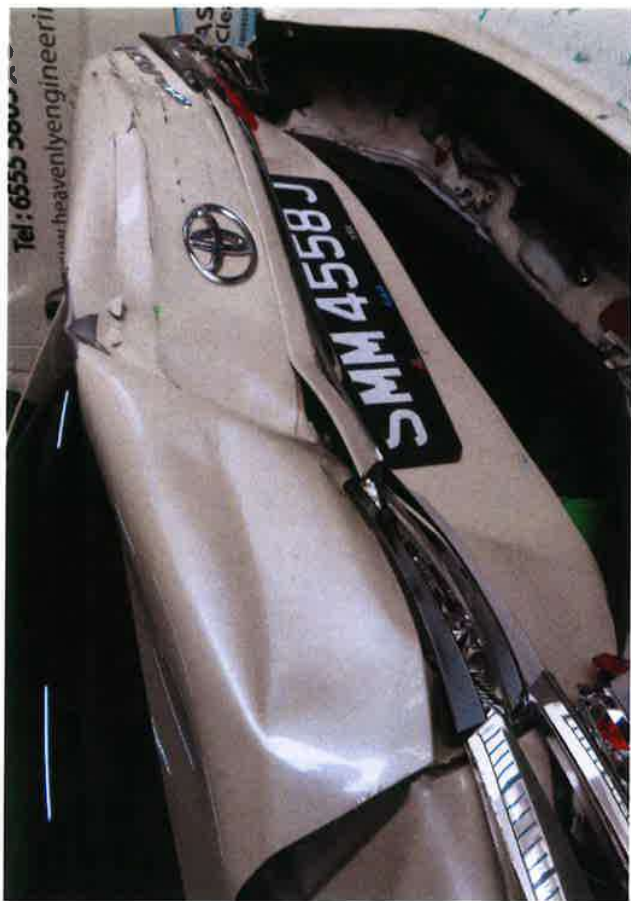
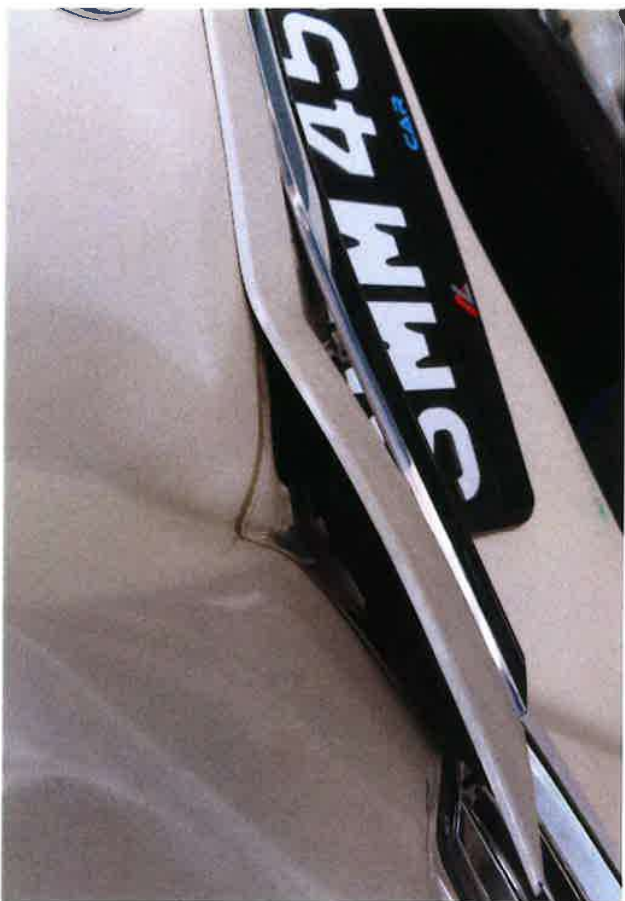
The impact of the collision has damaged/affected the boot lid, boot lid lamp, rear bumper, rear fender, tail lamp and etc.

Please refer to the Annex for a detailed account of the damages and photographs taken.
