## LKK Auto Consultants Pte Ltd

## ADJUSTMENT ON REPAIR COST FOR VEHICLE NO. GBD 2327A

### PHOTOGRAPHS FOR VEHICLE NO. GBD 2327A

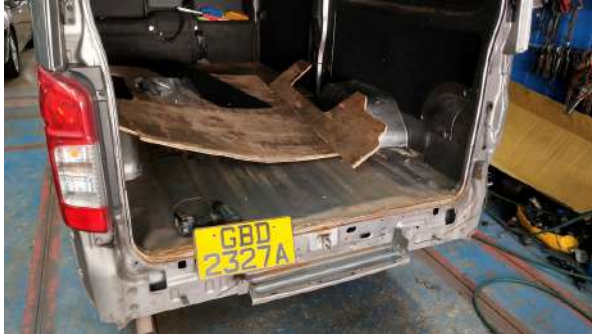
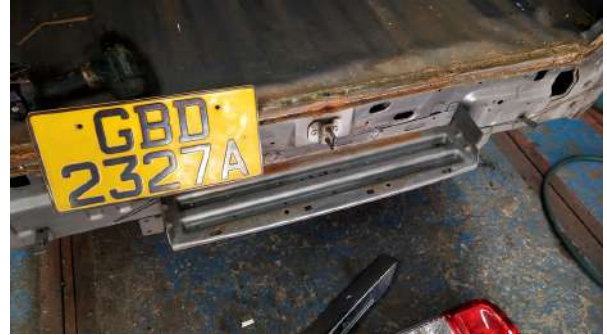
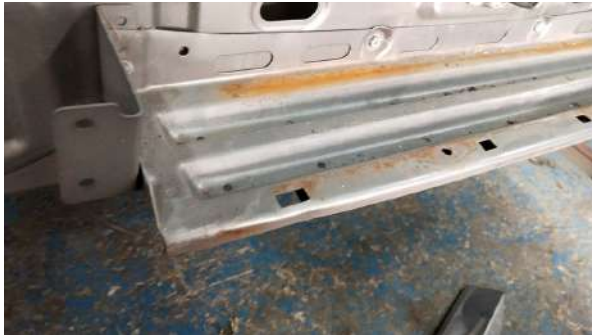
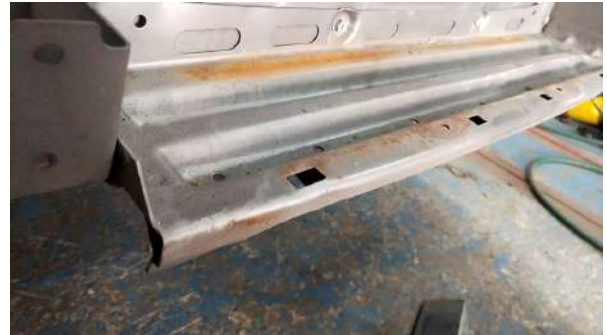
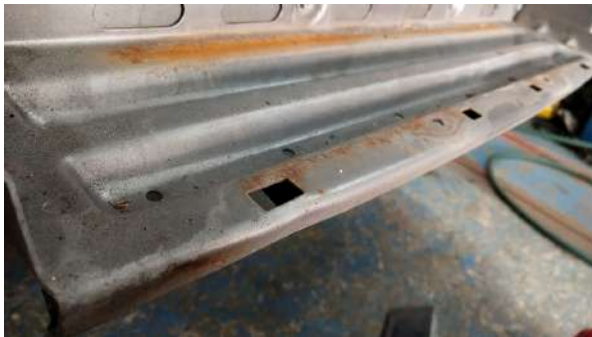
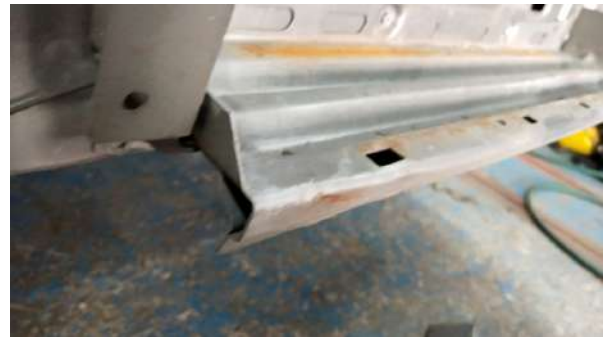
**PHOTOGRAPHS FOR VEHICLE NO. GBD 2327A**

**RE-INSPECTION**

| Affiliated to Federation Internationale Des Experts En Automobile | | | | |
|---|---|---|---|--|
| | THE VEHICLE SUSTAINED DAMAGES AT THE REAR PORTION.<br>DAMAGES SEE DETAILS. | | | |
