**ACCIDENT DAMAGED VEHICLE INSPECTION REPORT**

Date : 10 August 2022
Our Ref : TP/THH/SCL813Y/8688

Registration No : SCL 813 Y
Make : B.M.W
Model : M6 SMT 2DR ABS LED DSC NAV HUD
Year : 2012 (COE Expiry 30 Jun 2032)

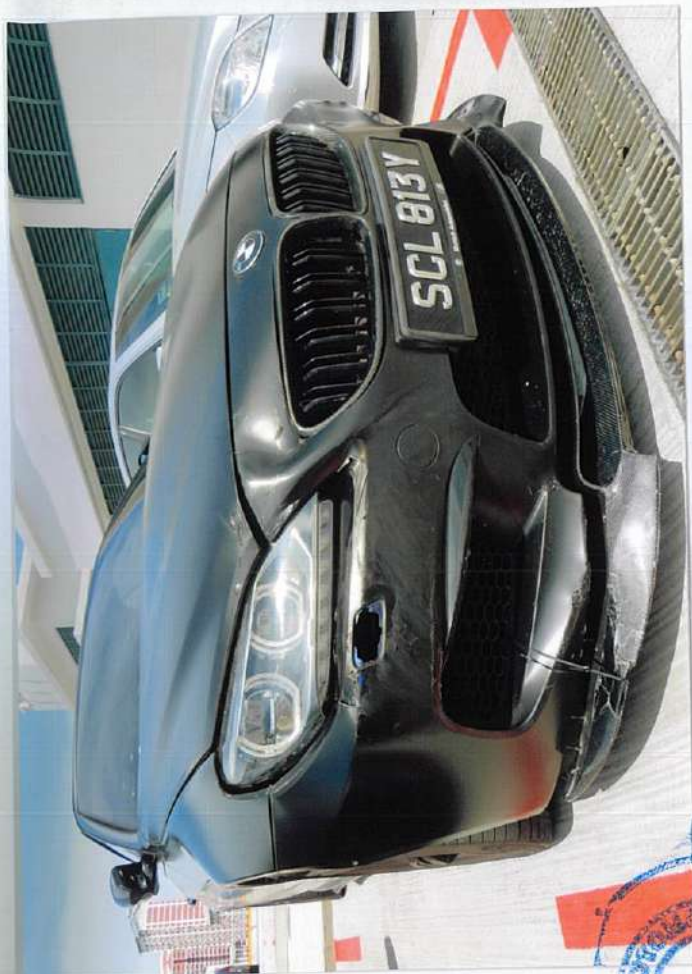
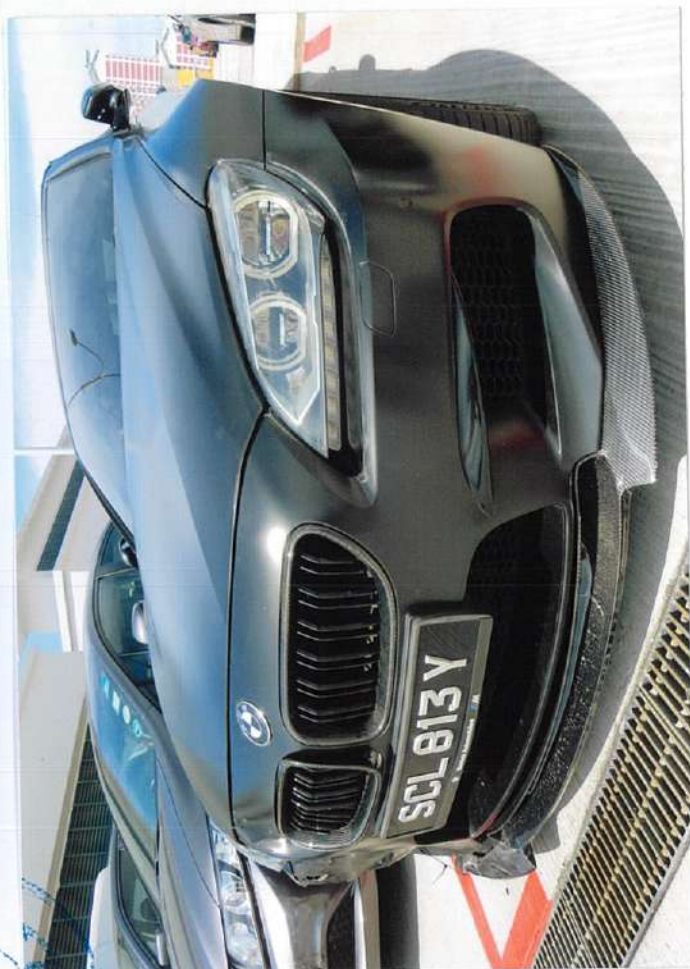
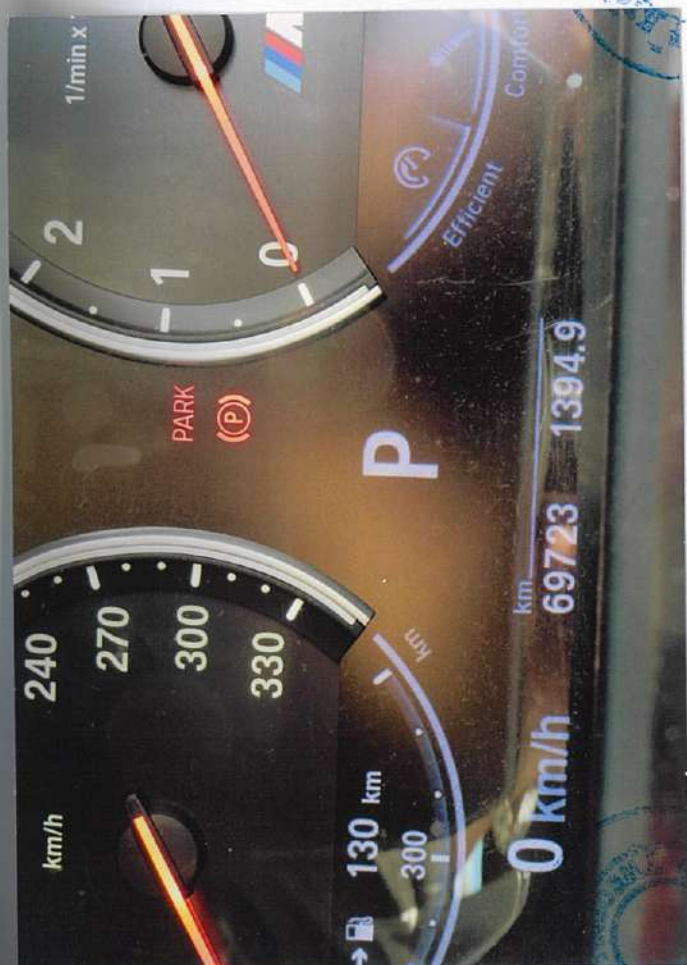
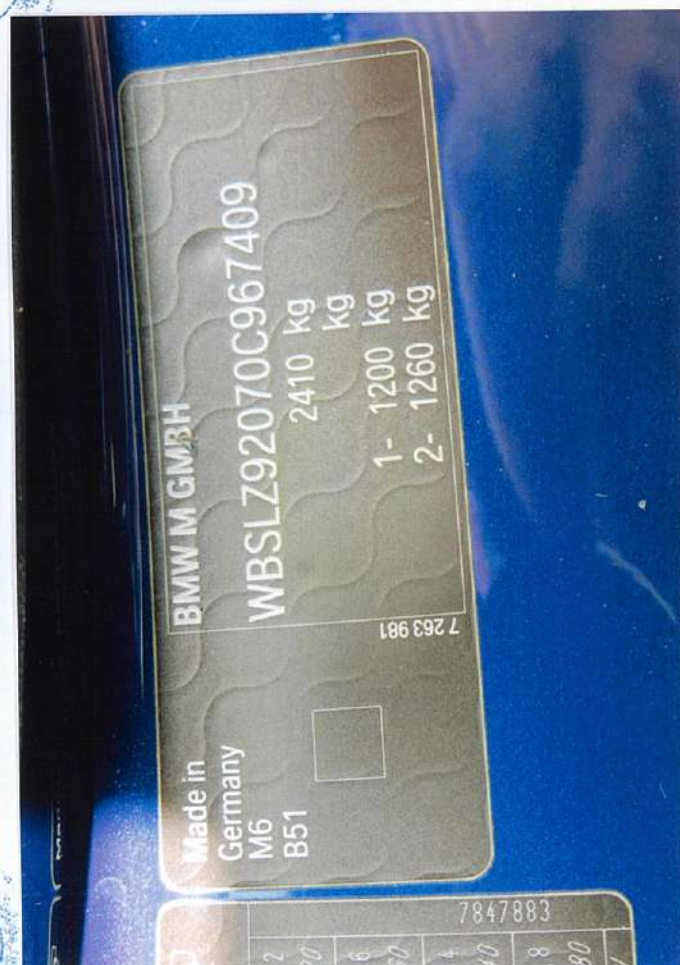
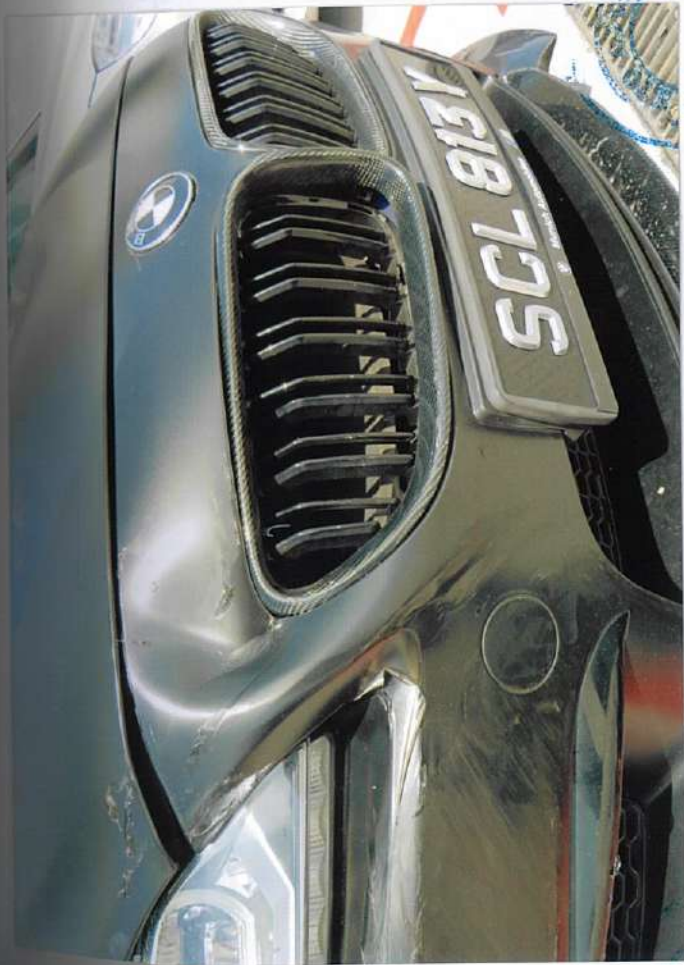
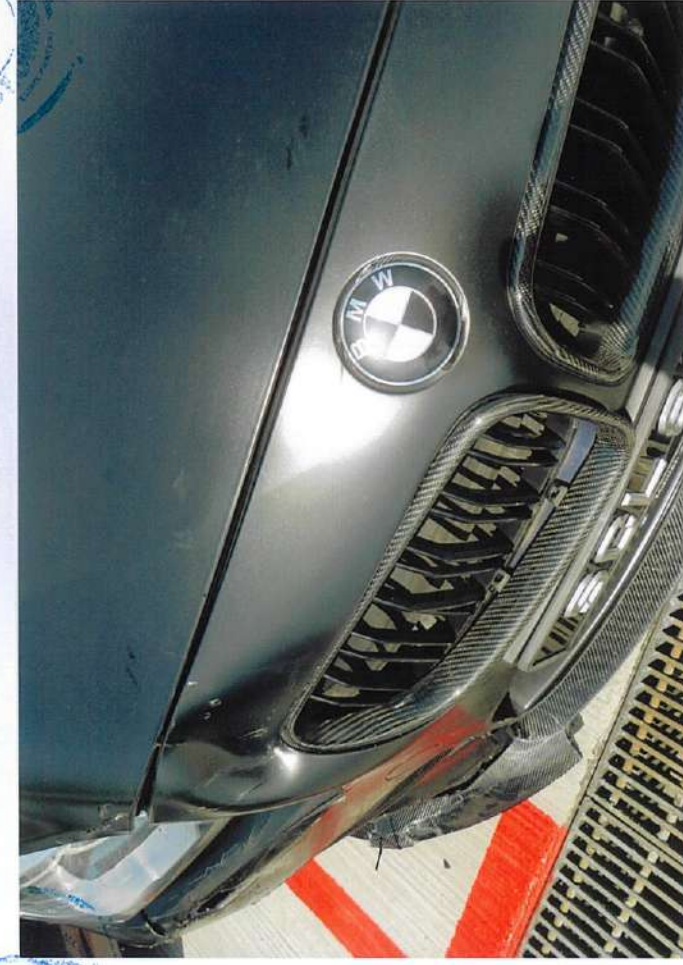
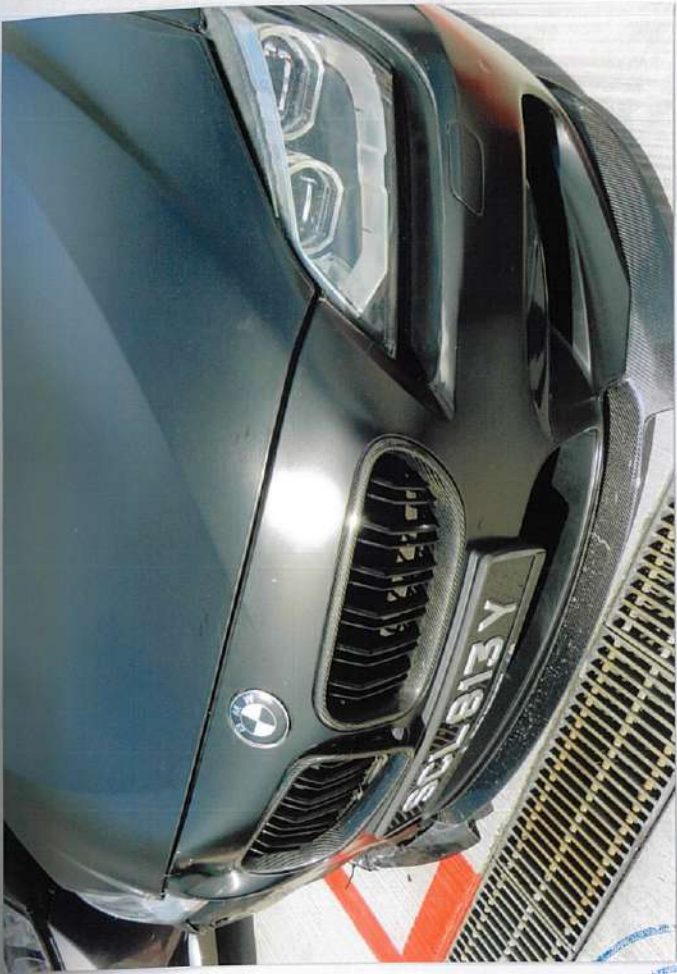
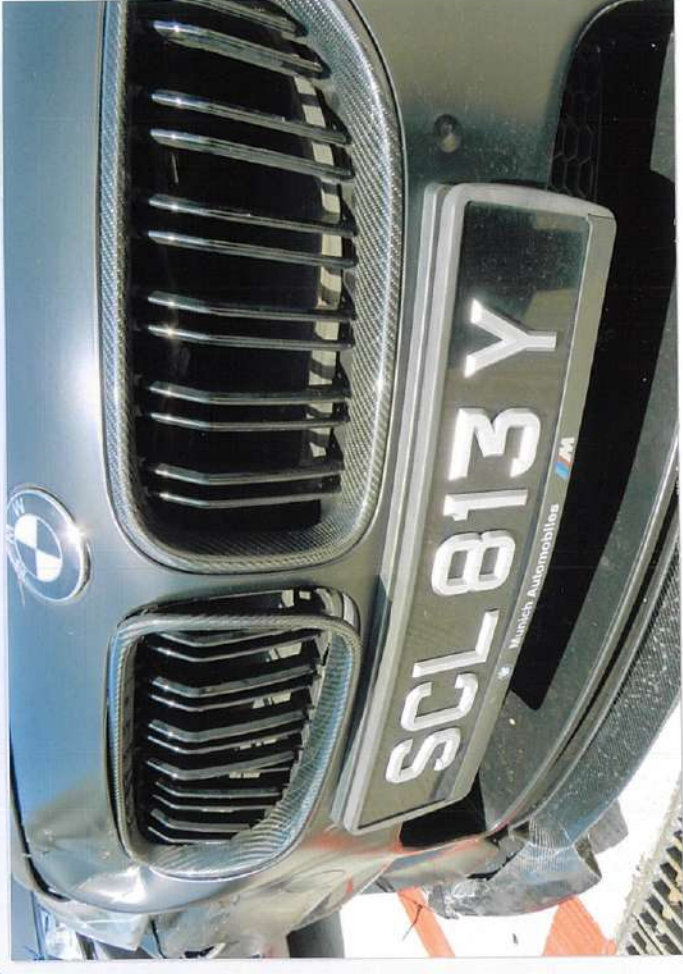
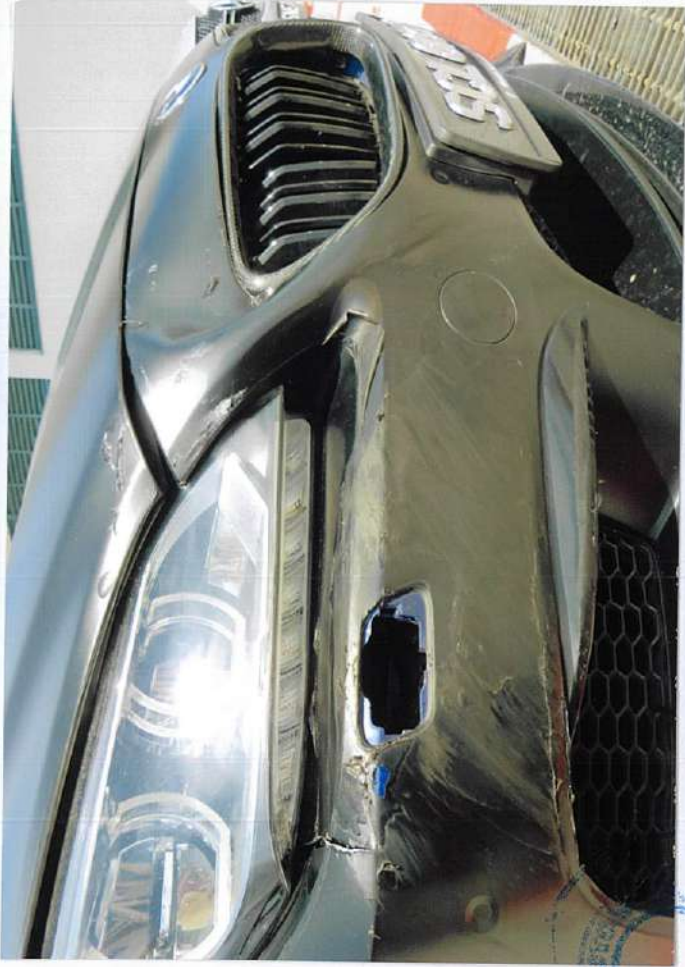
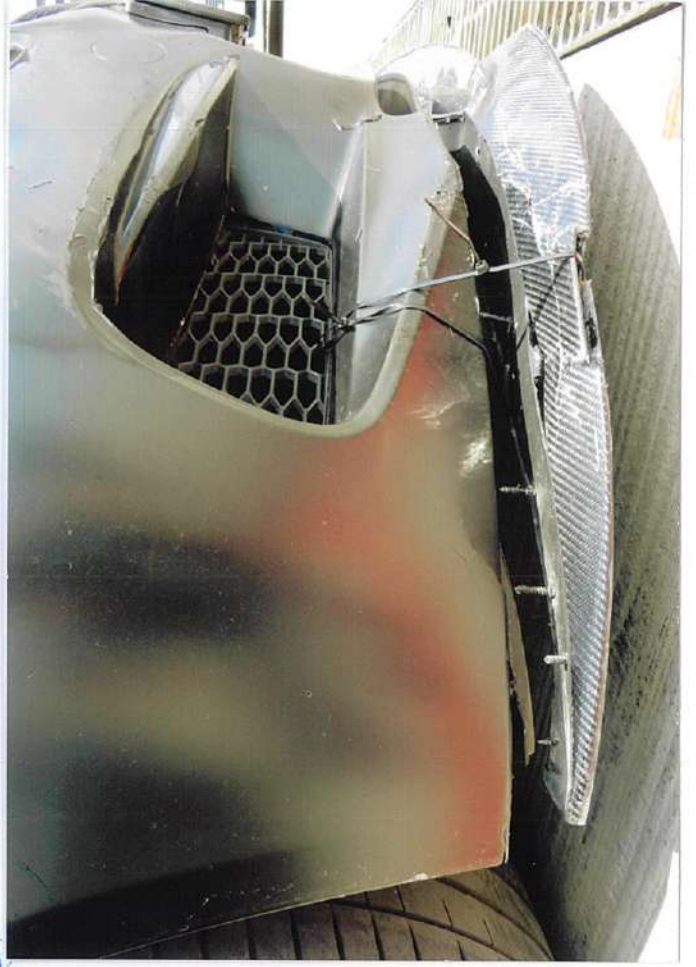
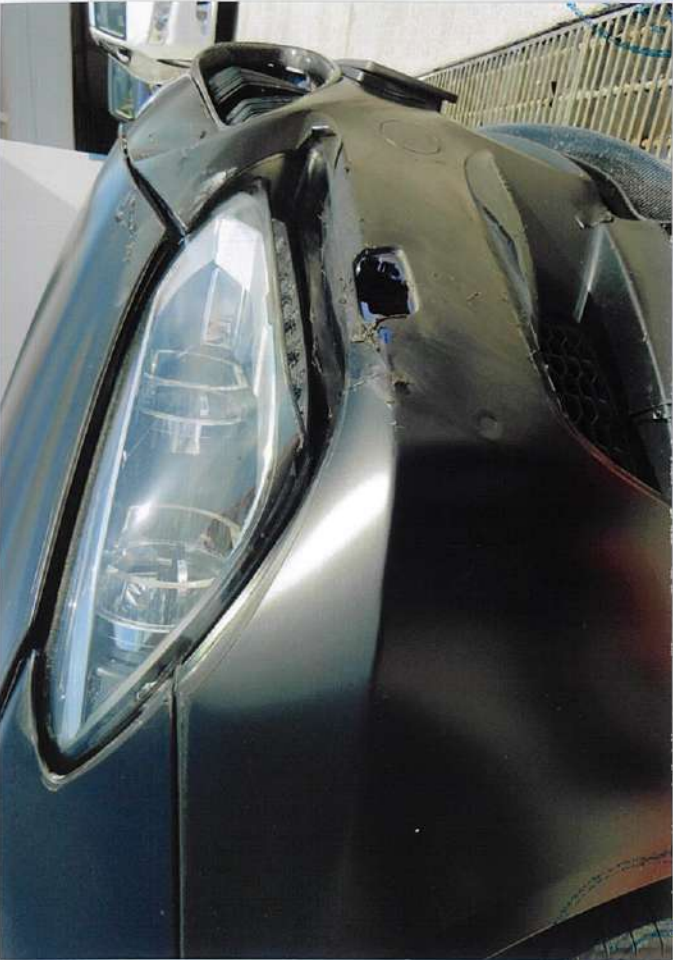
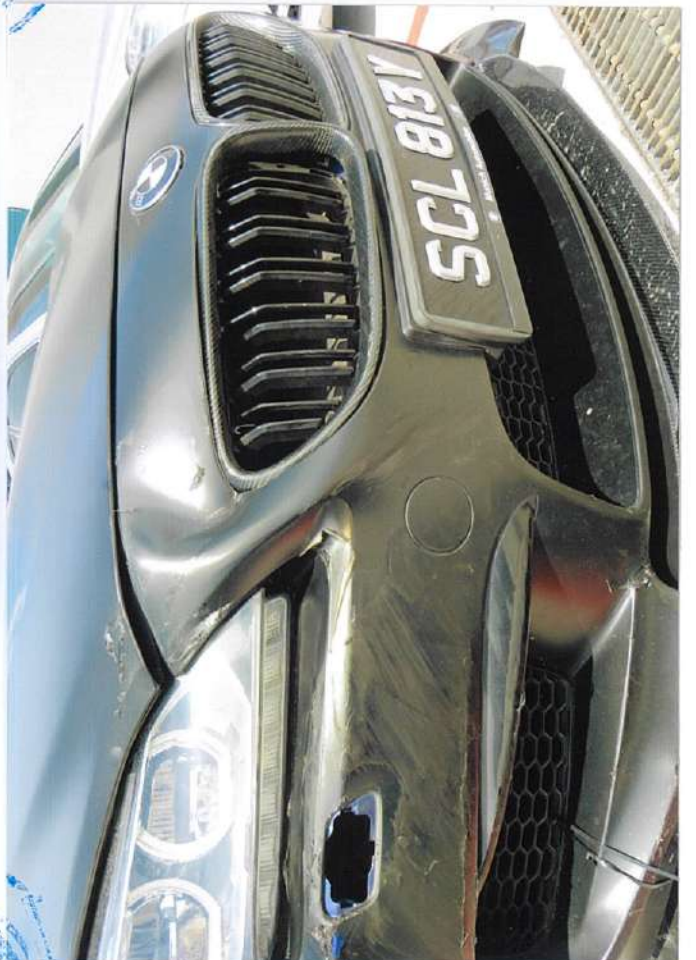
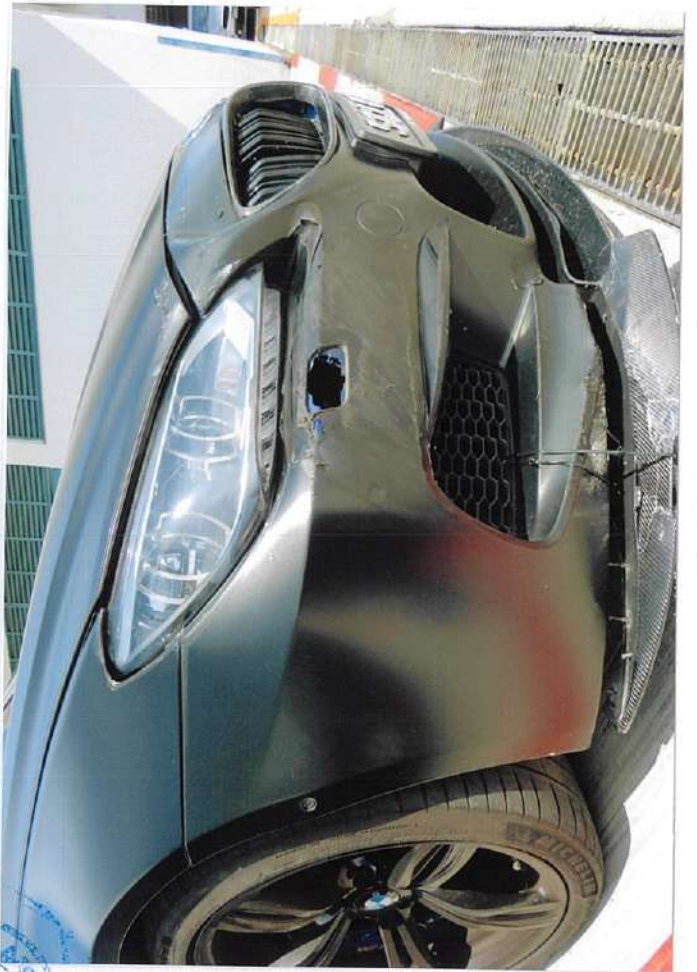
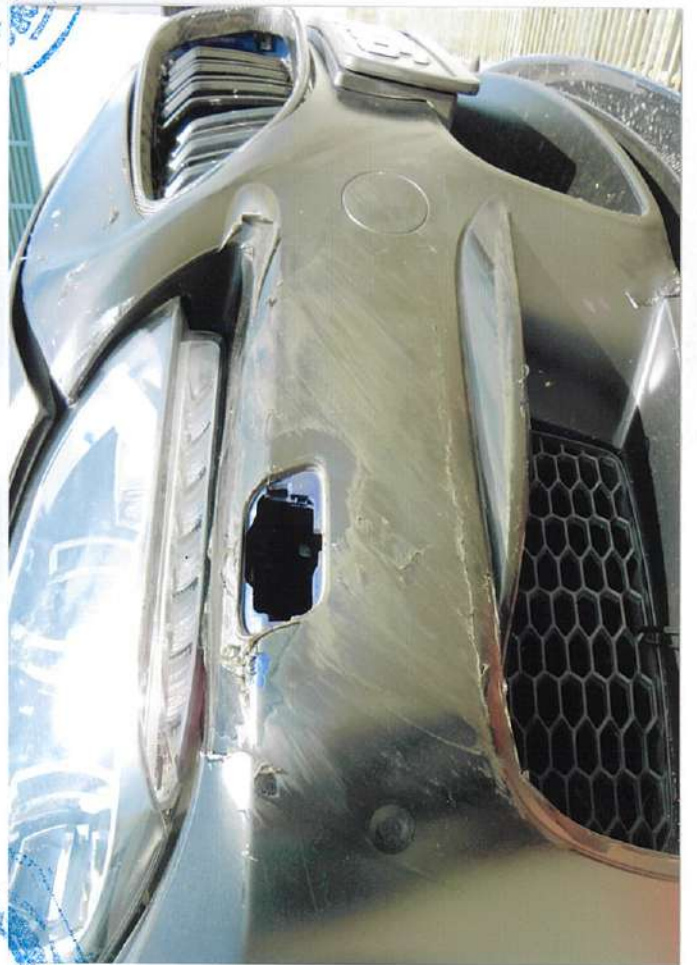
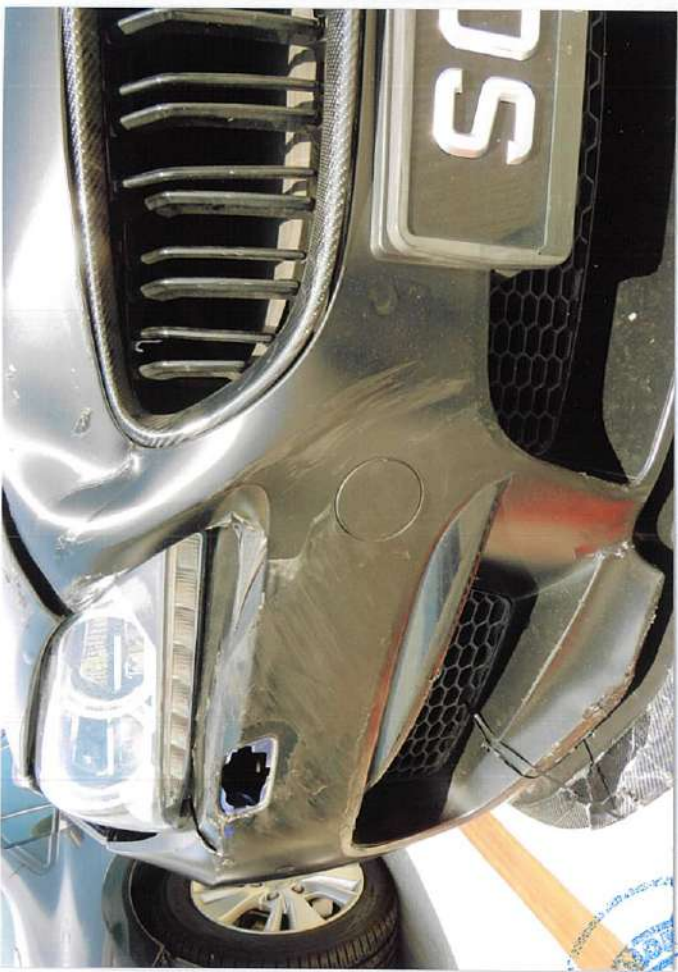
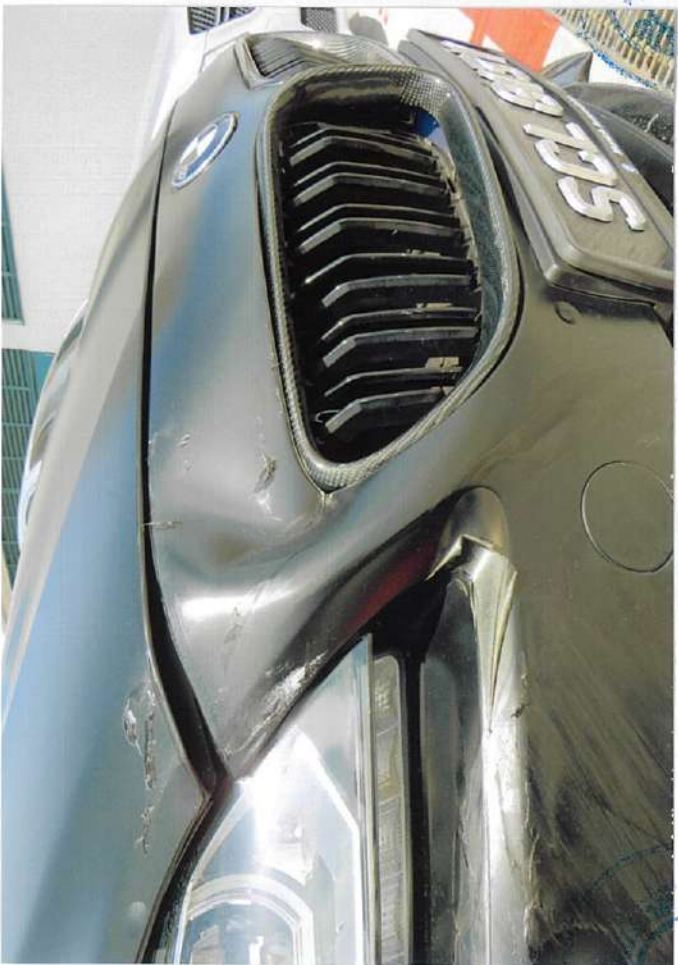
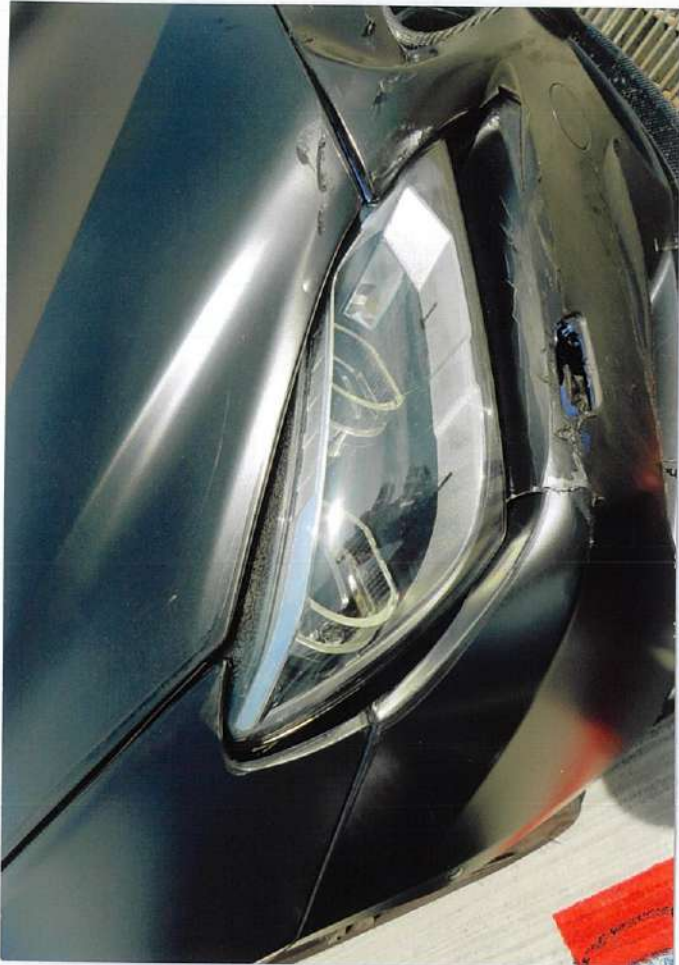
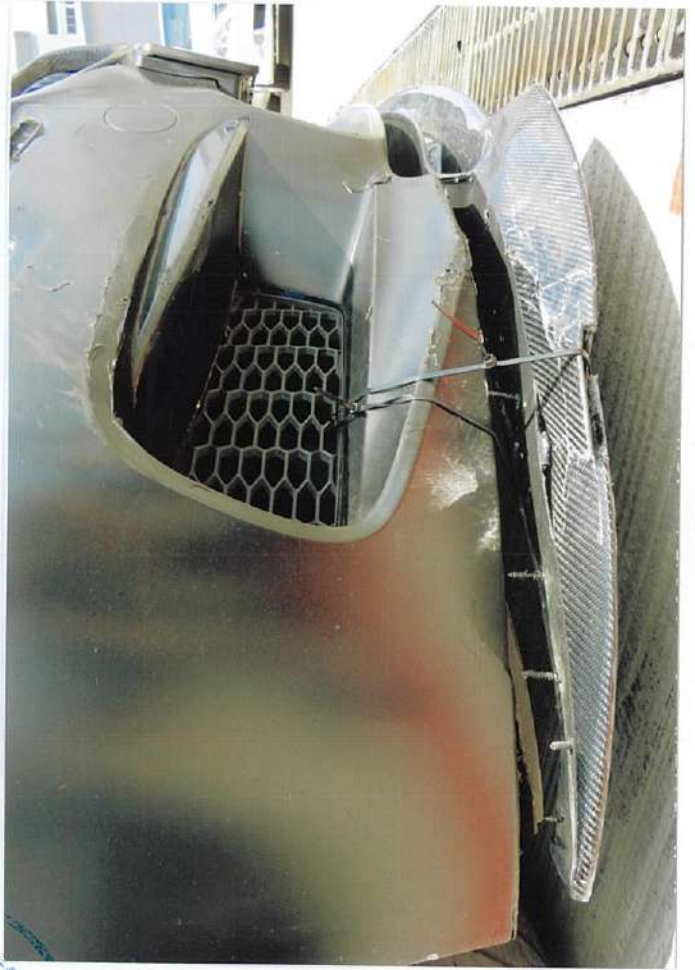
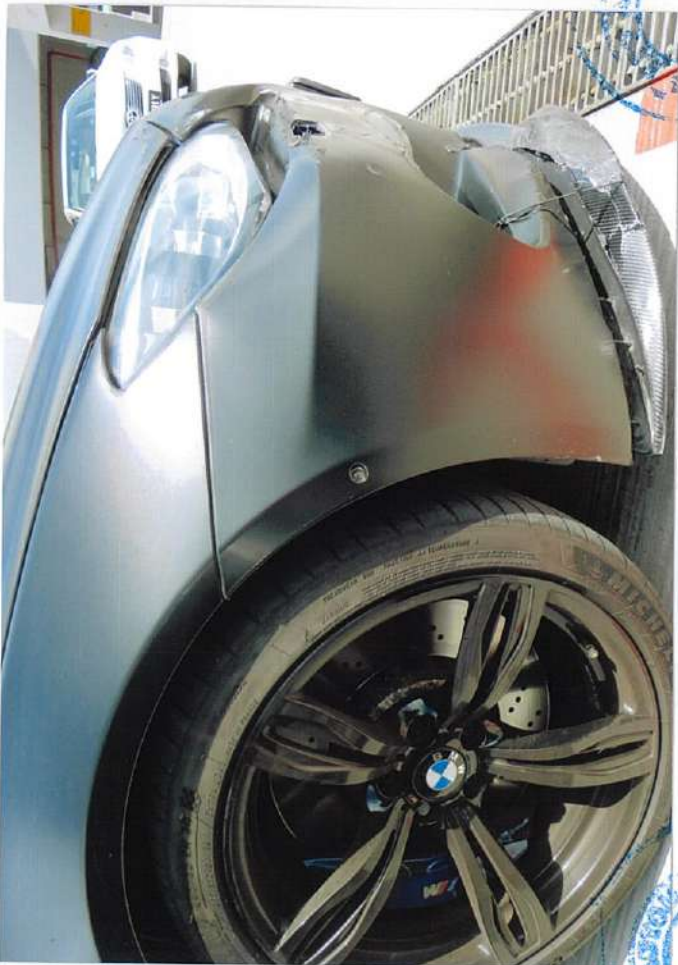
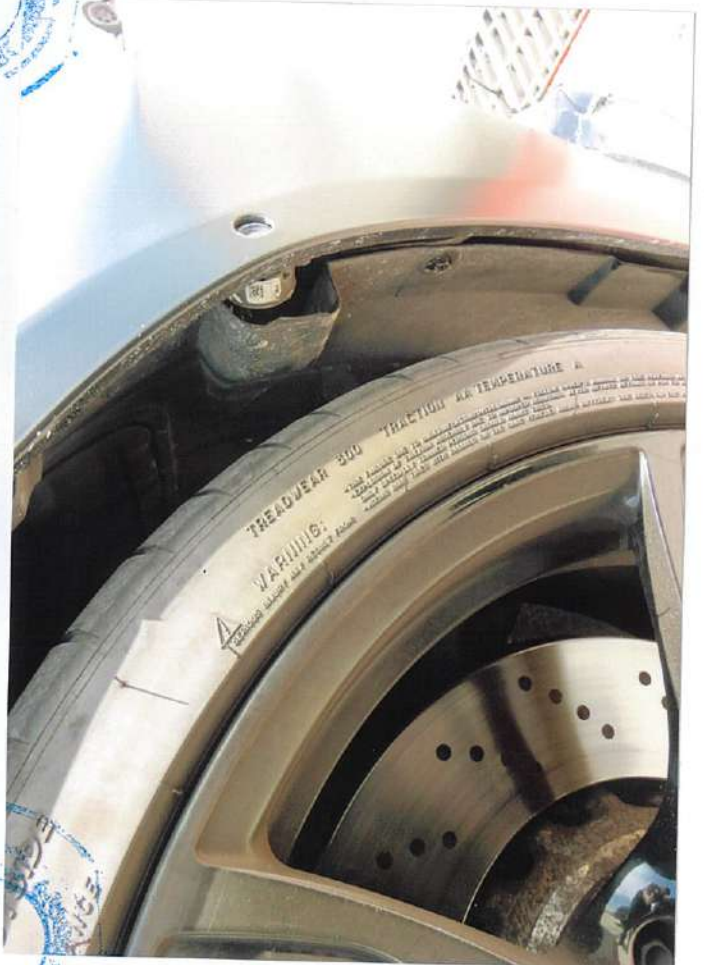
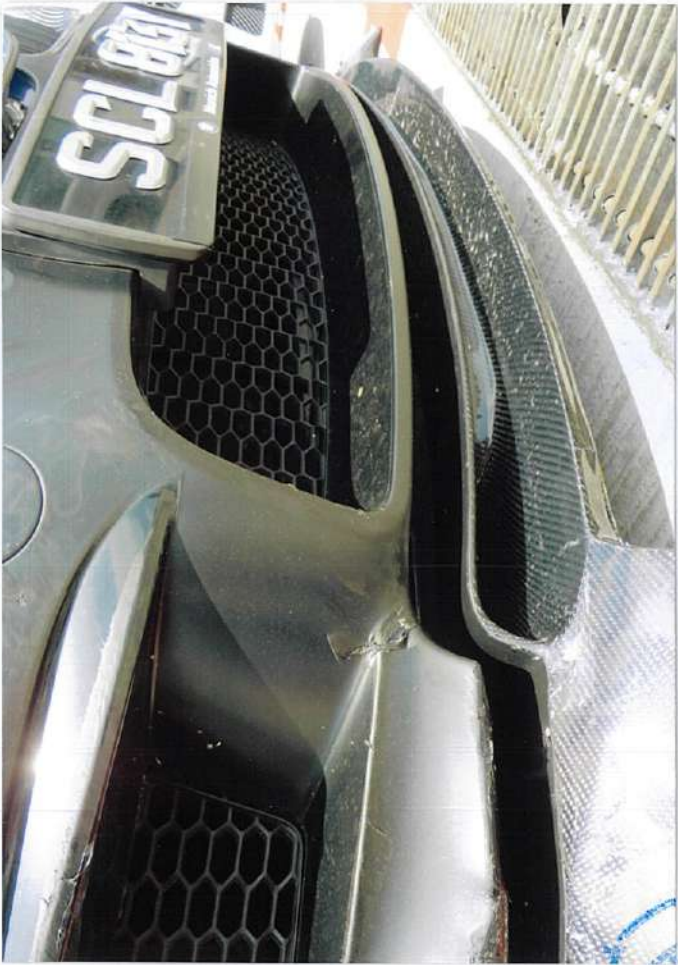
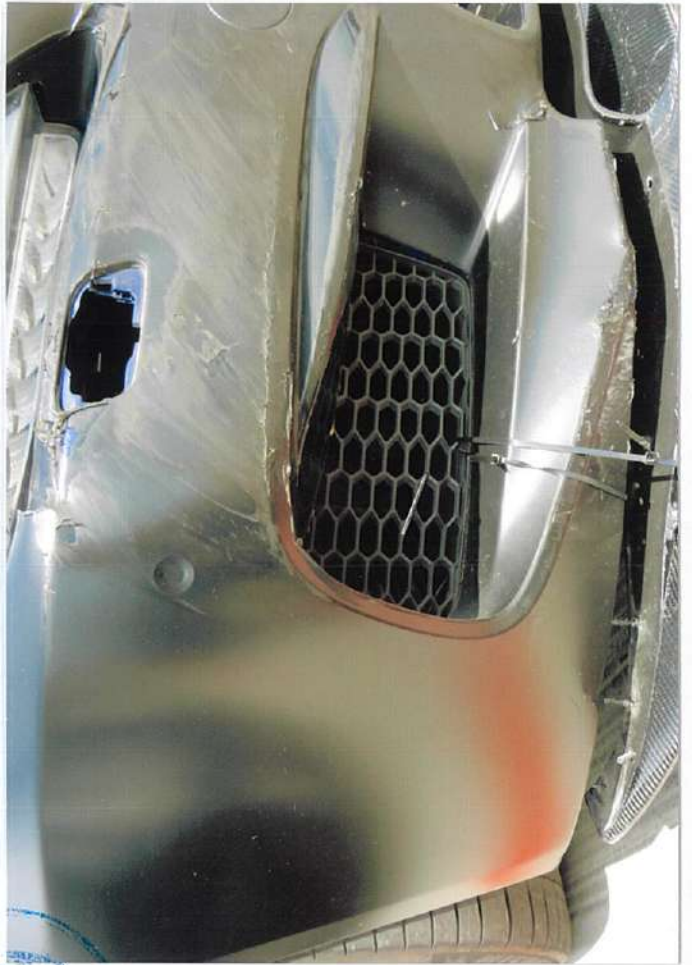
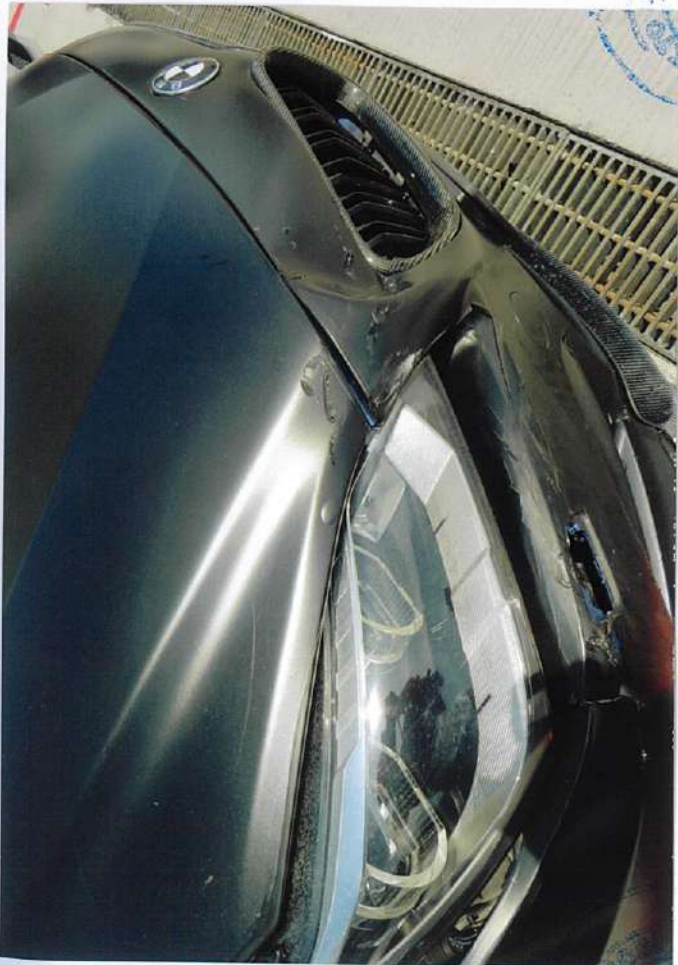
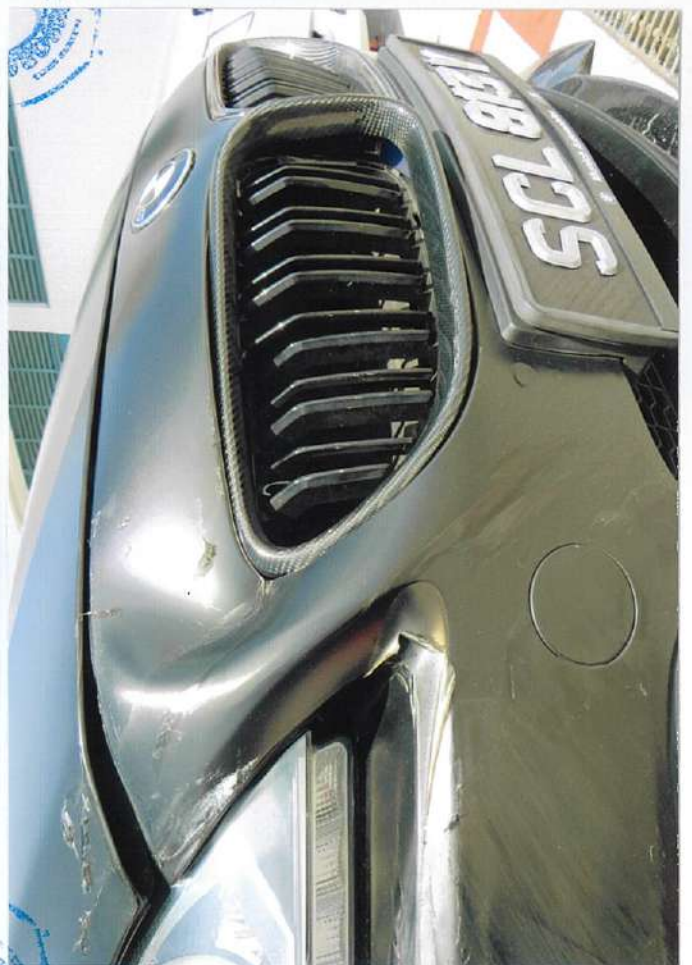
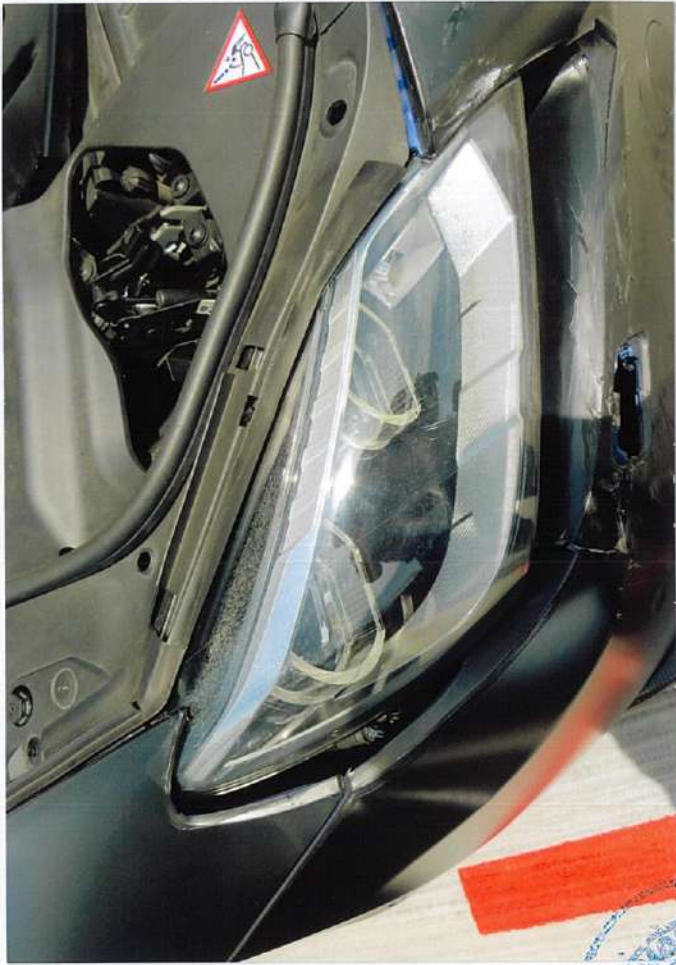
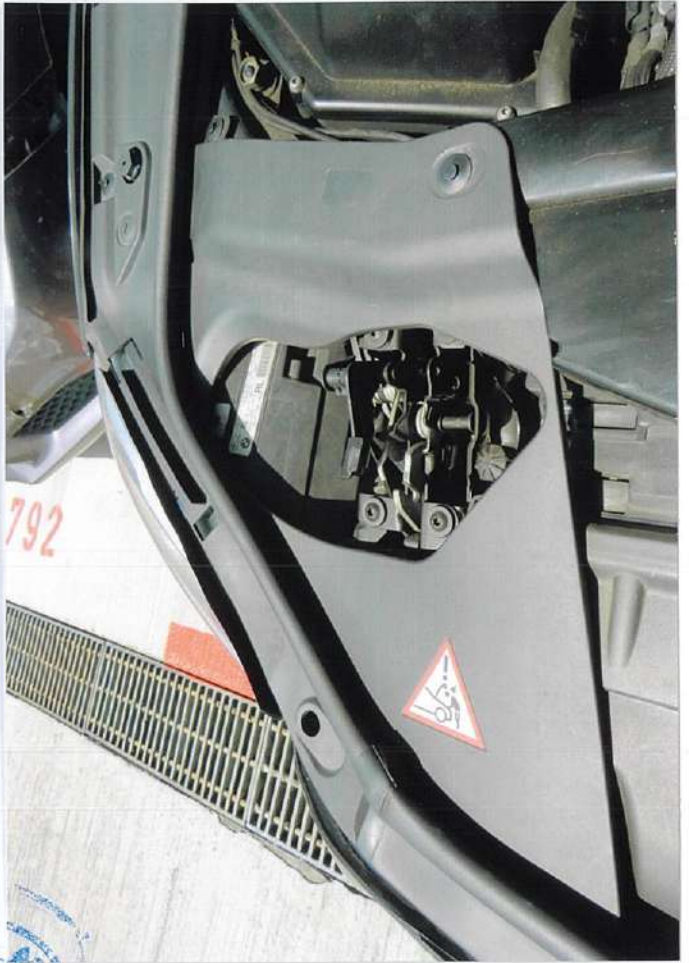
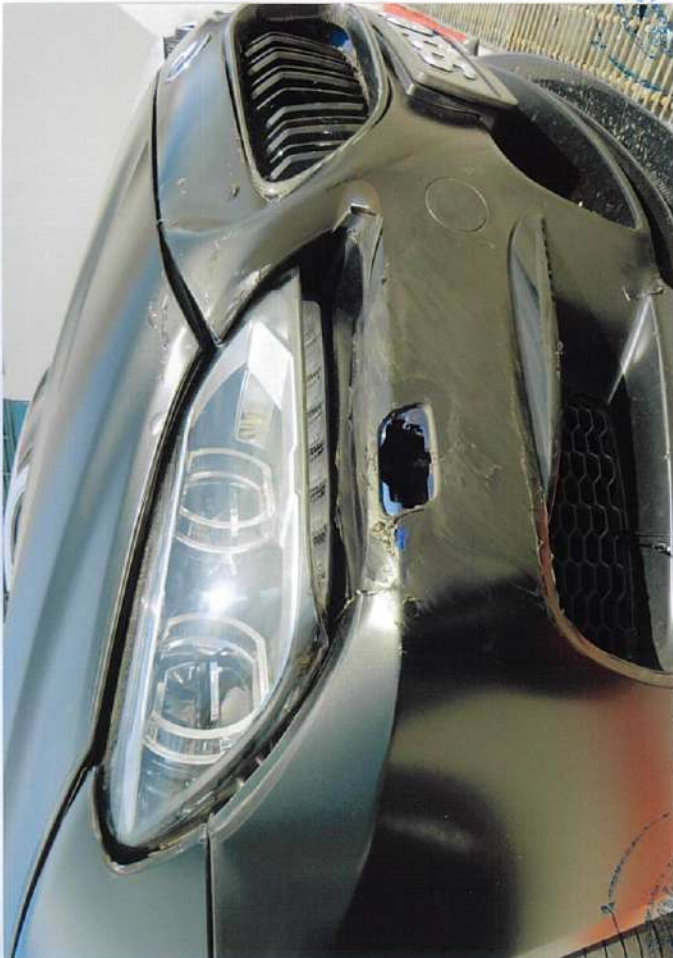
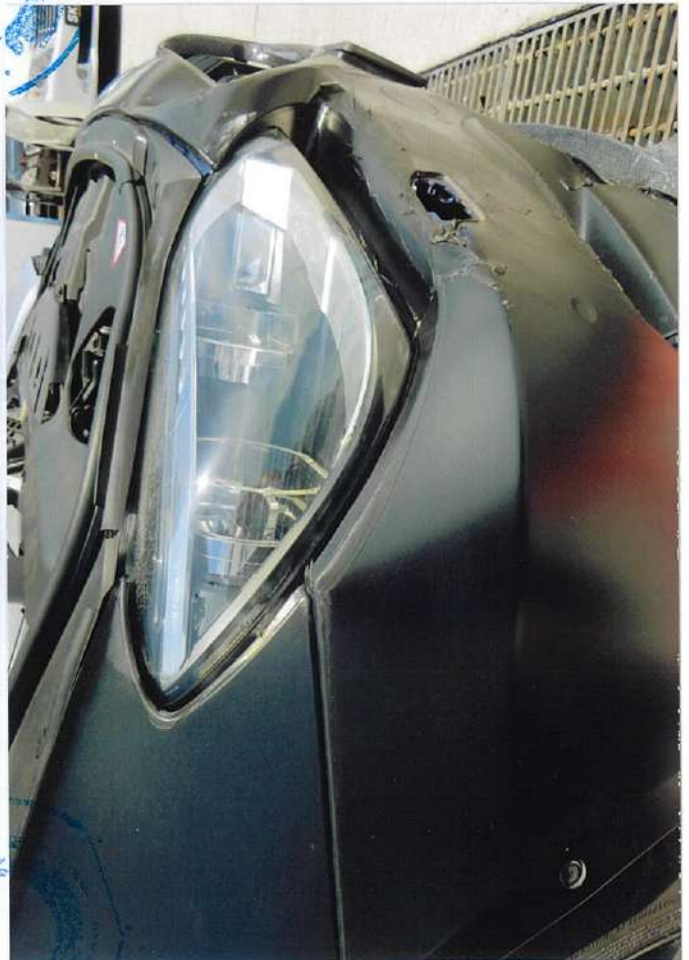
Enclosed Seventy-Six (76) photographs depicting damage to the vehicle and after repair.

The impact was confined to the front off side portion of the vehicle.
The damages appeared to be consistent as per the accident report statement.
Please refer the attached schedule and photographs for details.
