CARLINK CONSULTANCY

ACCIDENT VEHICLE INSPECTION / ASSESSMENT REPORT

Our Ref: CL 12346 GBC 3073 E

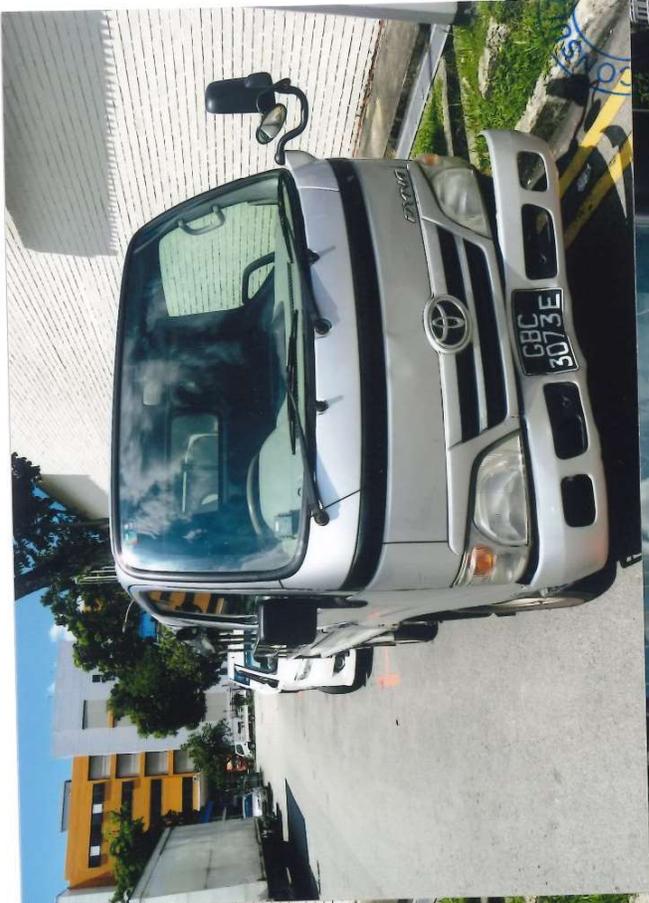
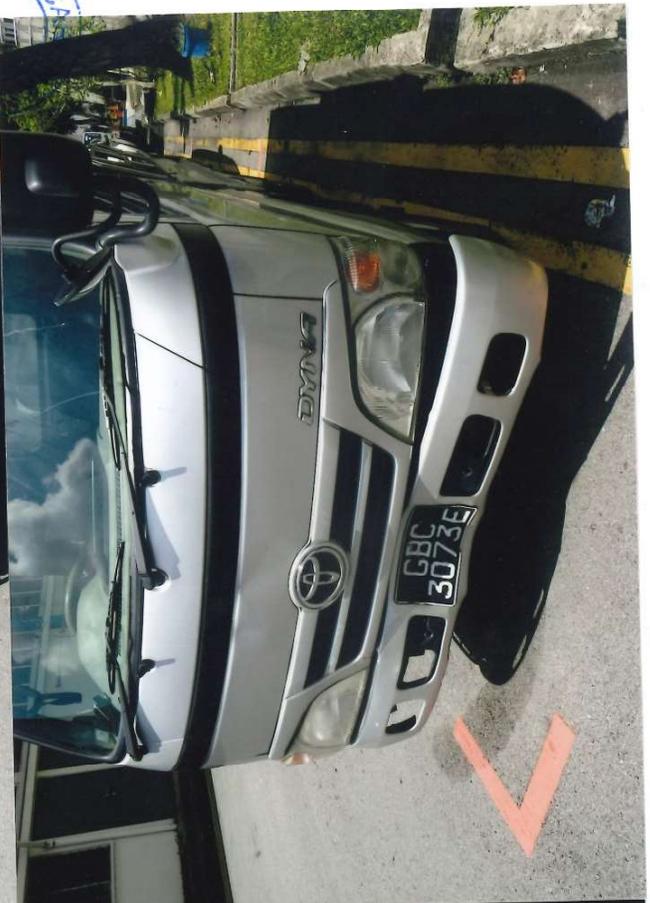
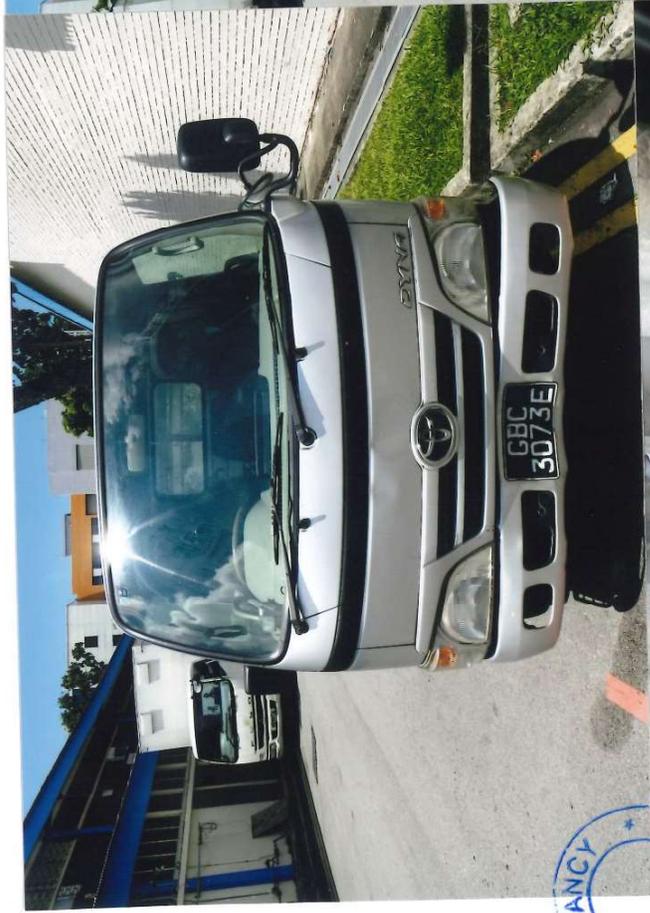
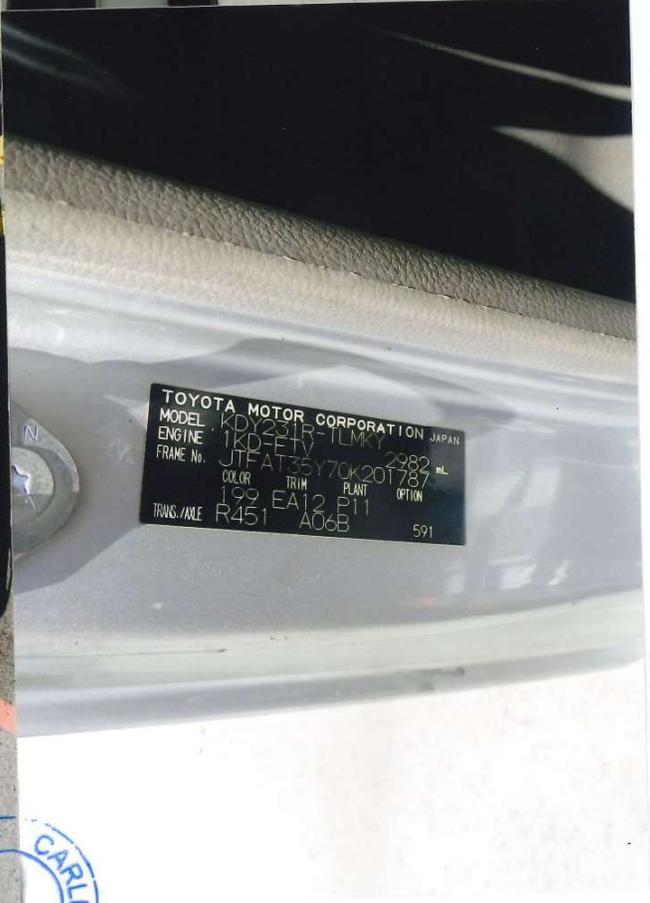
TOYOTA MOTOR CORPORATION JAPAN			
MODEL	KDY251R-TLMK1		
ENGINE	1KD-FE-TV		
FRAME No.	JTF AT 35Y70K 201787	2982	ML
COLOR	TRIM	PLANT	OPTION
199	EA12 P11		
TRANS./MILE	R451	A06B	591
