Our reference: 22 - 170593

RE: Road Traffic Accident on 08-04-2022
Lim Lee Tiang

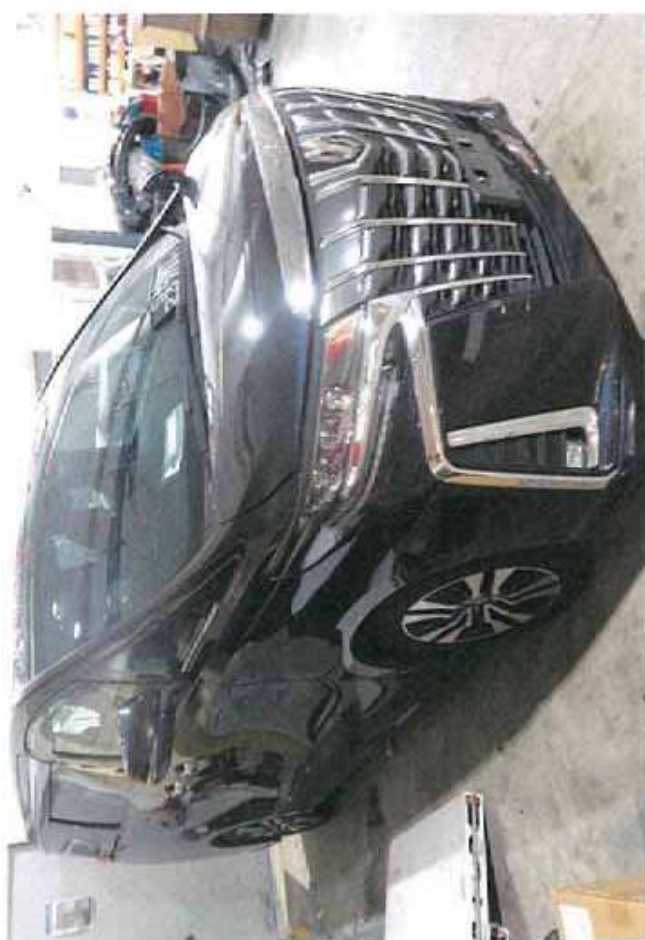
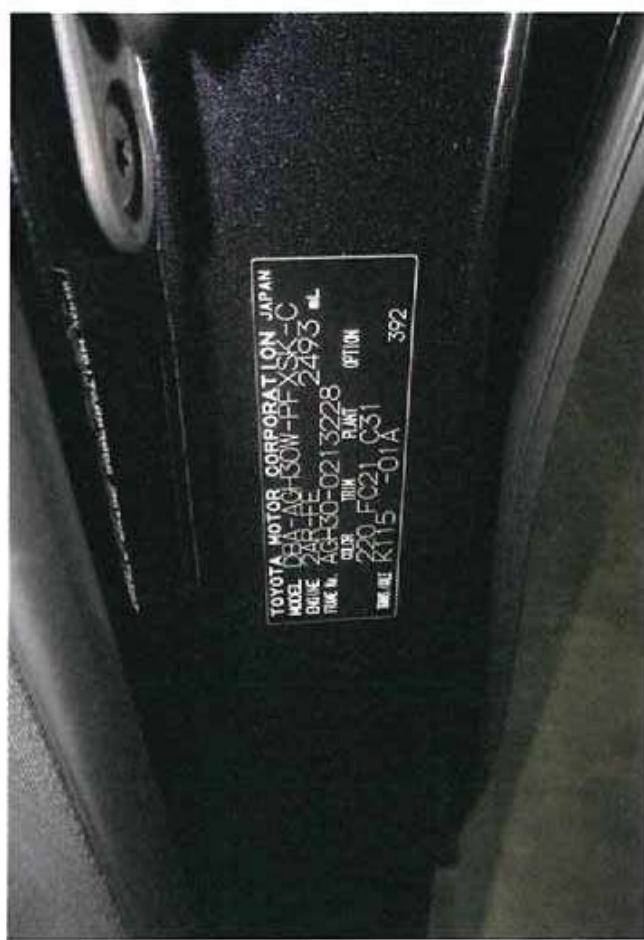
TOYOTA MOTOR CORPORATION JAPAN
MODEL DATA 80W-FFXSK-C
ENGINE 2AR-FE 2493 cc
TYPE No. AG-00-0213228
COLOR TRIM PLANT OPTION
DATE DEL KT15-01A 392
