UNITED Appraisal And Management Pte Ltd

| DESCRIPTION | AMOUNT |
|---|---|
| Registration no. : SMN4433E | |
| Make/Model : Mercedes Benz C180 Coupe AMG Line | |
| Our reference : UAM22.06.32-AK-STP-JSS-SMN4433E | |

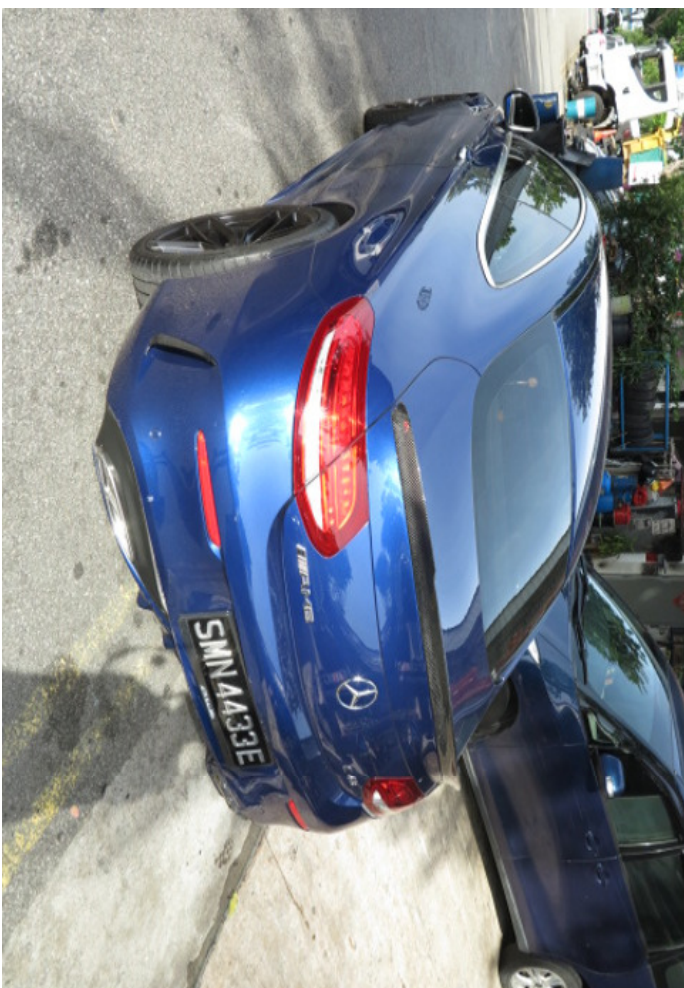
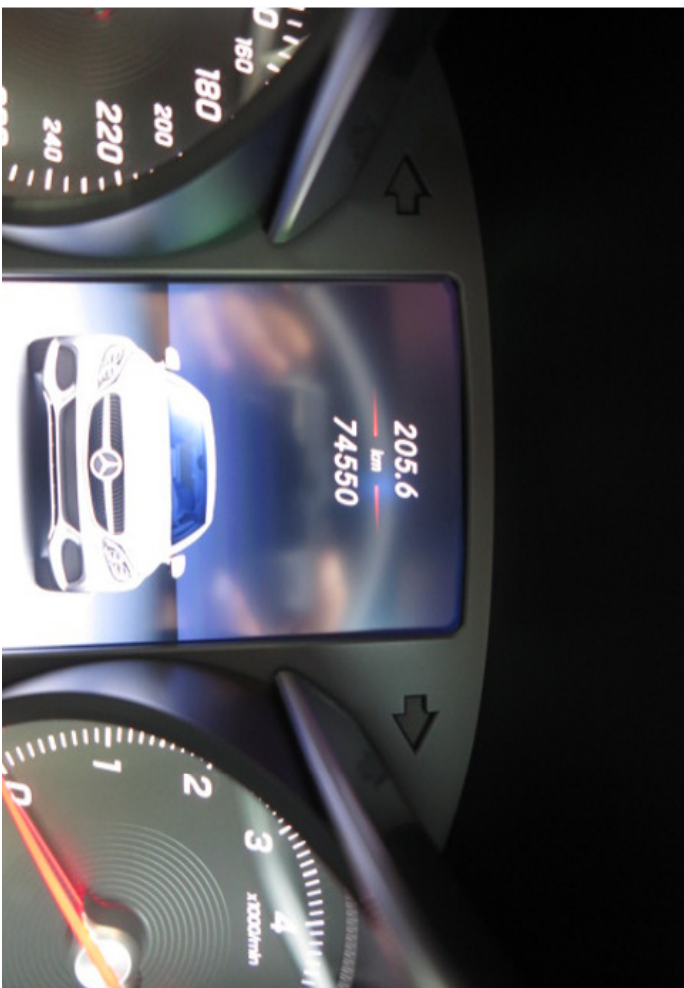
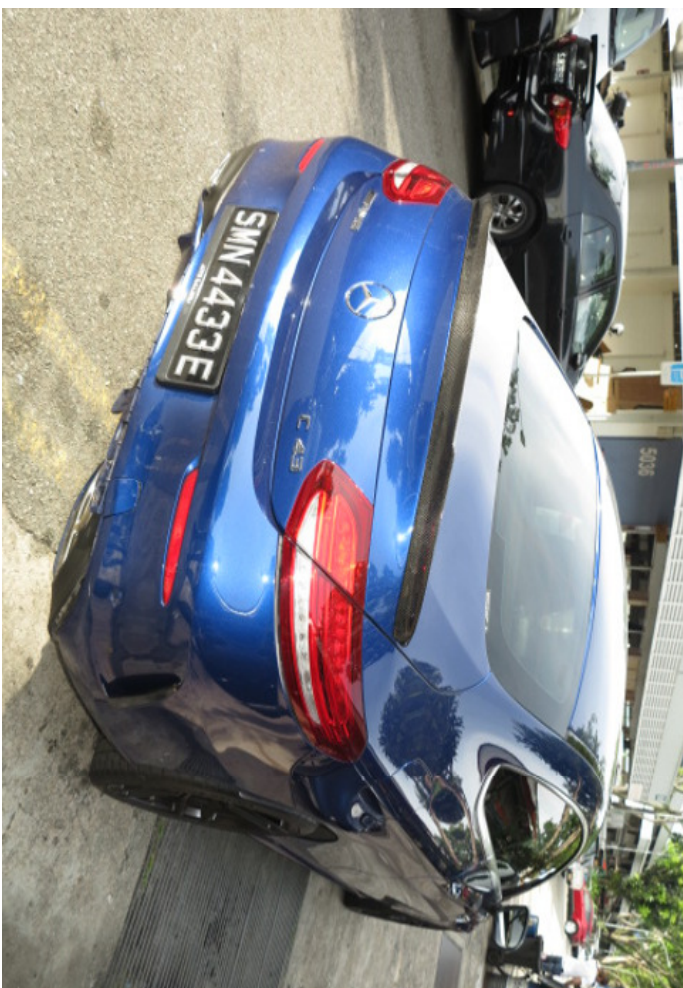
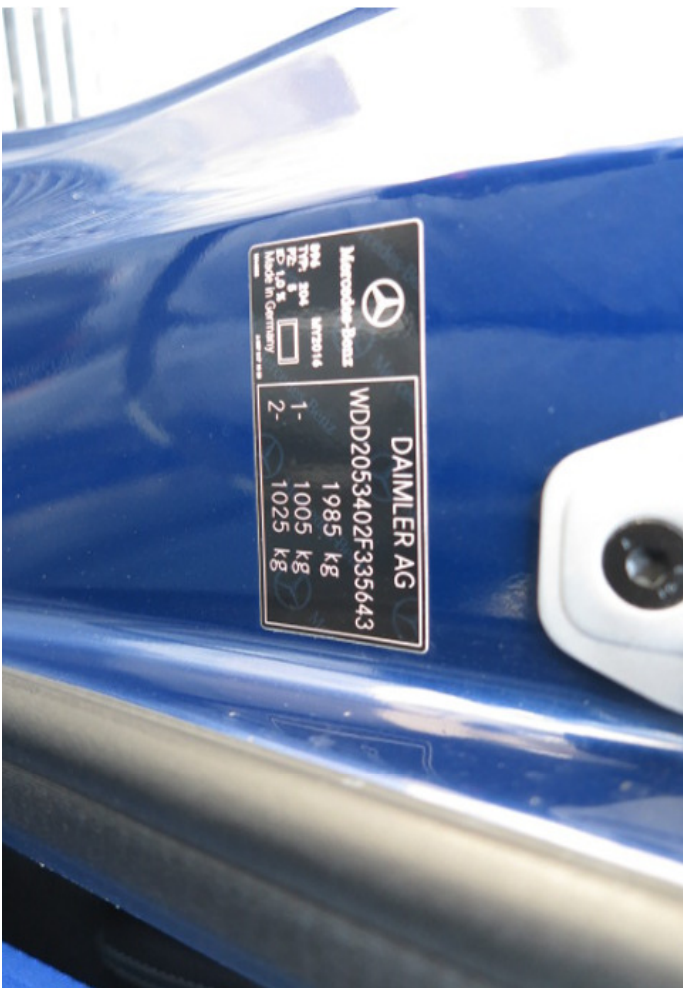
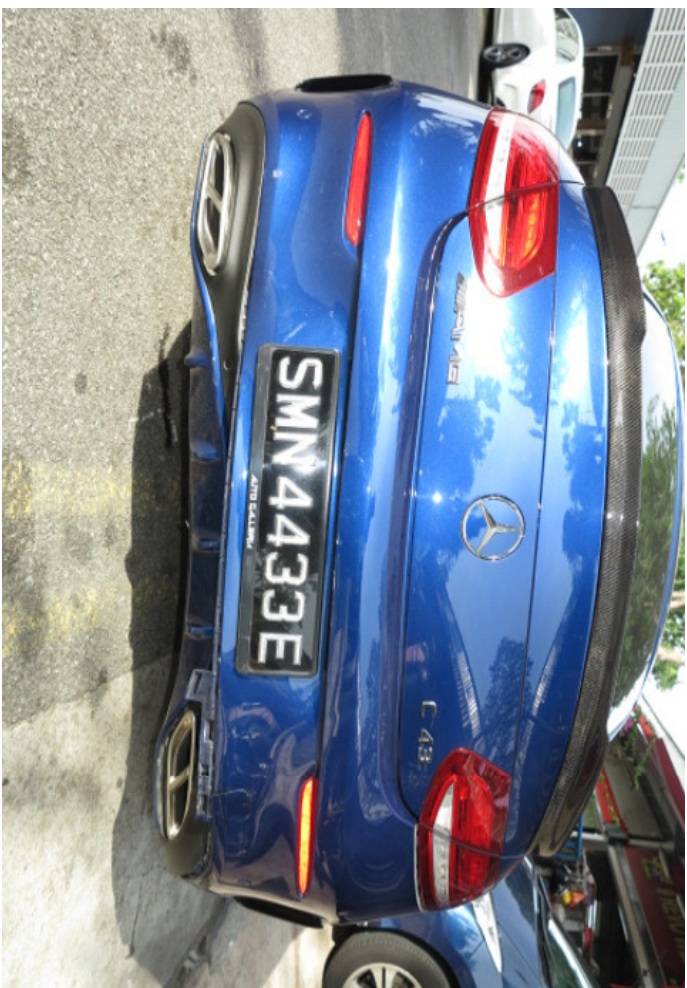
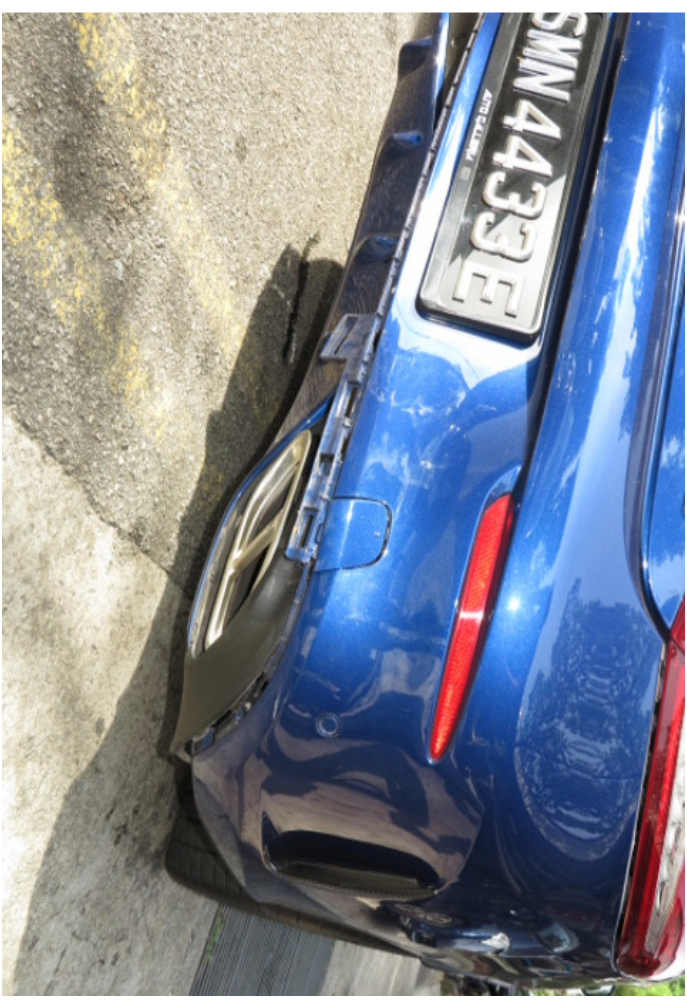
The impact of the collision has damaged / affected the rear bumper, rear bumper lower, bootlid, rear end panel and etc...

Please refer to Annex A (Appraisal Schedule) for a detailed account of the damages and photographs taken.
