VEHICLE DAMAGE INSPECTION REPORT

Our Ref: 686/TP/2019

Reg No:	SKA9789M	Make &	Chevrolet
Reg date:	19/11/2011	Model	Cruze 1.6L Auto
Colour:	Red	Engine No:	F16D4242888KA
Type:	Motor Car	Chassis No:	KL1JA69E9BK128501
Type of Claims:	Third Party	Odometer No:	243795km
		Engine Cap:	1598cc

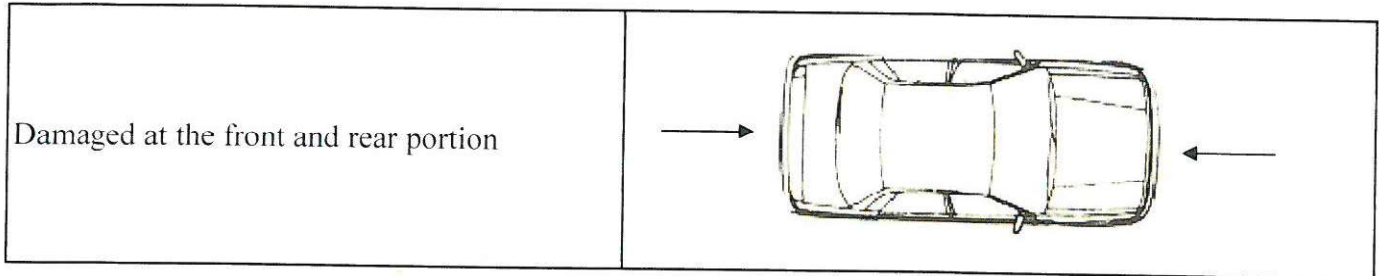
POINT OF IMPACT

Our visual inspection of the vehicle revealed that the damages noted are at the front and rear portion.
