TP Motor Claims by SMY 735 C

DAMAGED VEHICLE (SMY 735 C) INSPECTION REPORT (WITHOUT PREJUDICE)

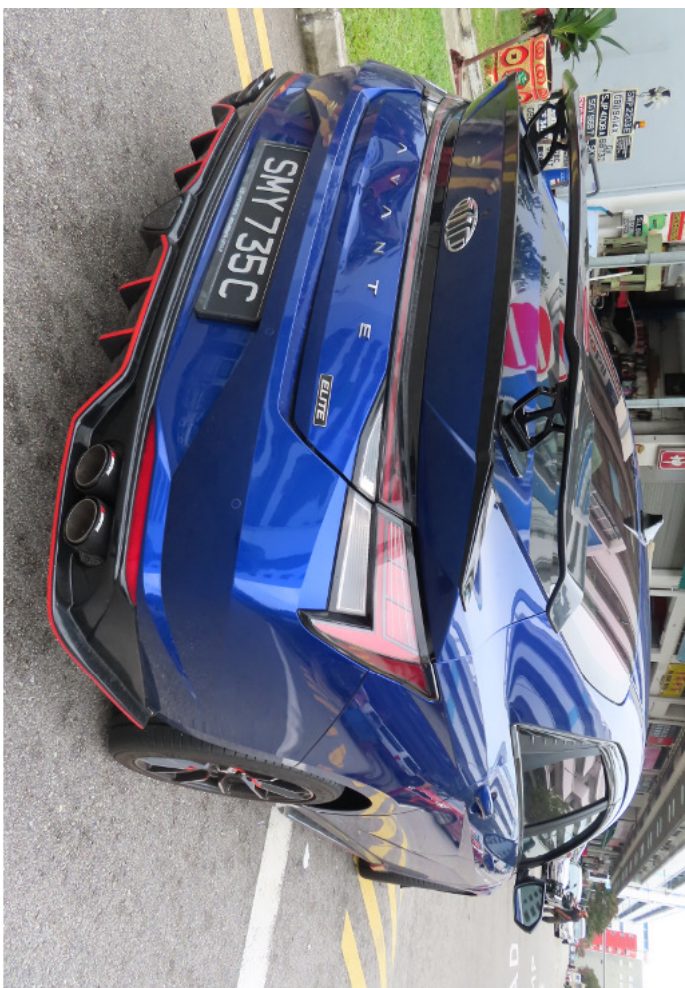
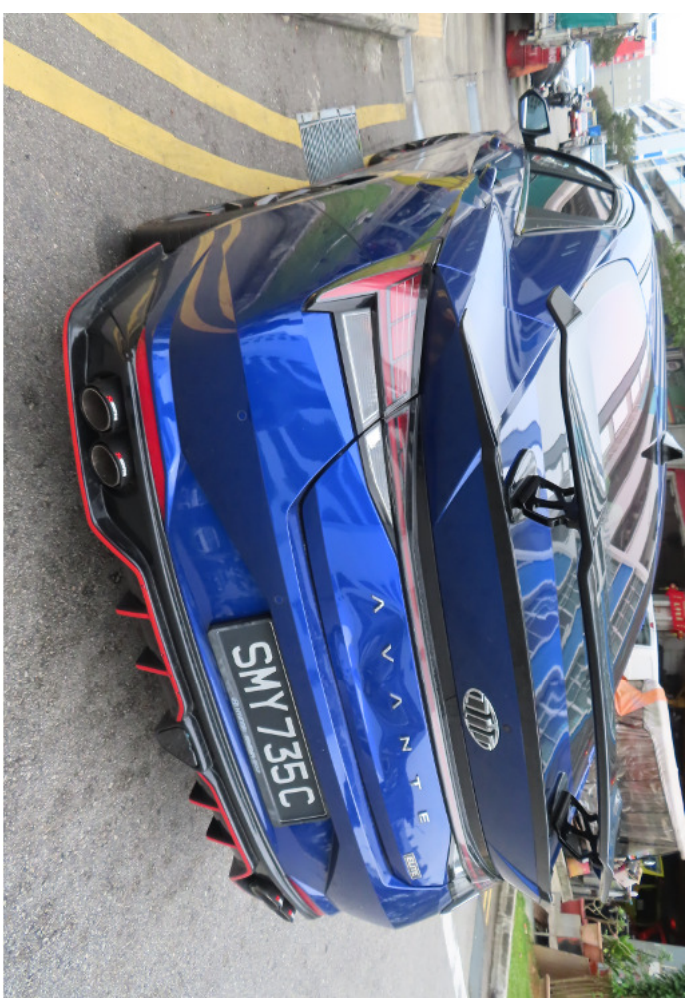
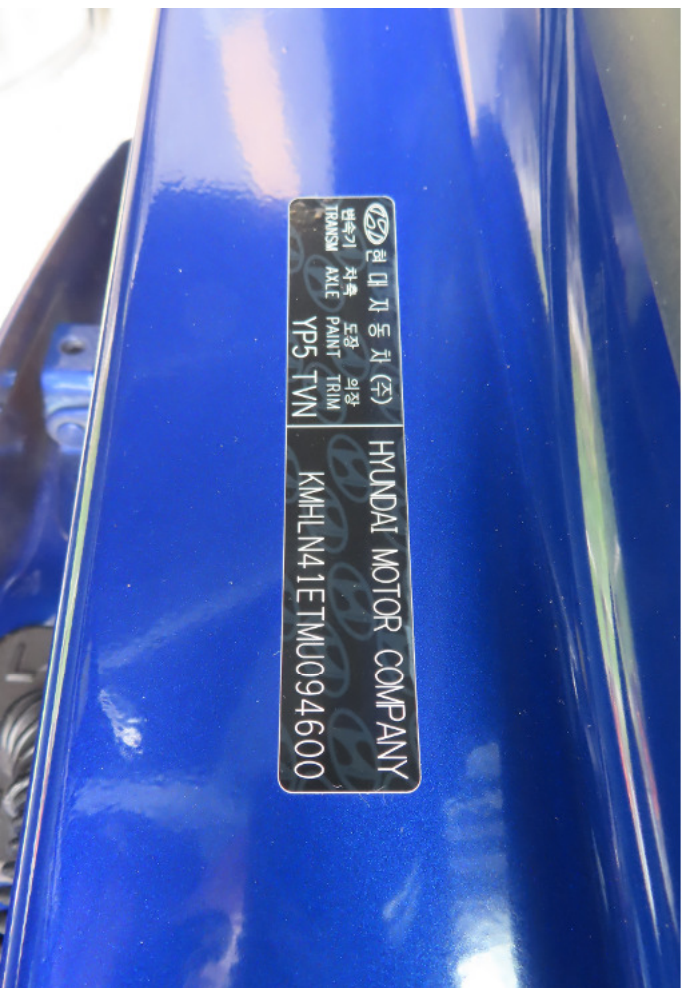
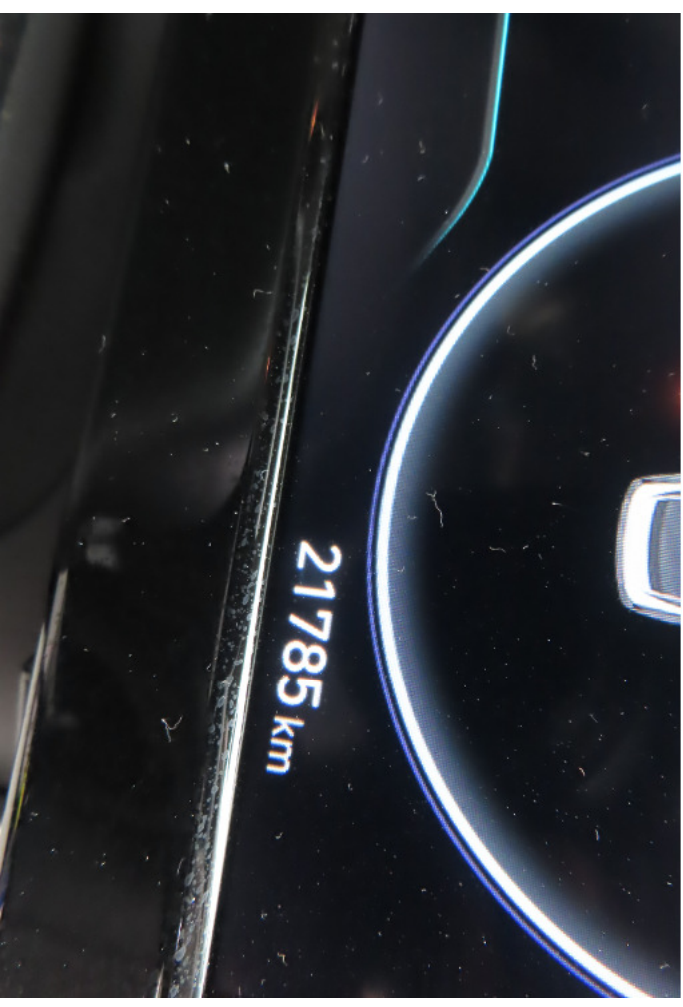
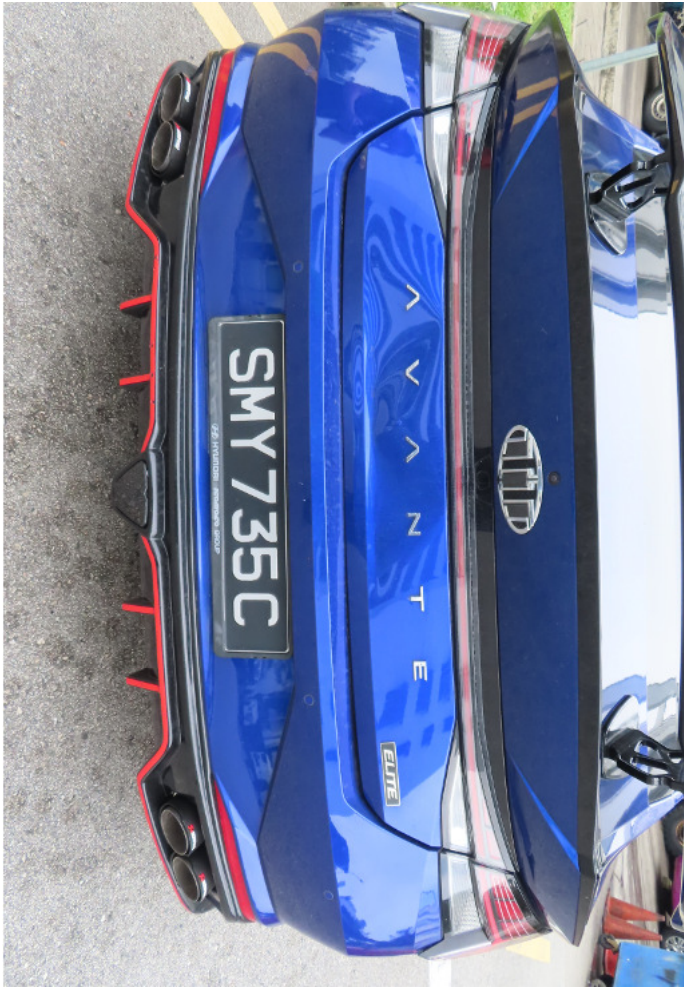
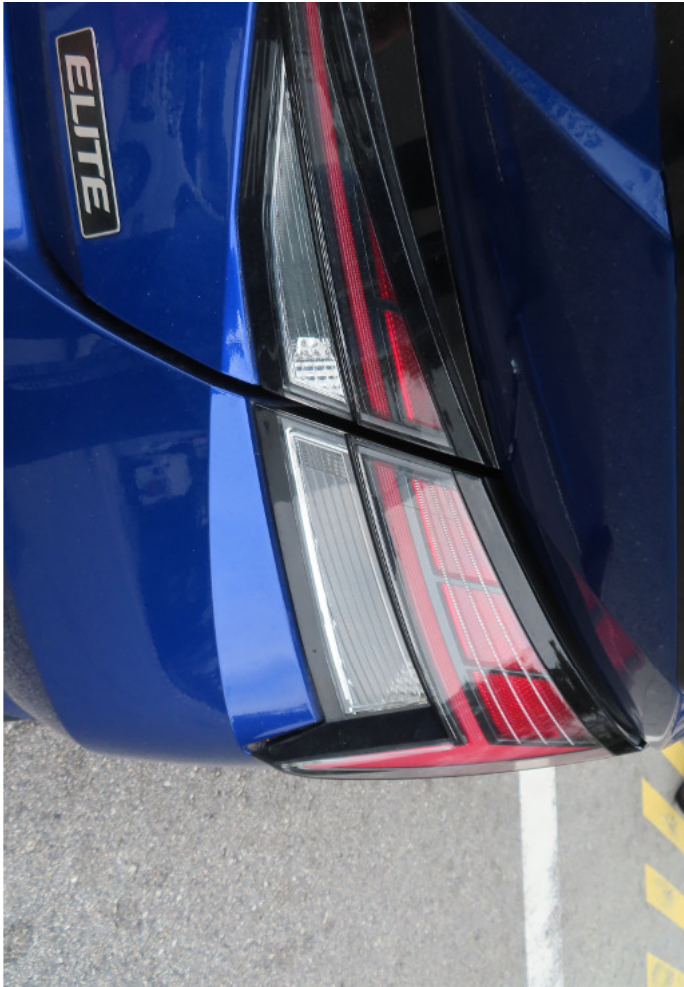
The impact of the collision has damaged/affected the rear bumper, rear bumper lower spoiler, bumper sensor and etc.

Please refer to the Annex for a detailed account of the damages and photographs taken.
