**LKK Auto Consultants Pte Ltd**

Vehicle No. PC 9719X

1. Policy Particulars :- THIRD PARTY CLAIM

ADJUSTMENT ON REPAIR COST FOR VEHICLE NO PC 9719X

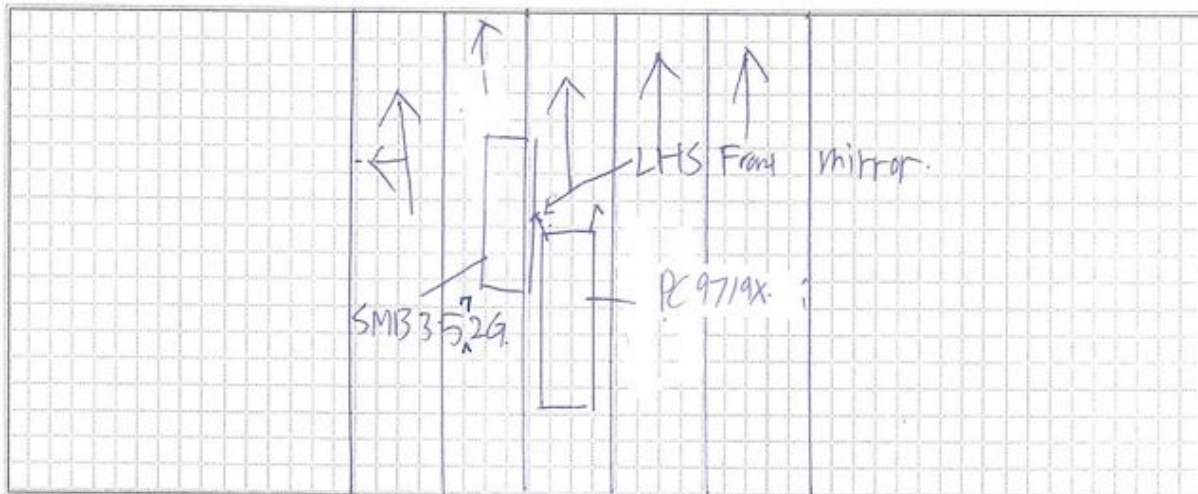
Sketch Plan

ON 12 SEP 2024 at about 1716hrs I was driving my Company Vehicle PC9719X, ON Orchard Rd towards Bras Basah Rd. Vehicle SM13.35729 Back RHS collided PC9719X Front LHS Front mirror.

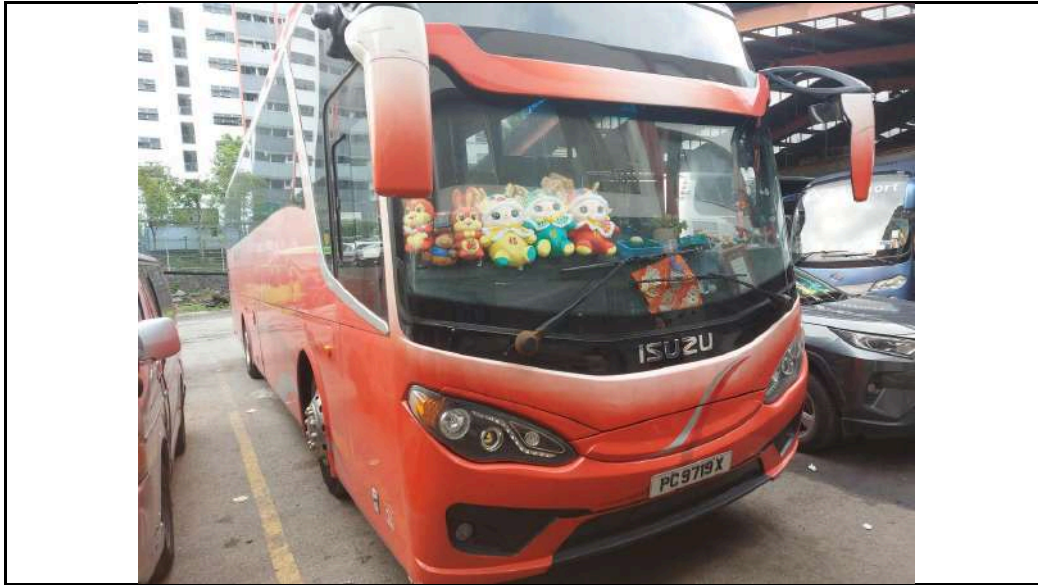
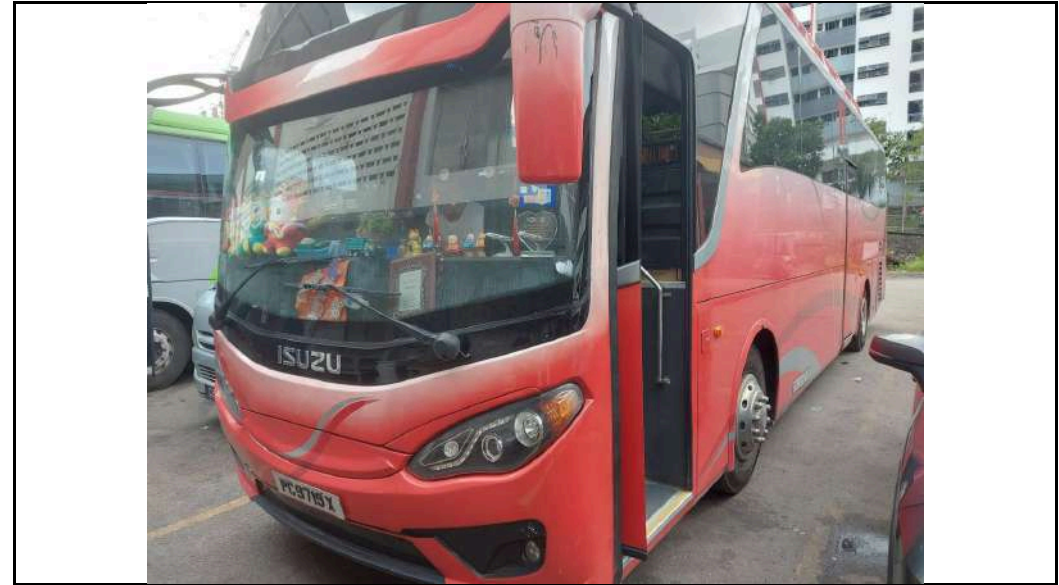
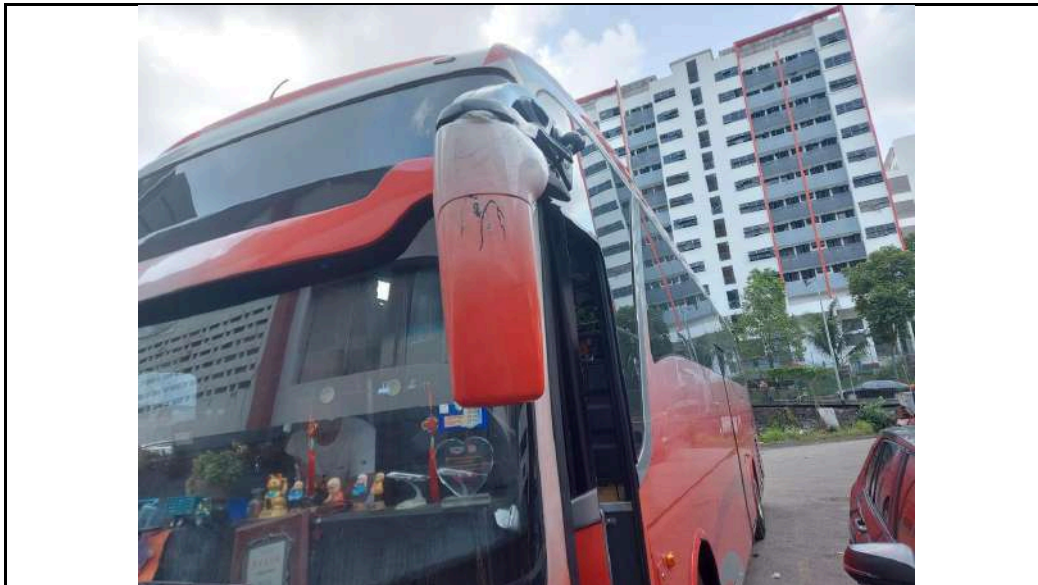
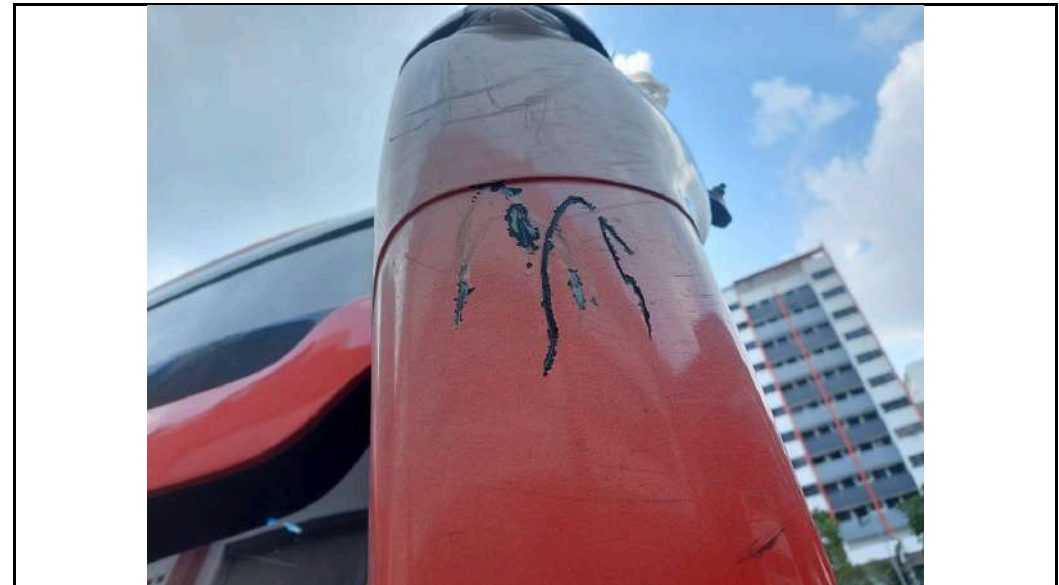
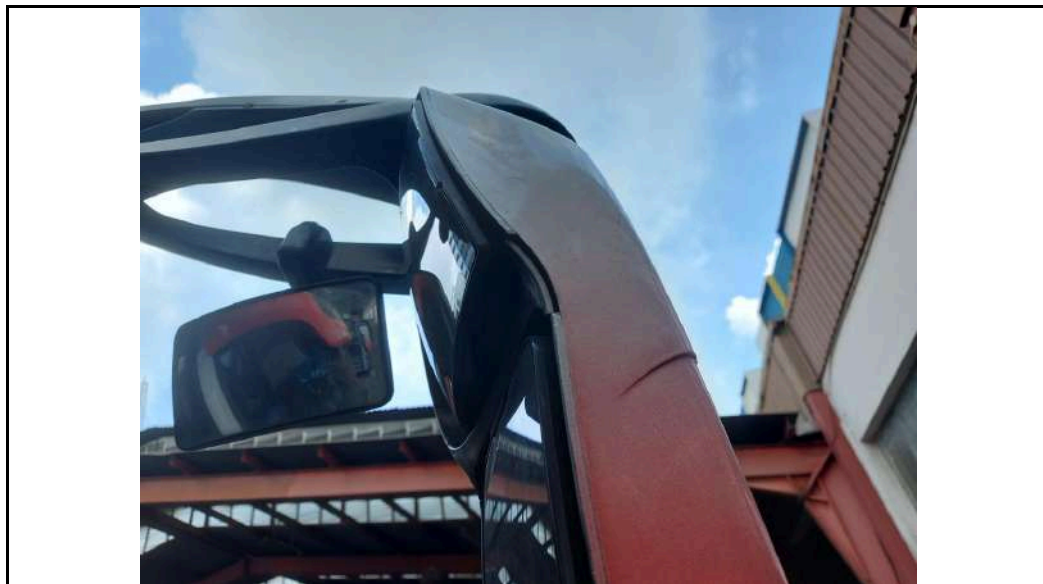
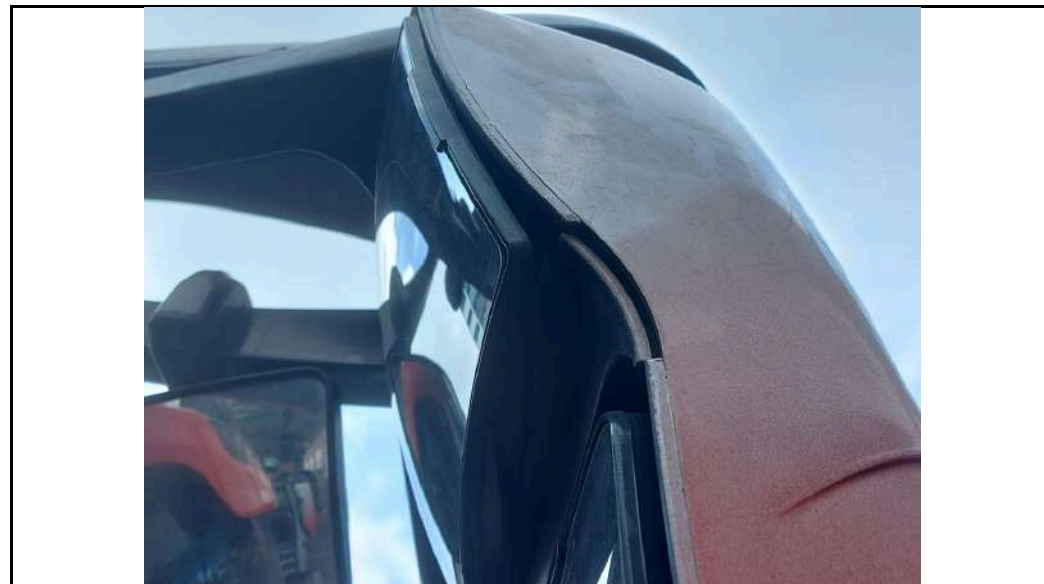
PHOTOGRAPHS FOR VEHICLE NO. : PC 9719X

THE VEHICLE SUSTAINED DAMAGES AT THE FRONT N/S PORTION.

REPLACEMENT OF PARTS				
Qty	Description of Parts	Condition	Workshop Estimate (\$)	Our Adjusted (\$)
1	FRONT LH REAR VIEW MIRROR ASSY	DISTORTED	\$1,950.00	\$1,950.00
	LESS 0.00 / 10.00% DISCOUNT		\$0.00	(\$195.00)
			\$1,950.00	\$1,755.00

Labour				
	Description of Parts	Condition	Workshop Estimate (\$)	Our Adjusted (\$)
	CHECK WIRING		\$20.00	\$20.00
	SPRAY PAINTING		\$200.00	\$180.00
	LABOUR CHARGES		\$300.00	\$180.00
			\$520.00	\$380.00

RECOMMENDED COST OF REPAIRS			\$2,135.00
--	------------------------------------	--	--	-------------------
