Vehicle No. SMU 6176Y  
Insured Veh. SHB 223T  
Claim No. TAX/06/24/2046  
Policy No.  
Accident Date 16/06/2024  
Inspection Date 25/06/2024

| Make & Model | VOLVO XC40 T4 (A) | C.C | 1969 |

### 4. Description of Damages

## ADJUSTMENT ON REPAIR COST FOR VEHICLE NO SMU 6176Y

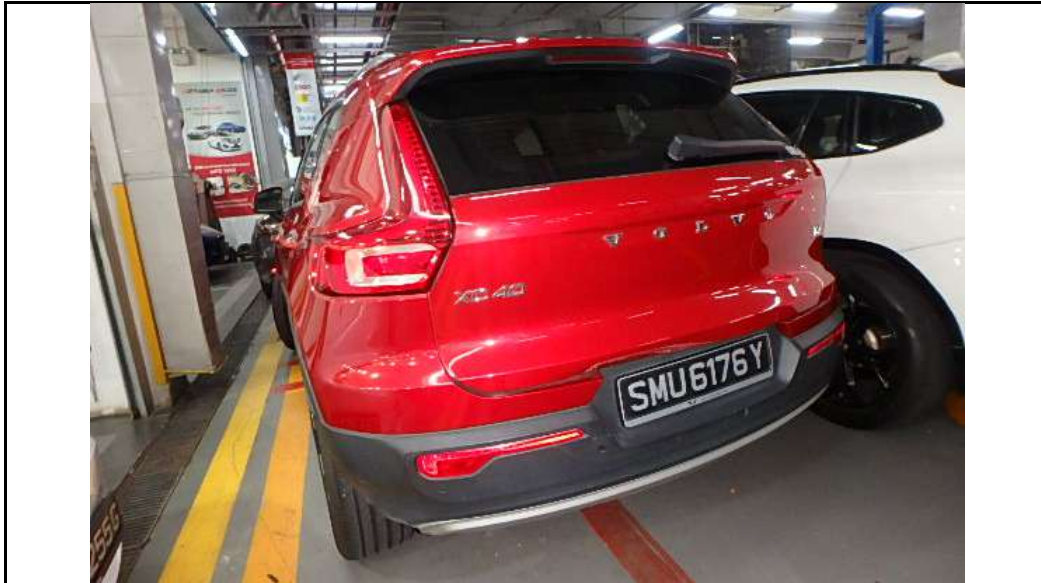
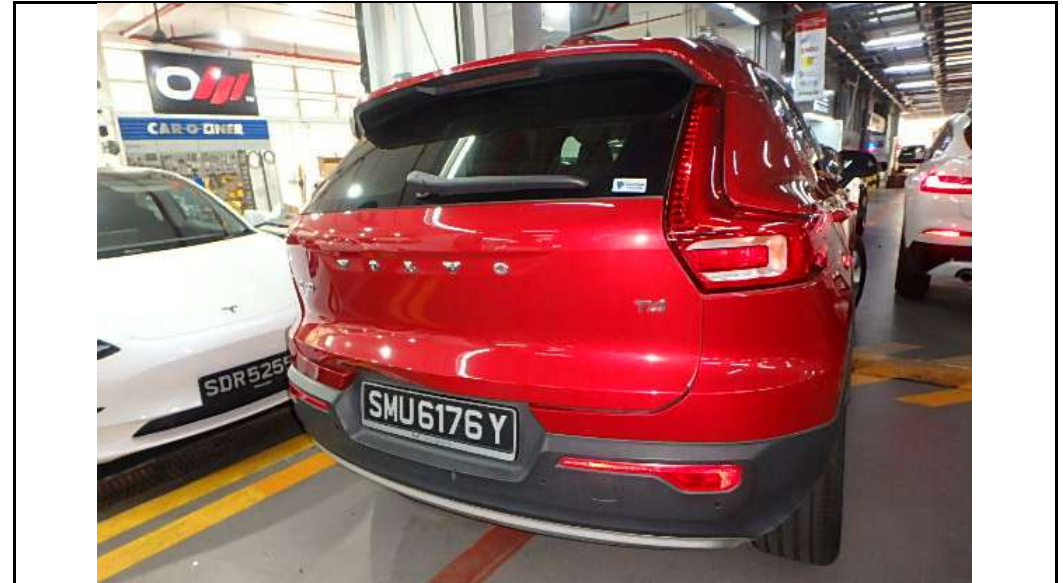
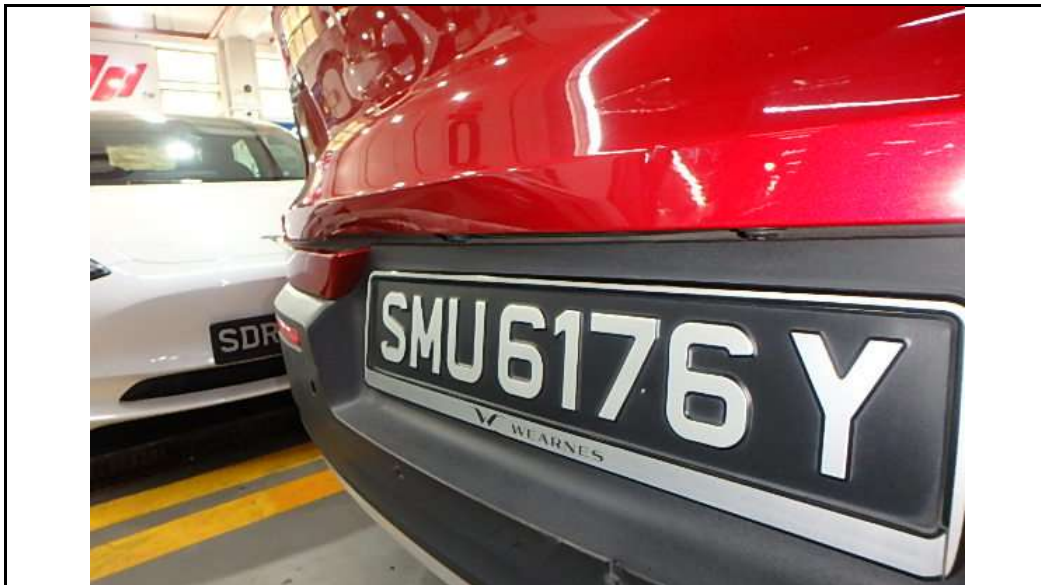
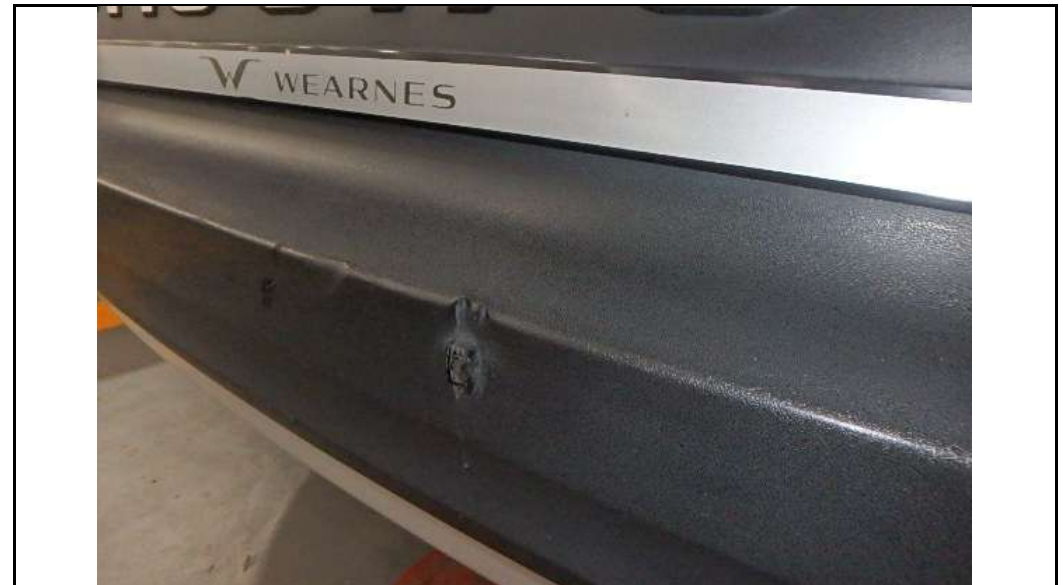
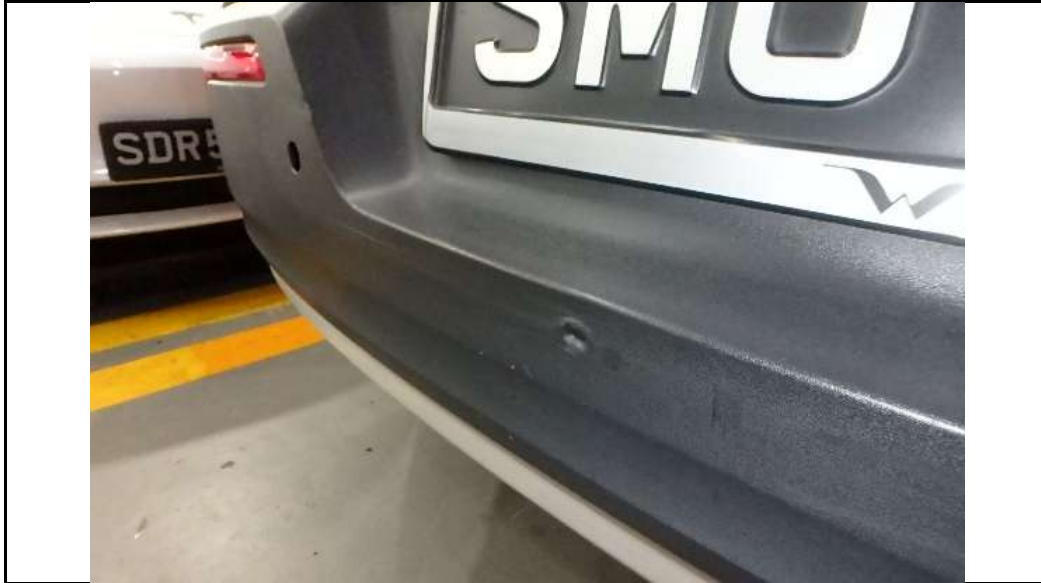
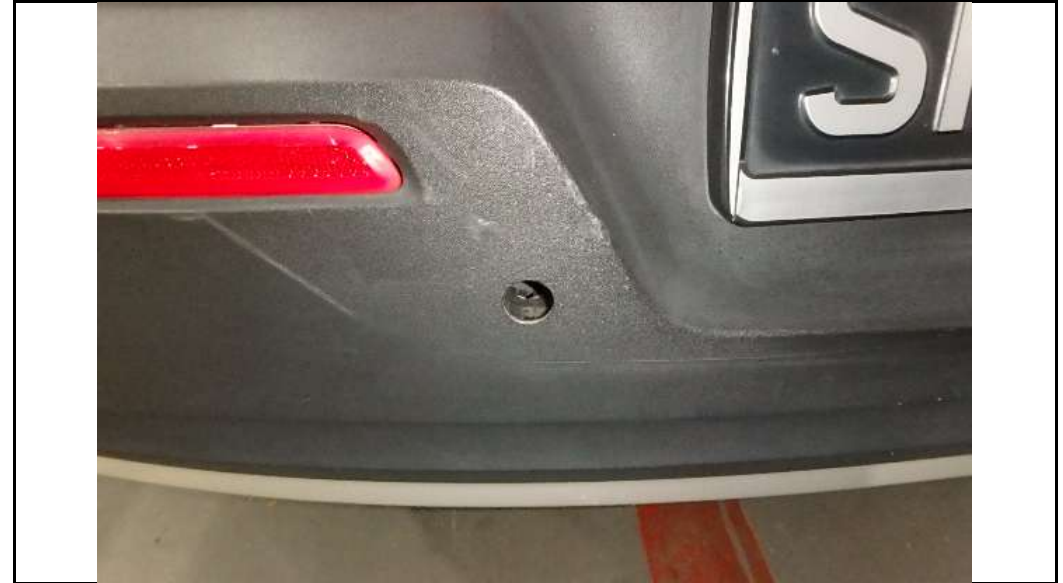
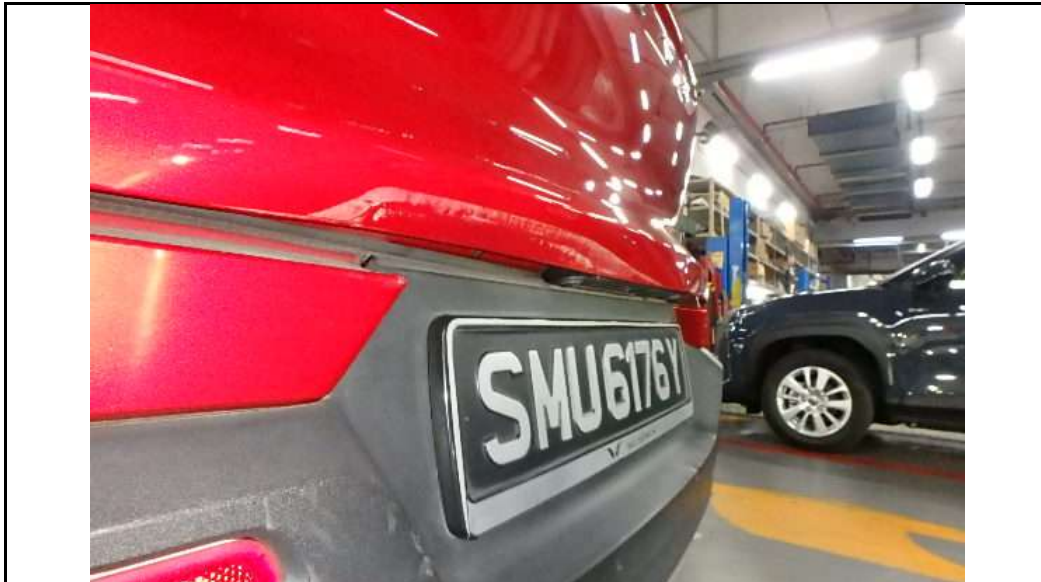
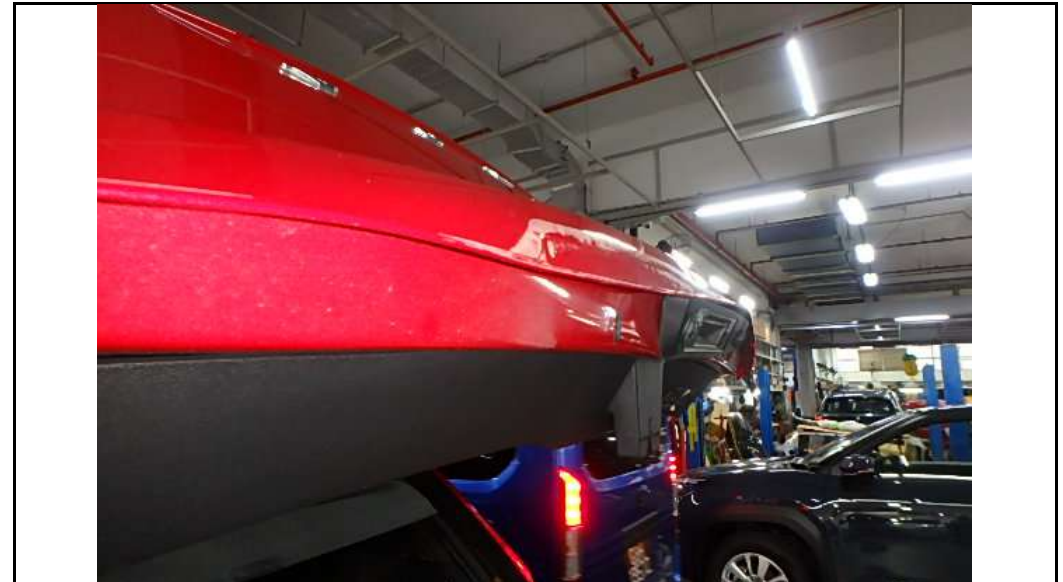
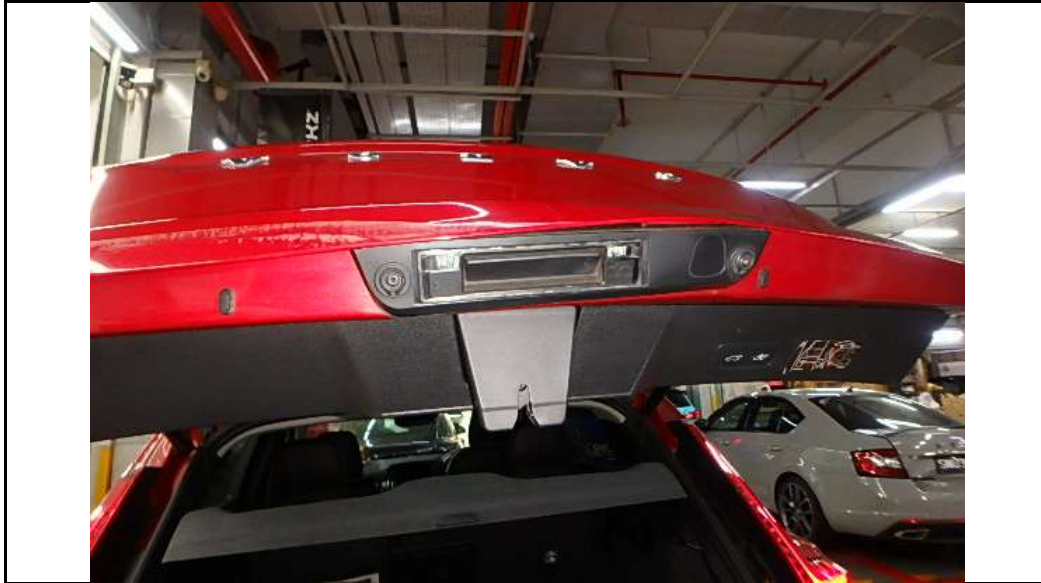
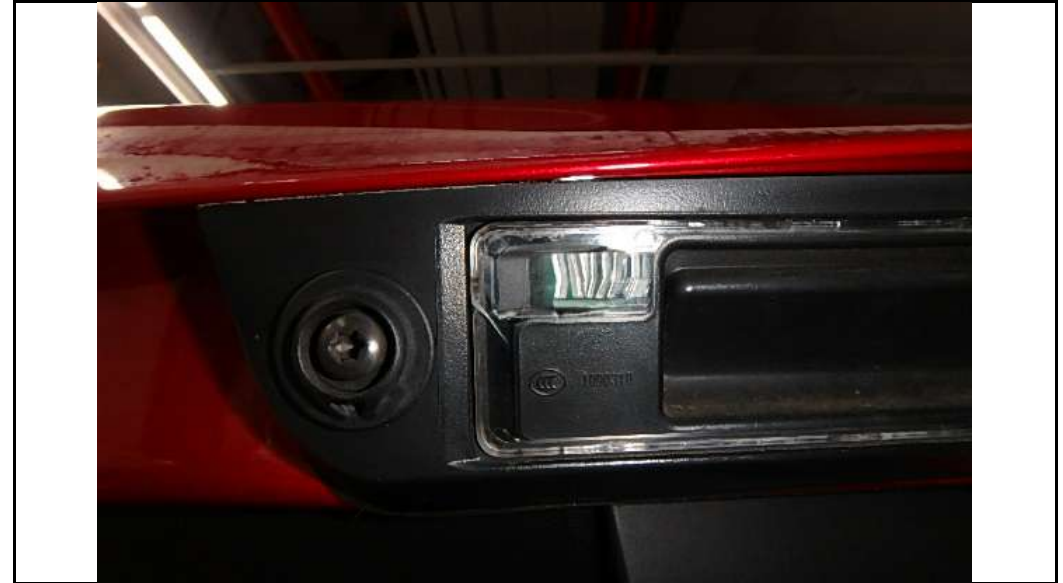
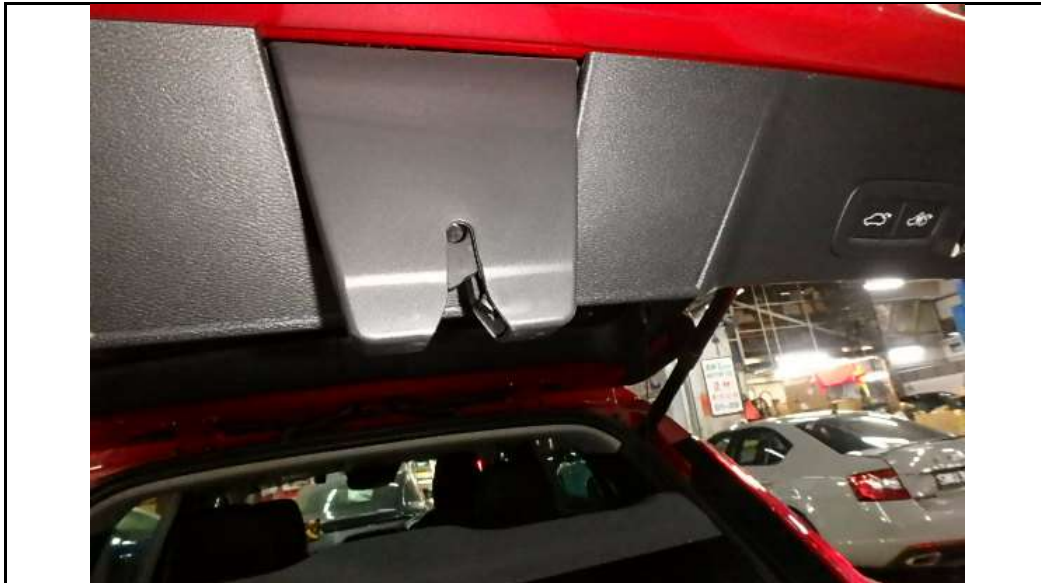
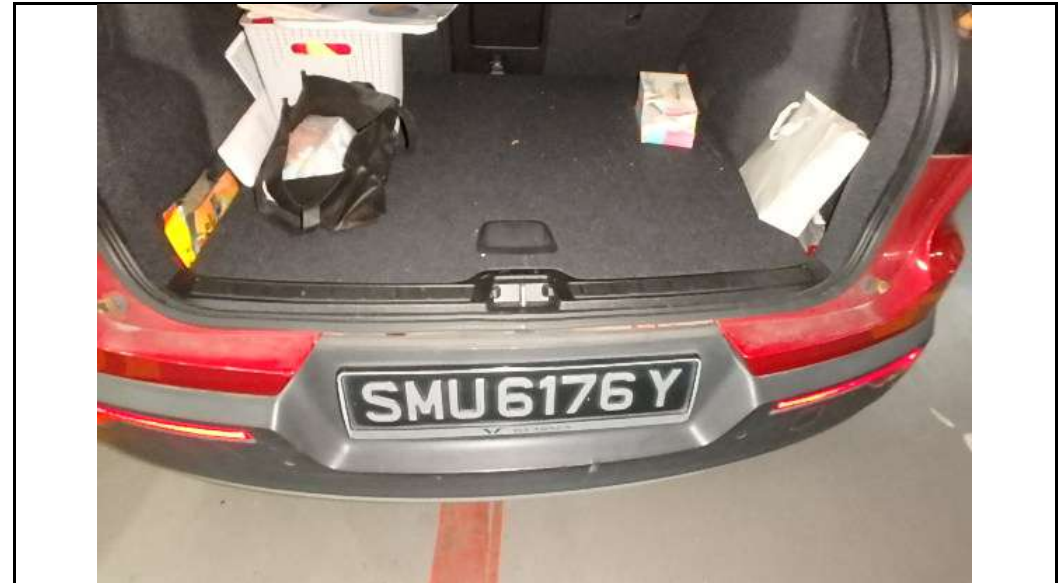
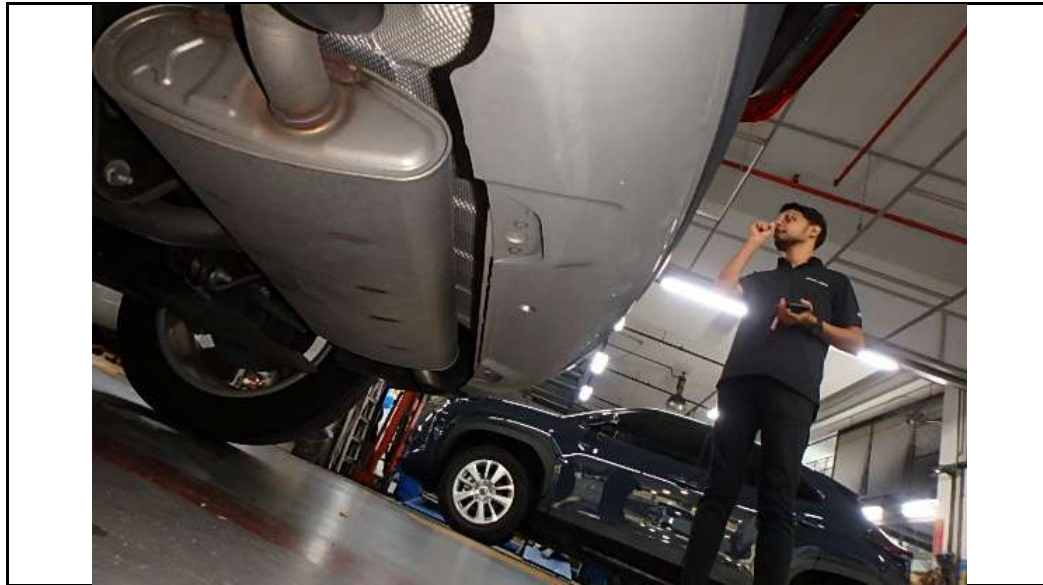
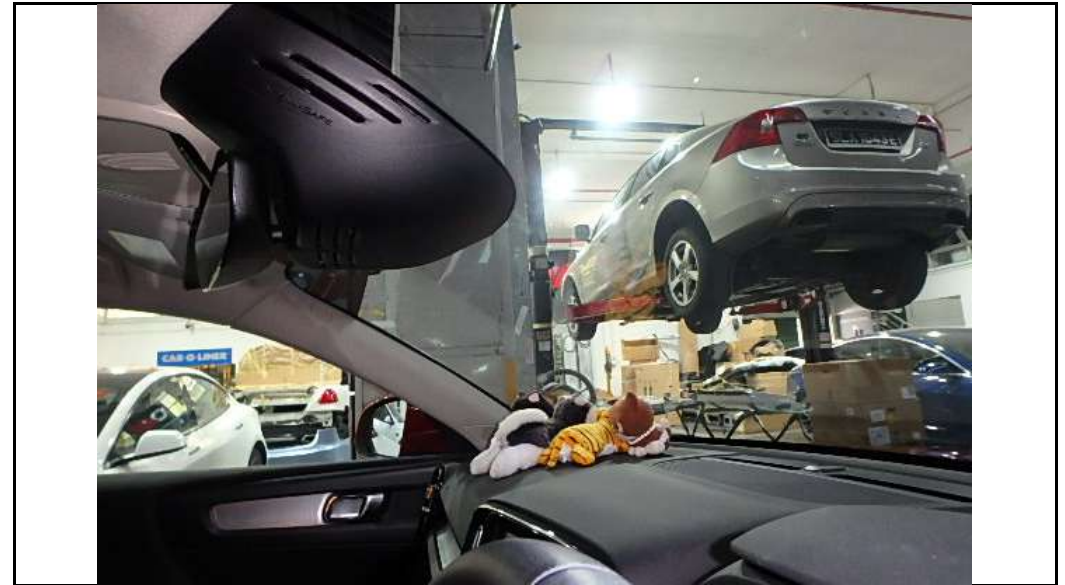
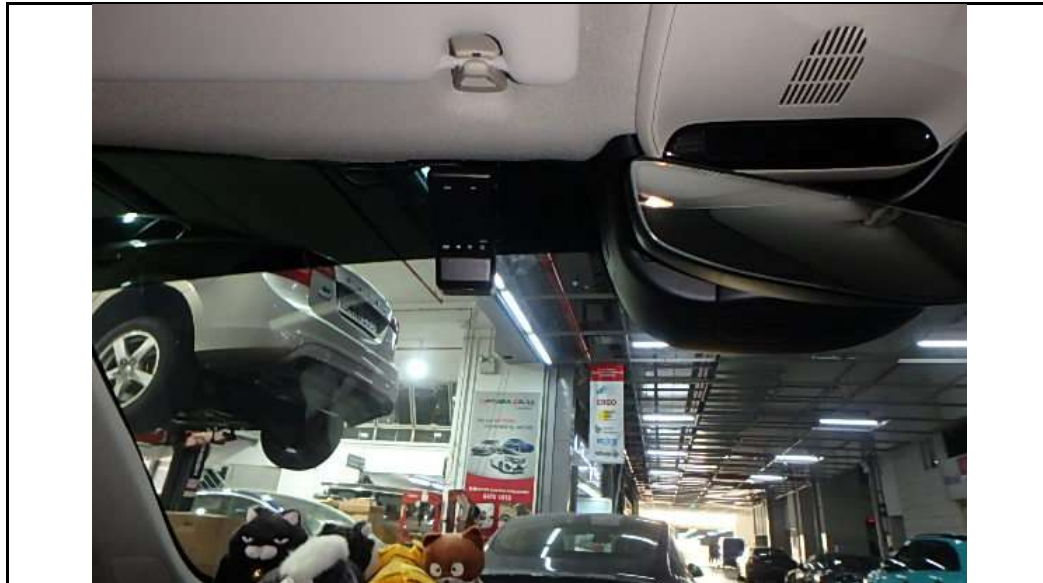
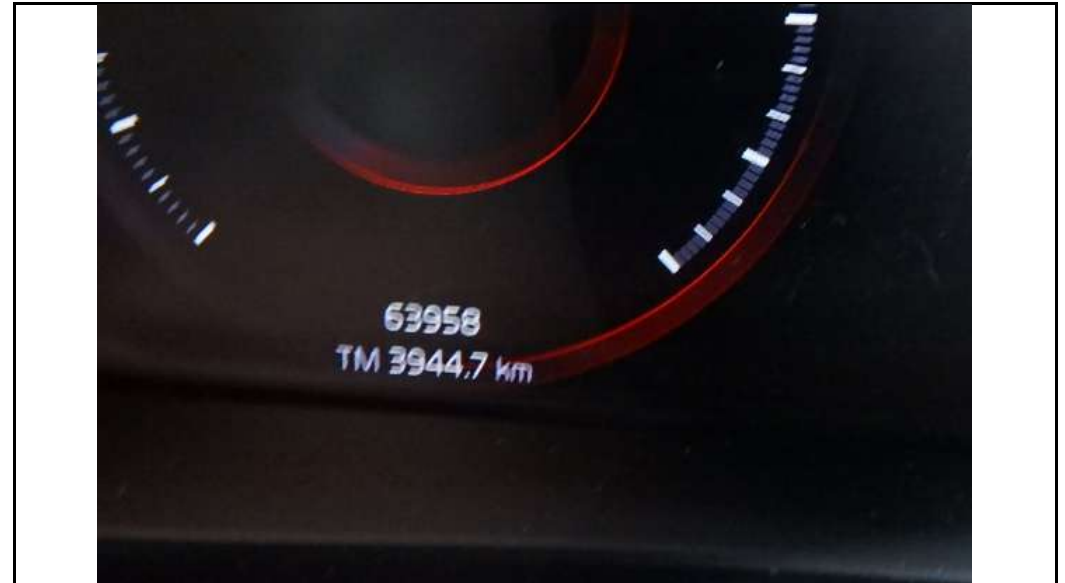
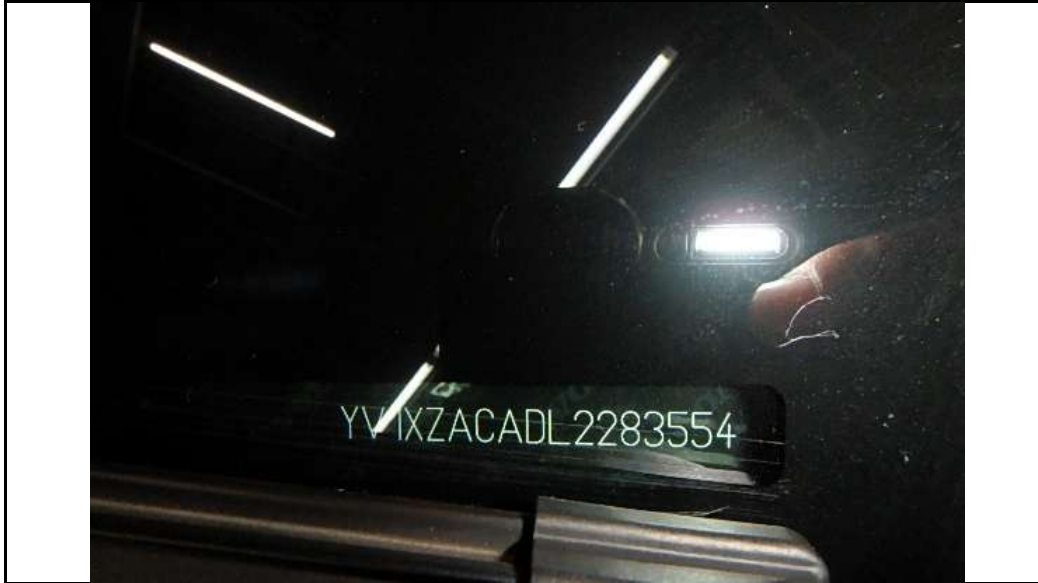
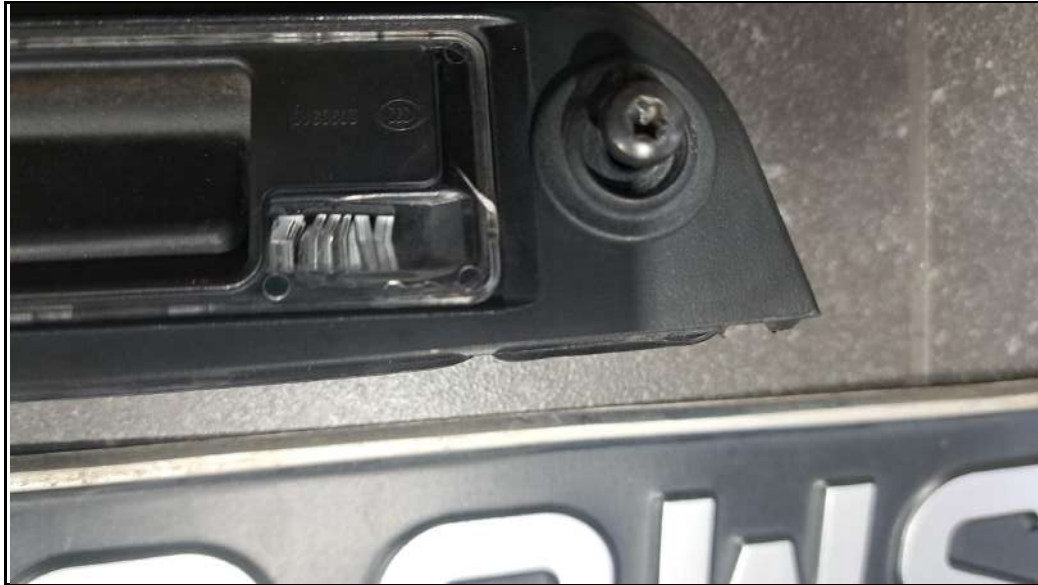
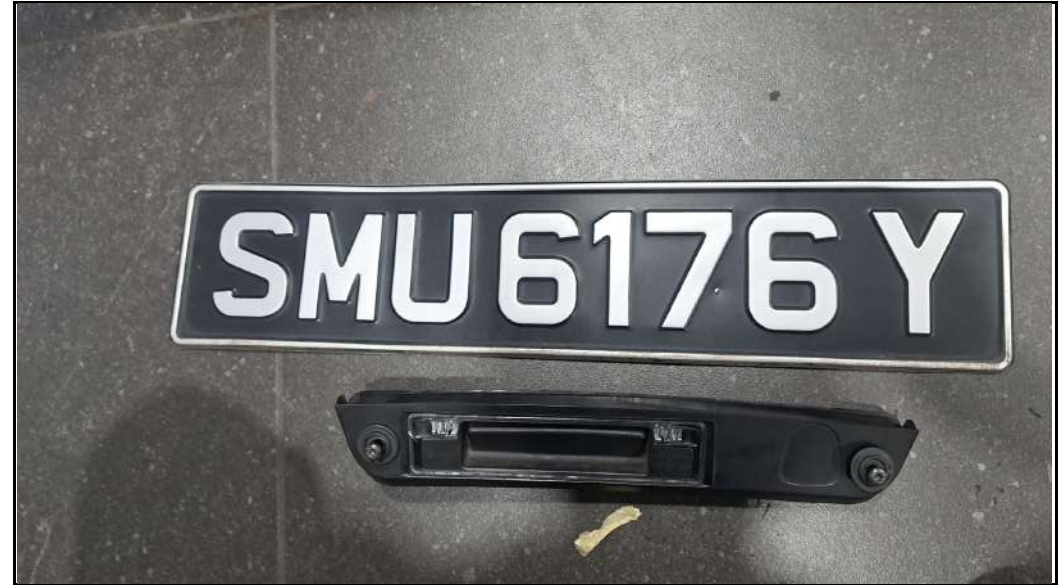
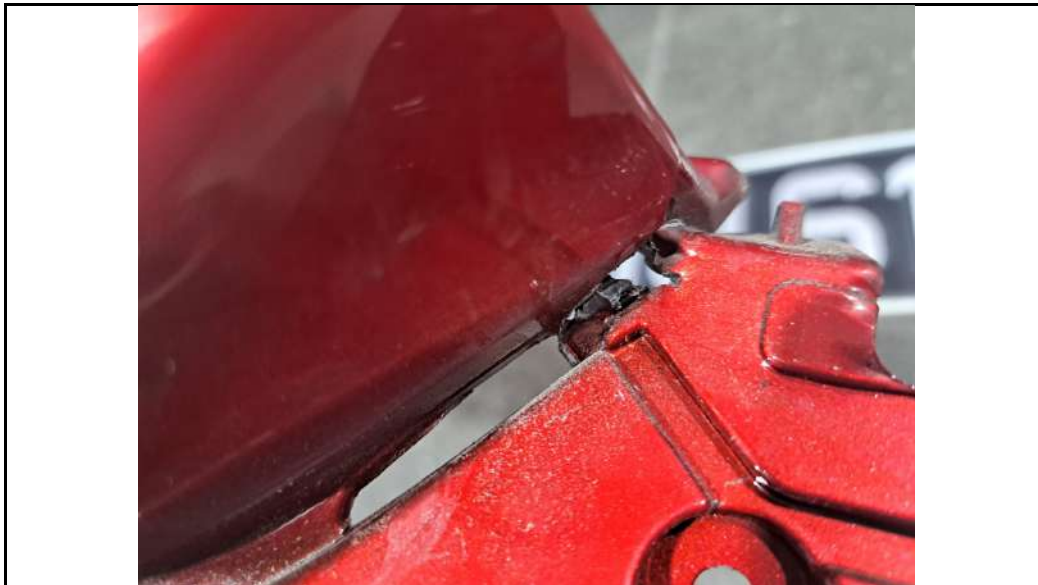
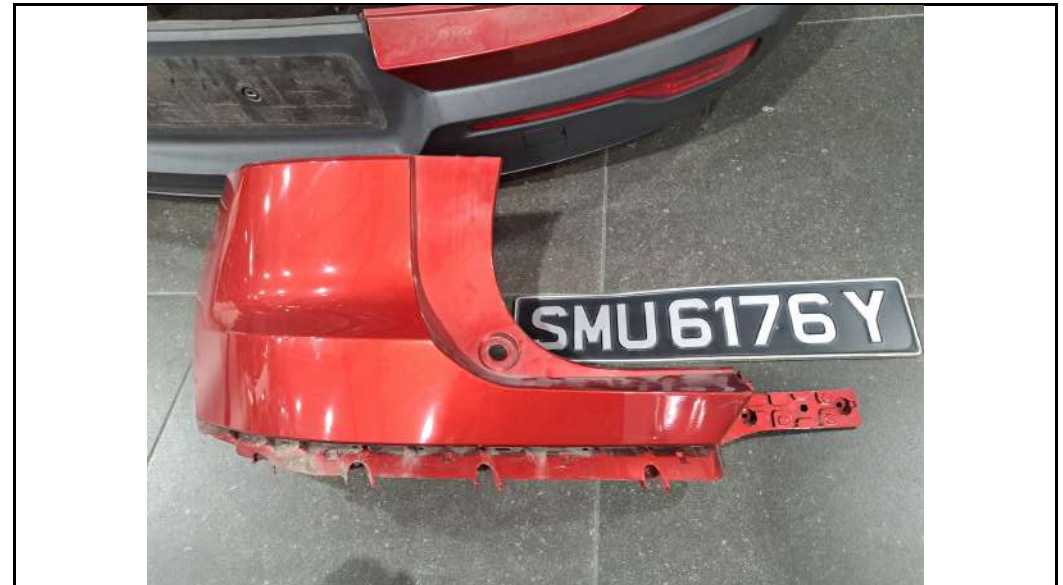
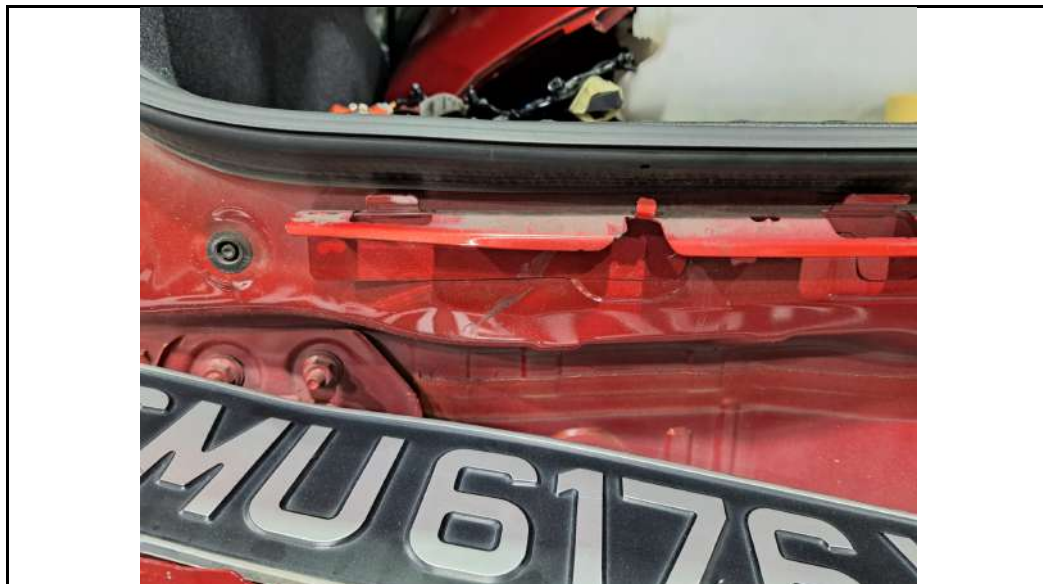
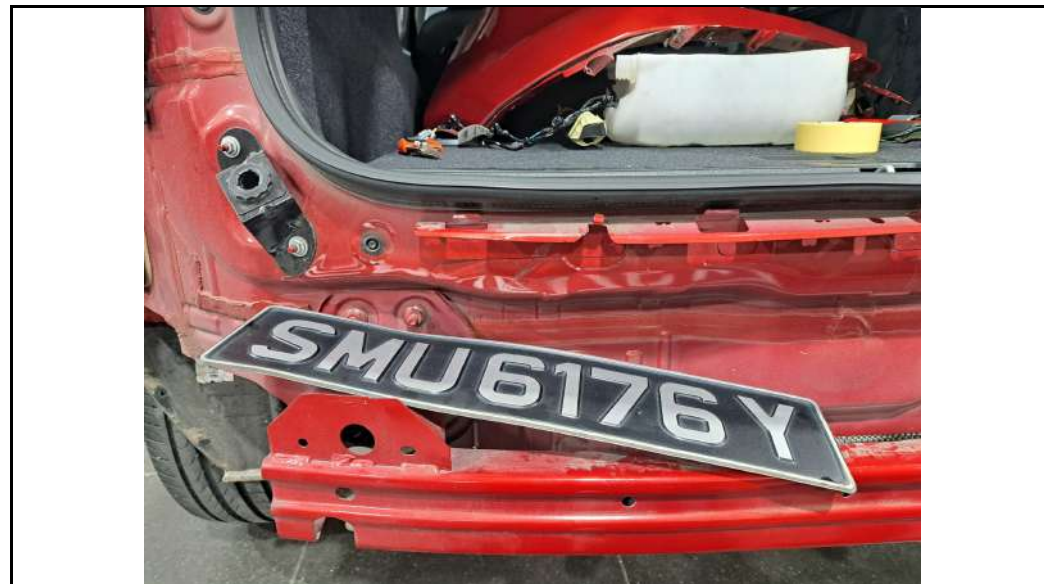
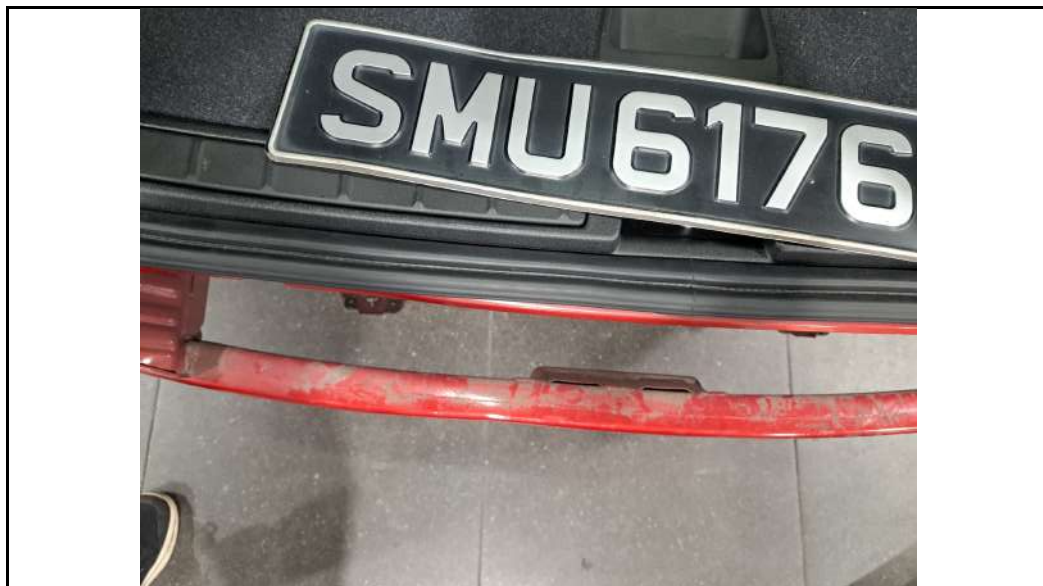
**PHOTOGRAPHS FOR VEHICLE NO. : SMU 6176Y**

THE VEHICLE SUSTAINED DAMAGES AT THE REAR PORTION.

| Labour | | | | |
|---|---|---|---|---|
| | TO REMOVE, REPLACE, REPAIR, READJUST & REFIX RR AFFECTED AREAS | | \$800.00 | \$550.00 |
| | TO REMOVE, PUTTY, REPAIR, SAND AND RESPRAY AFFECTED AREAS | | \$660.00 | \$660.00 |
