**LKK Auto Consultants Pte Ltd**

## ADJUSTMENT ON REPAIR COST FOR VEHICLE NO SNG 8913K

## PHOTOGRAPHS FOR VEHICLE NO. : SNG 8913K

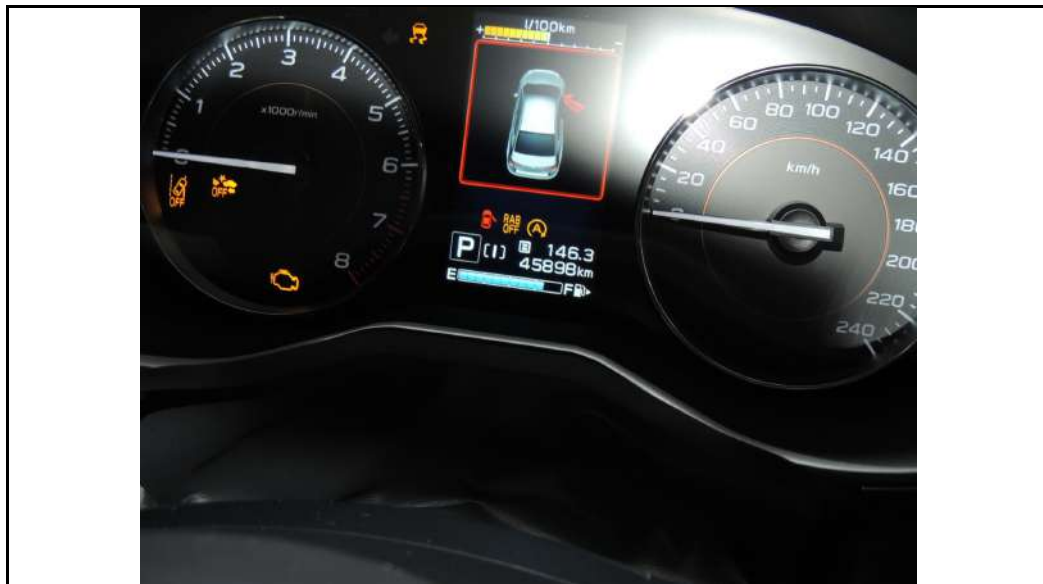
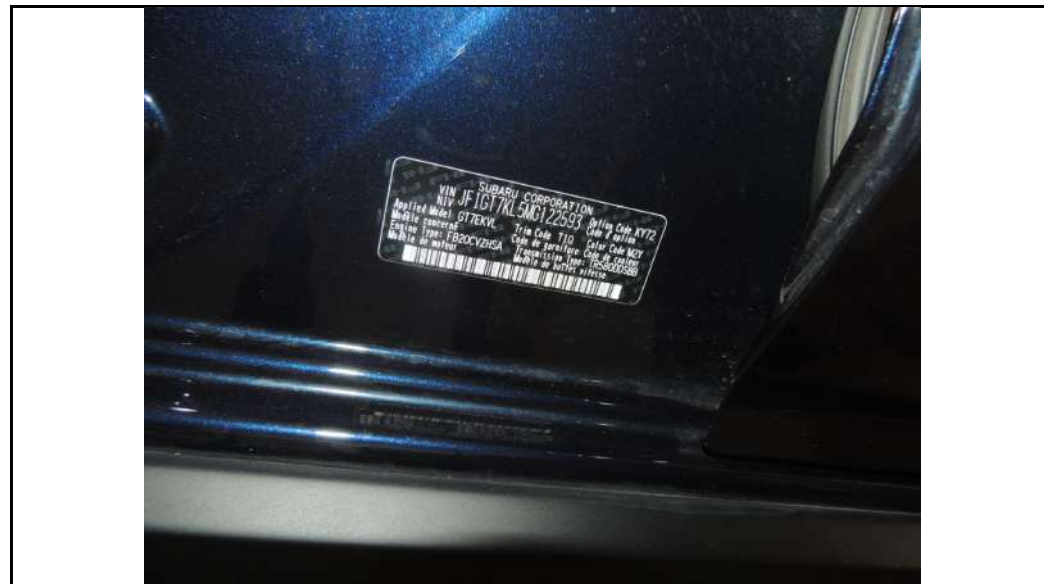
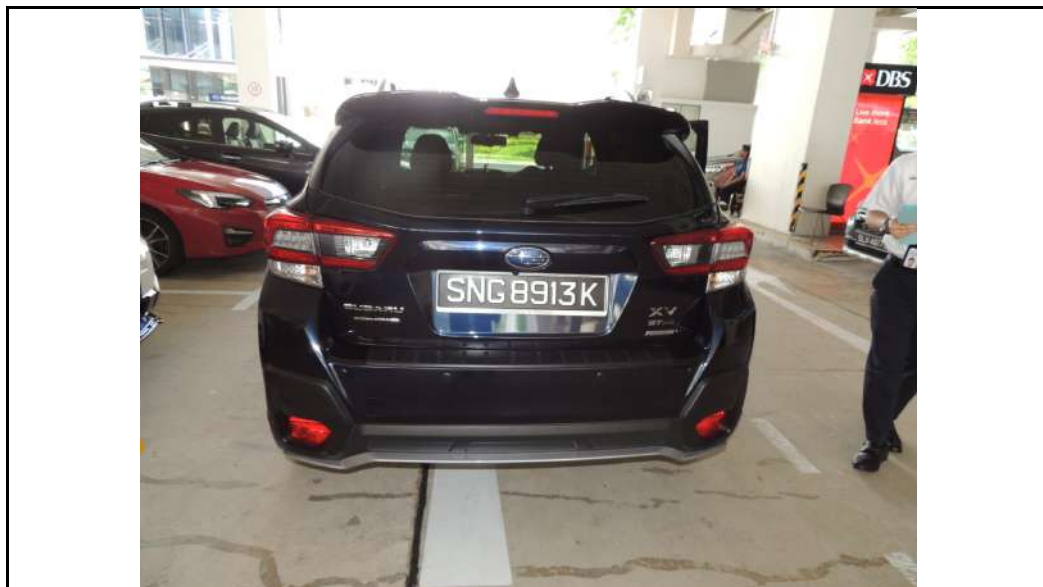
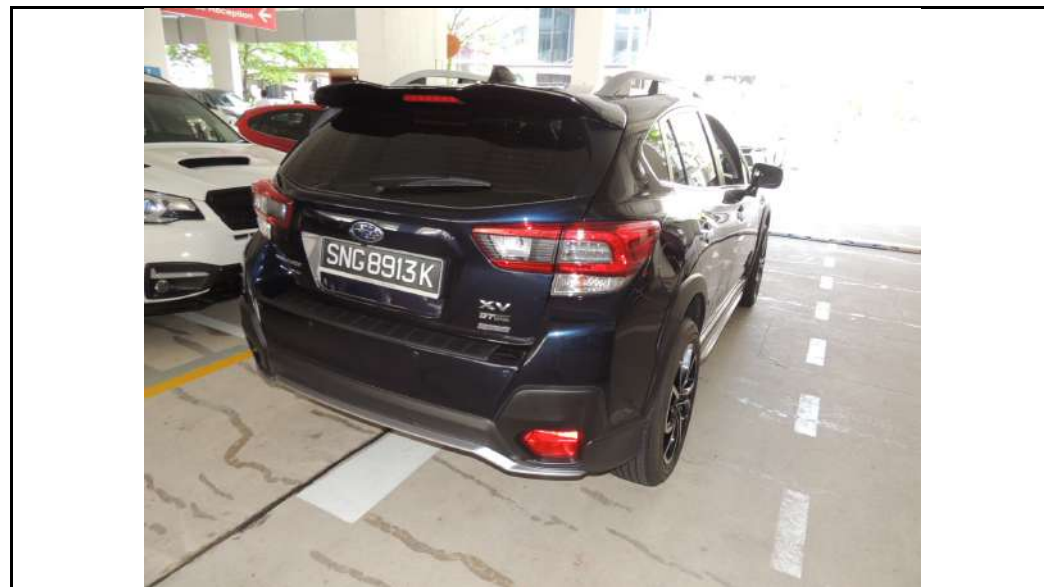
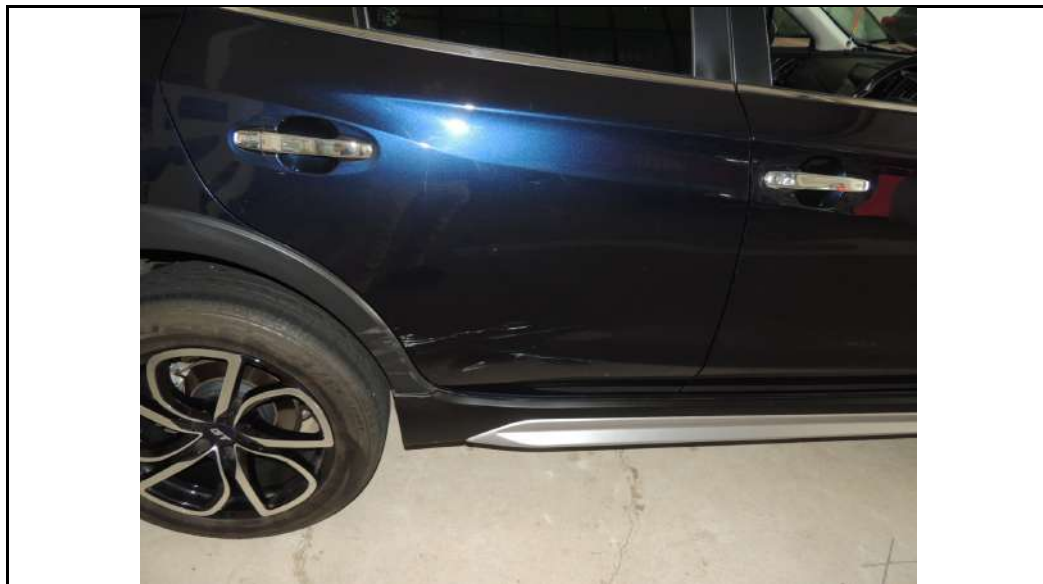
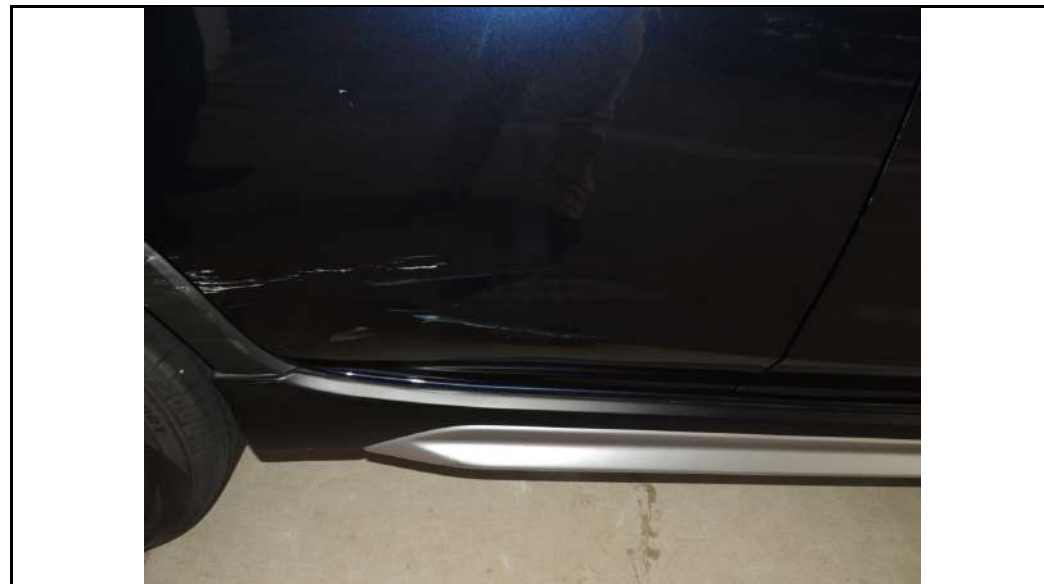
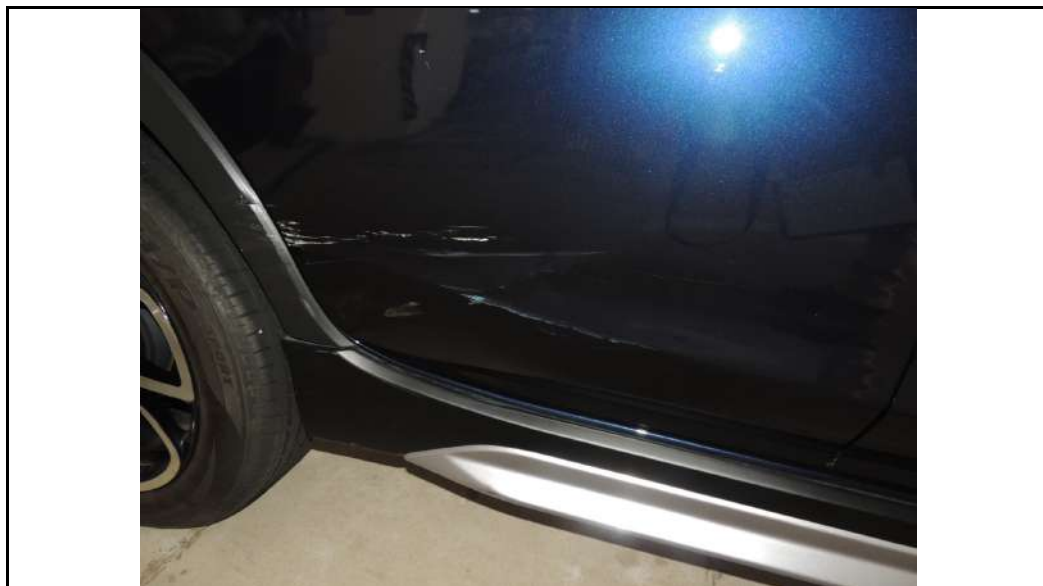
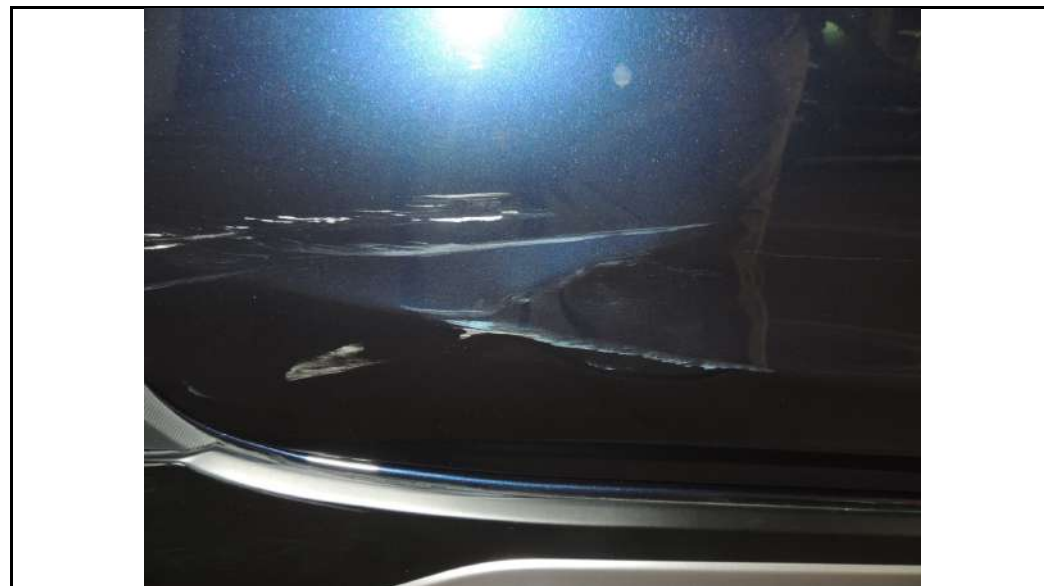
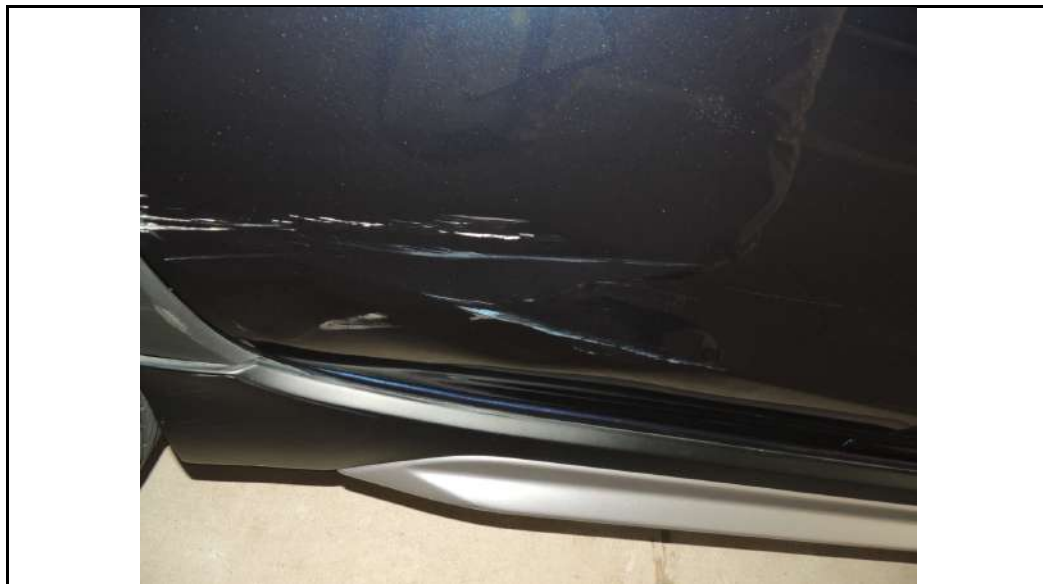
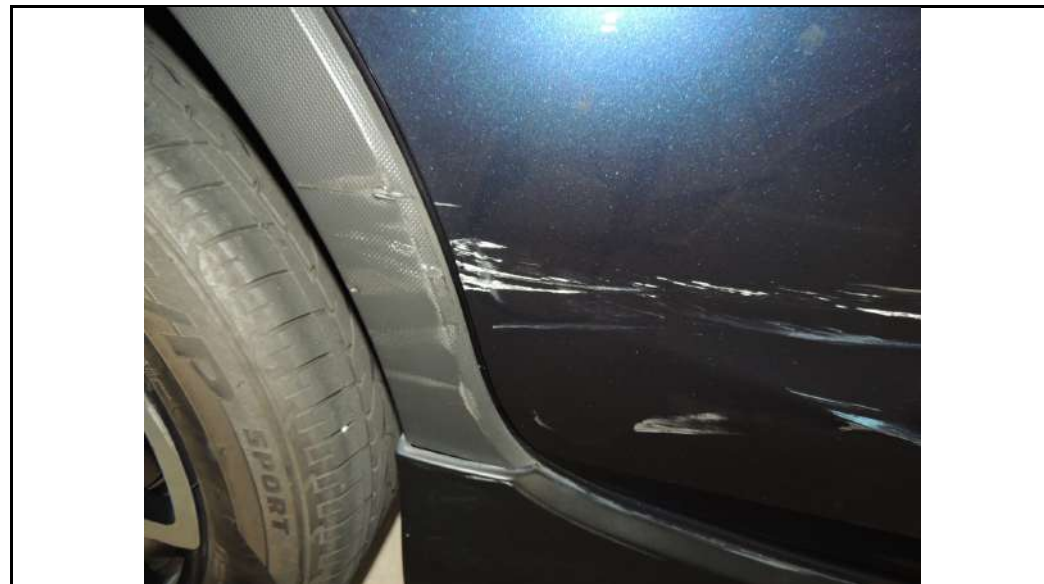
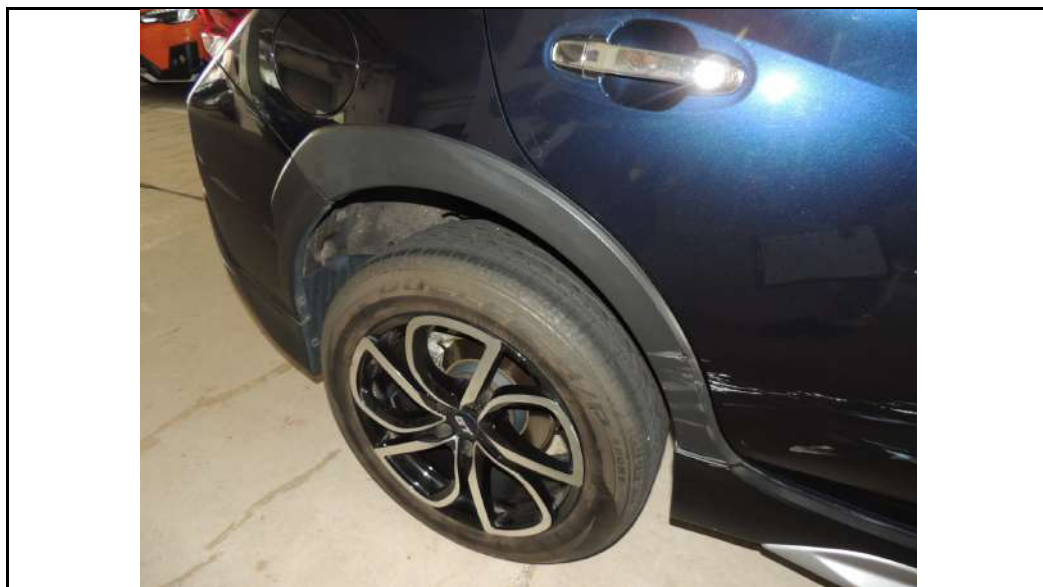
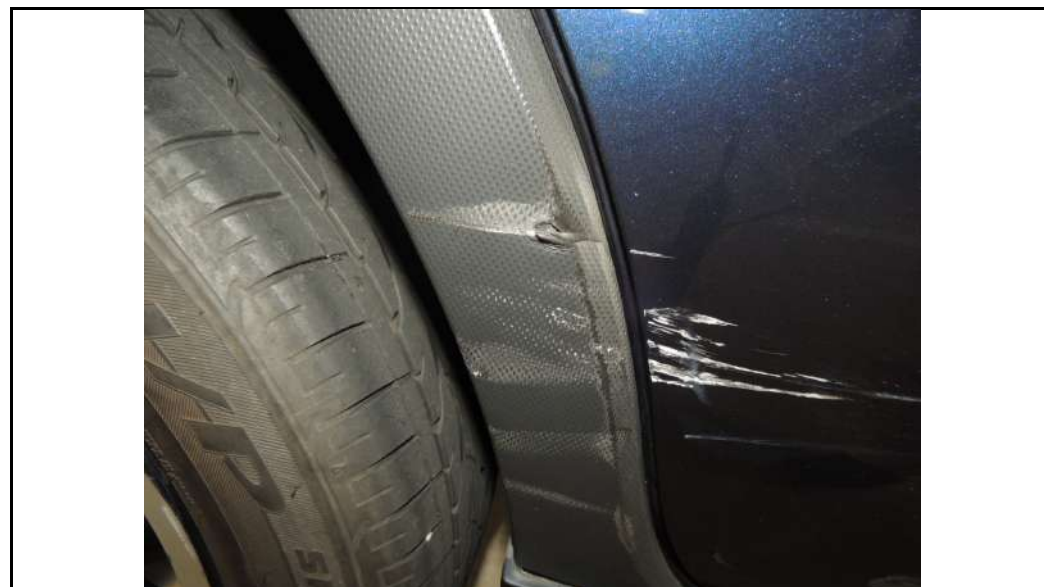
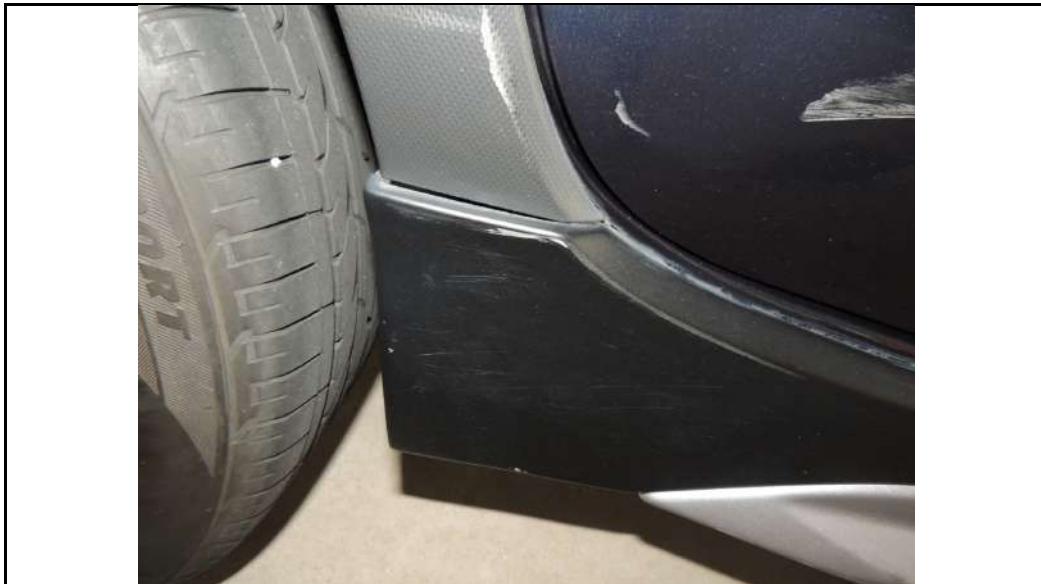
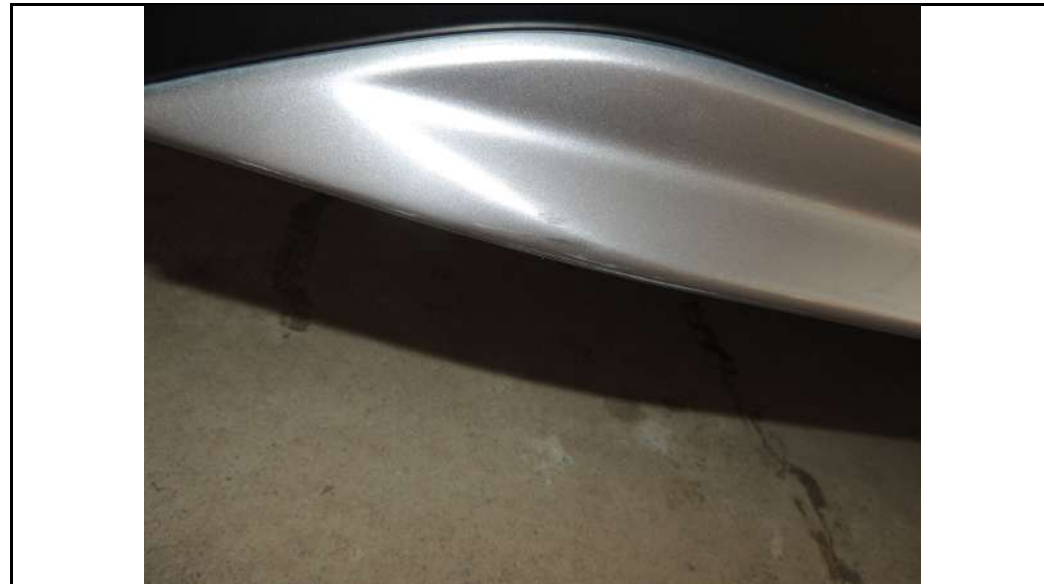
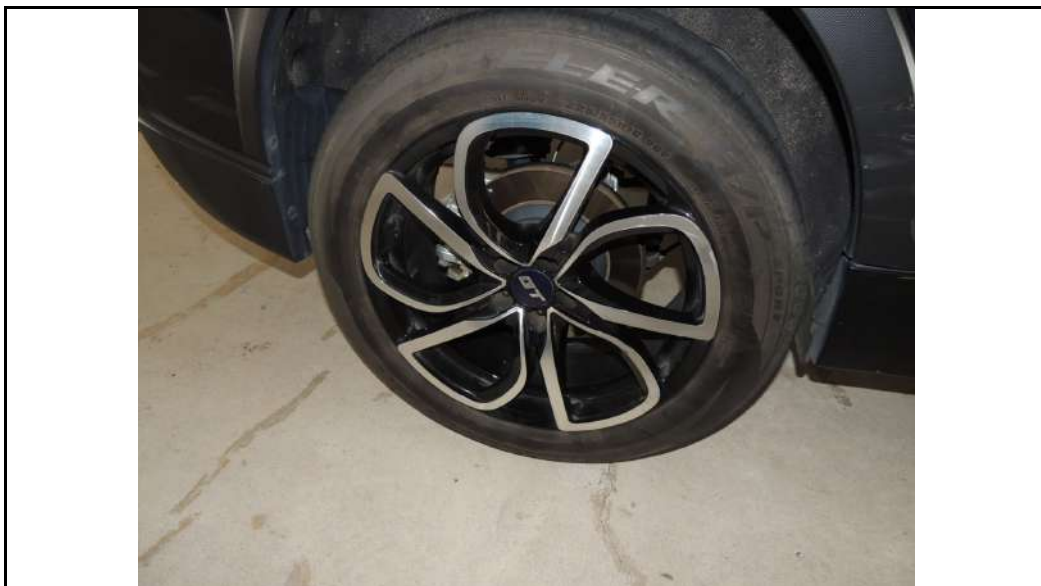
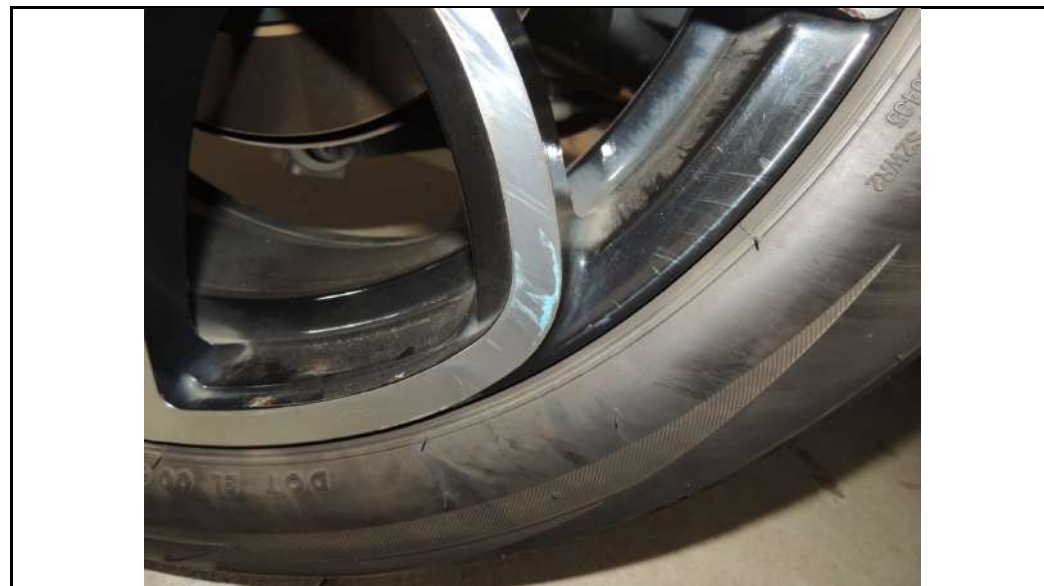
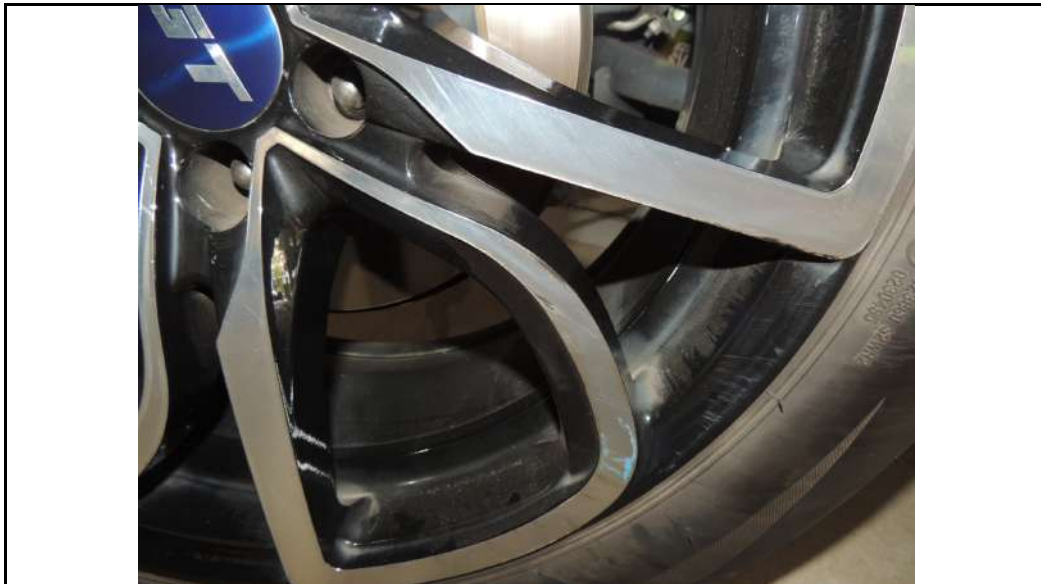
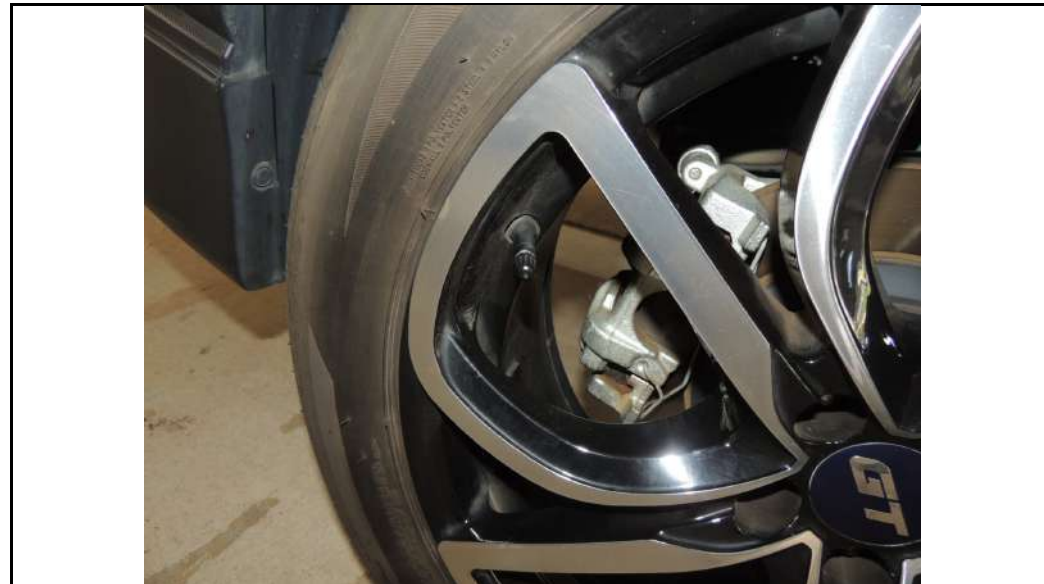
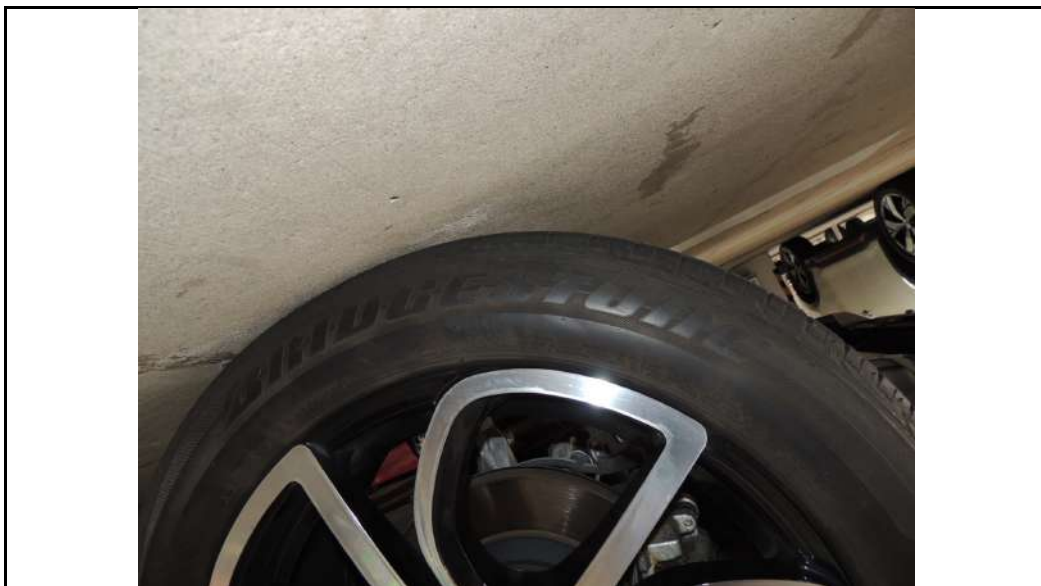
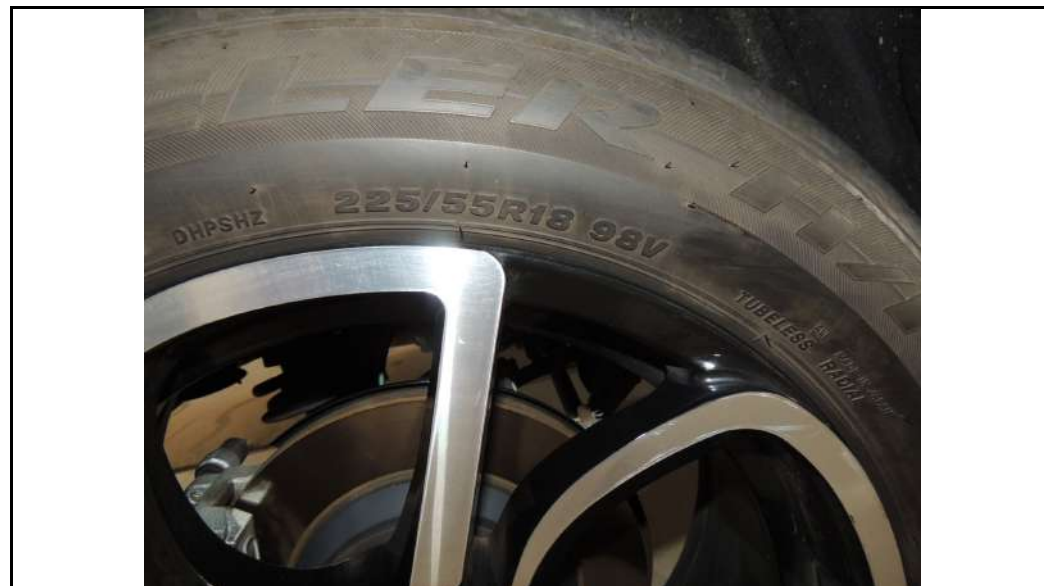
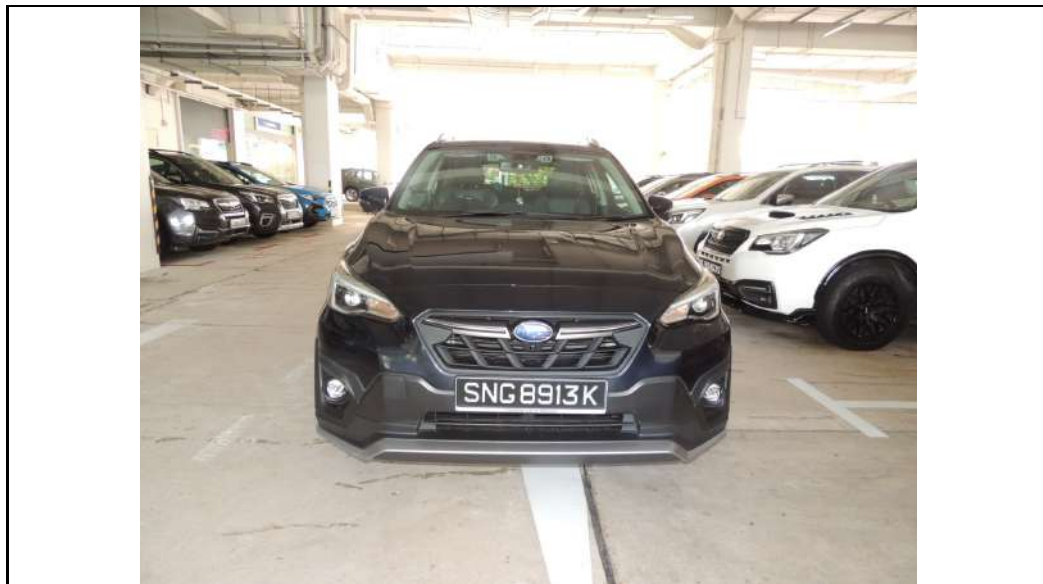
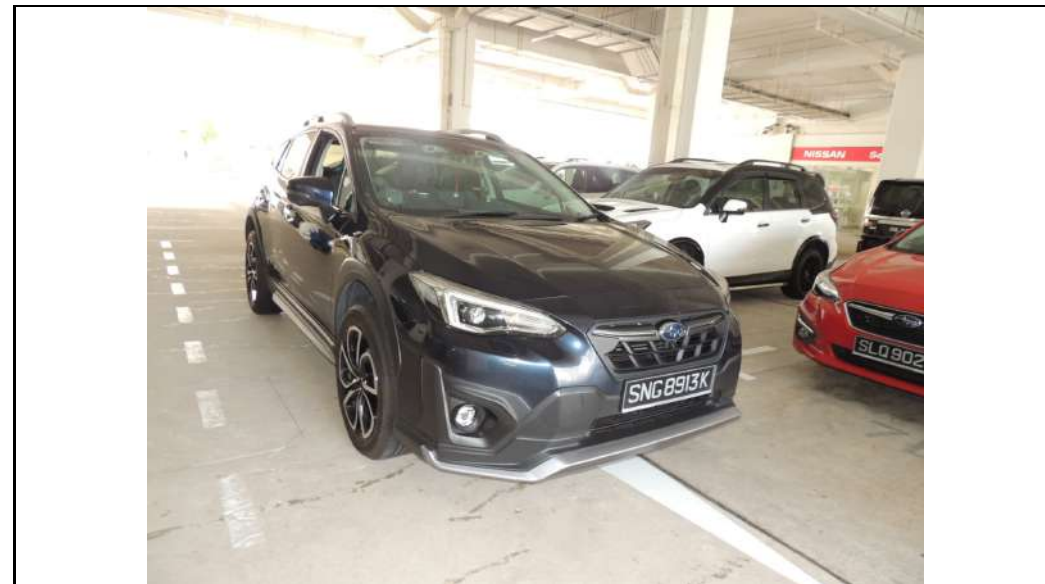
THE VEHICLE SUSTAINED DAMAGES AT THE O/S REAR PORTION.

DAMAGES SEE DETAILS.

| Labour | | | | |
|---|---|---|---|---|
| | REPLACE REAR RHS DOOR ,RHS SIDE SKIRT ,QTR GARNISH AND WHEEL | | \$3,000.00 | \$1,360.00 |
| | RESPRAY REAR RHS DOOR ASSY | | \$2,000.00 | \$600.00 |
