## ASSIGNMENT

Veh No: SJW 3078S Yr Regn: 2010, 03Type: ☒ M.C. / M.Cycle / Bus / Van / Lorry / Taxi / Prime Mover /

Insurer Reference: SJW3078S  
Repairer Reference: CM/11/24/0067  
Date calculated: 07/11/2024 9:18 AM

Full Report  
Registration: SJW3078S  
Printed: 07/11/2024 9:18 AM

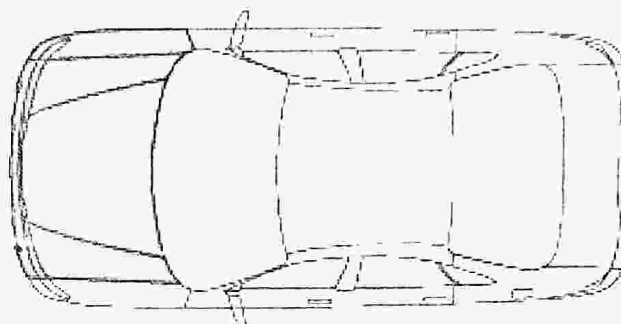
### Damage Areas

Frt + O/S

The U/C / Chassis frame / Body Structure affected due to collision.

Code	Description	Time Base 10 WU/h	Price = 42.00 SGD/h	
			WU	Price SGD
86510R00	RENEW COMPLETE FRONT BUMPER INCLUDES: FRONT BUMPER, FRONT BUMPER REINFORCEMENT AND REQUIRED ATTACHED PARTS R + R AND IF NECESSARY RENEW.		6.0	25.20
92000R0R)	R + R RIGHT HEADLIGHT UNITS INCLUDES: SET HEADLIGHT BEAMS		2.0	8.40
66300R5A	R + R RIGHT FRONT WING		7.0	29.40
NO NUMBER	R + R RIGHT FRONT WING BADGE		2.0	8.40
97606R00	R + R AIR CONDITIONING CONDENSER		10.0	42.00
98620R00)	R + R WASHER RESERVOIR		1.0	4.20
25300R00)	R + R RADIATOR INCLUDES: R + R COMPLETE RADIATOR SHROUD		7.0	29.40
25431R00	R + R RADIATOR OVERFLOW TANK		2.0	8.40
NO NUMBER	R + R RIGHT FRONT WHEEL		1.0	4.20
NO NUMBER	R + R FRONT WHEEL(S)		1.0	4.20
51715R0R)	R + R R/F STEERING KNUCKLE		5.0	21.00
51715R0R)	RENEW R/F STEERING KNUCKLE		4.0	16.80

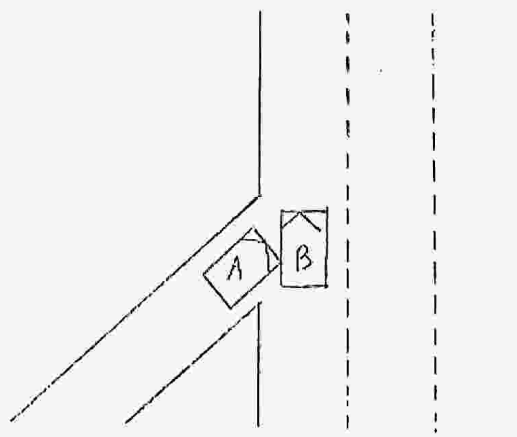
Sketch Plan

A : 3JW 3078 9  
B : 3KN 1776 U

On 05/11/2024 at about 7:30pm, I was driving along slip road towards Woodlands Ave 5 and misjudged the STOP line. I accidentally collided into vehicle 8KN TT6U. We both stopped our vehicles to take some photos and exchanged particulars. We left the scene after that.
