Accident Repair Estimate

BUS NUMBER: *SMB3040A*

ACCIDENT REPORT NUMBER: AR-2024-6685

3RD PARTY CLAIM AGAINST : SLS5954Y

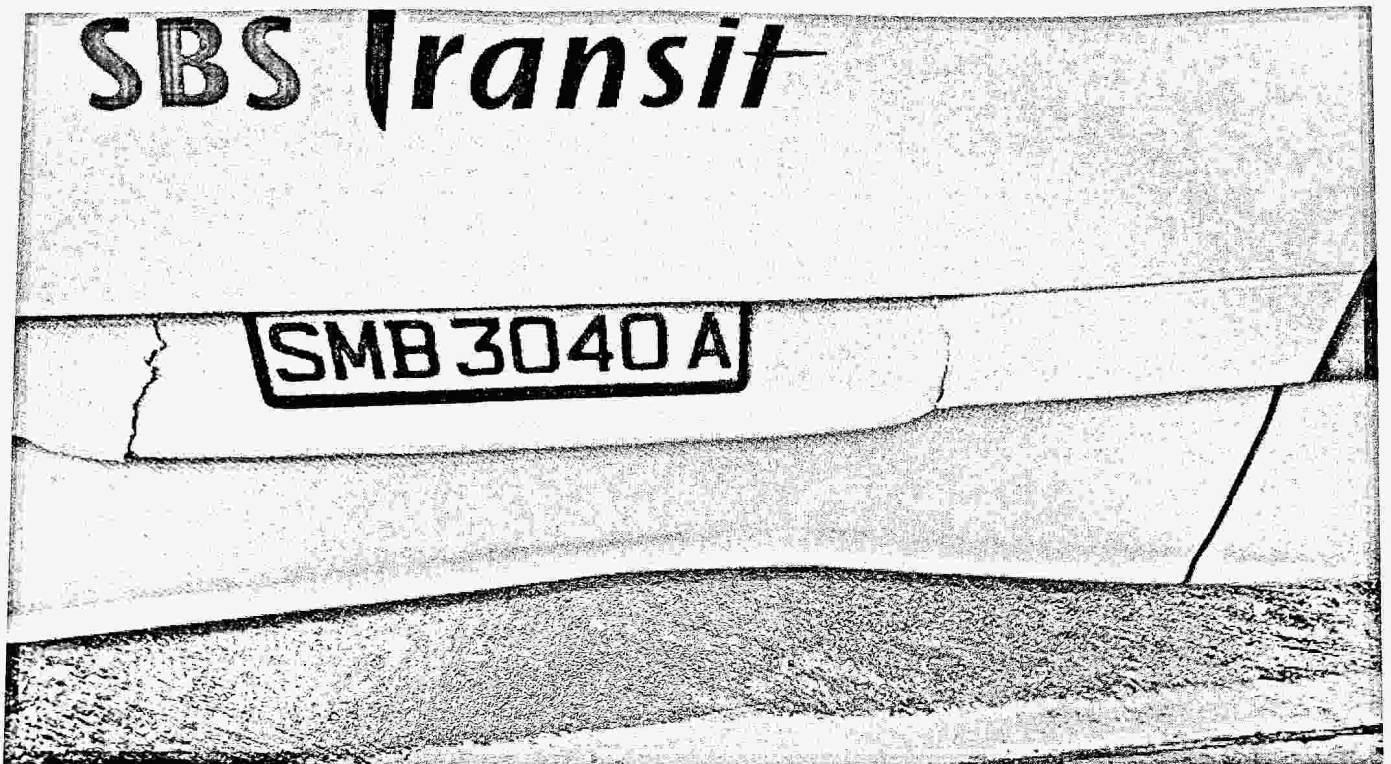
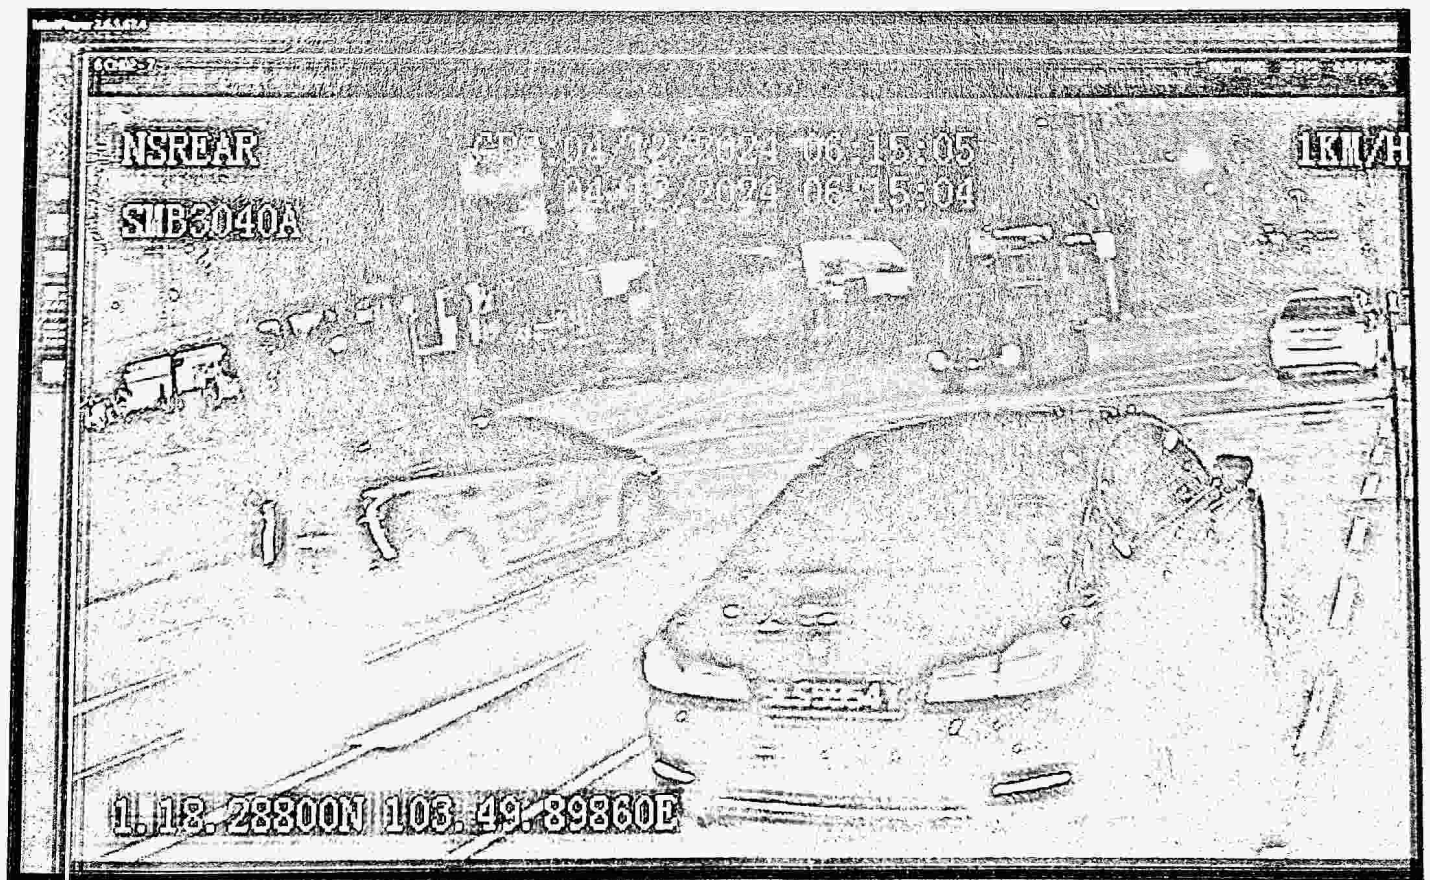
According to BC 83554: While my bus was stationary along Paterson Road junction right turn towards Lucky Plaza, at this point my bus jerked forward, however I did not suspect it was hitting by another vehicle. Upon arrived at BMI, I noticed the rear of my bus is dented and cracked on both side of my bus plate. OCC was informed and I was instructed to continue service.

I am a bus driver for Bus service 16, I drove Bus bearing plate number SMB3040A on 04/12/2024 leaving the bus terminal at about 0555hrs to start my standard Bus route for Bus service 16, however when I was along Paterson Rd junction right turn towards lucky plaza, I pulled my handbrake and released my foot brake, at this point my bus jerked forward and this happens sometimes when I release my foot brake too quickly so I did not suspect it was another vehicle hitting onto my bus, but at about 0900hrs when I returned back to bus terminal, I noticed the rear of my bus is dented in at the bottom and there were 2 crack lines on both side of my bus plate.

Part or Item Description	Quantity	Total Cost
DOOR.COMPLETE.C SERIES.RR ENG	1	\$1,300.00 <i>eng</i>
BUMPER.STEEL.RR	1	\$150.00 <i>bt</i>
BUMPER.REAR CENTER,REAR FRP	1	\$650.00 <i>na</i>
LENS-R-PAINTED 501675.REAR FRP	1	\$37.20 <i>na</i>
LENS-R-PAINTED 501674.REAR FRP	1	\$37.20 <i>na</i>
ADHESIVE SIKA 265 600ML SAUSAGE	3	\$39.00 <i>na</i>
TOTAL PARTS & MATERIAL COST		\$2,213.40
