| | Affiliated to Federation Internationale Des Experts En Automobile | | | | | |
|---|---|---|---|---|--|--|
| | THE VEHICLE SU | STAINED DAMAGES AT THE REA | AR PORTION. | | | |

ADJUSTMENT ON REPAIR COST FOR VEHICLE NO. SMS 9912E

PHOTOGRAPHS FOR VEHICLE NO. SMS 9912E

INSPECTION

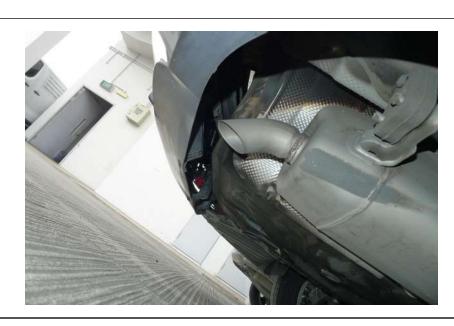
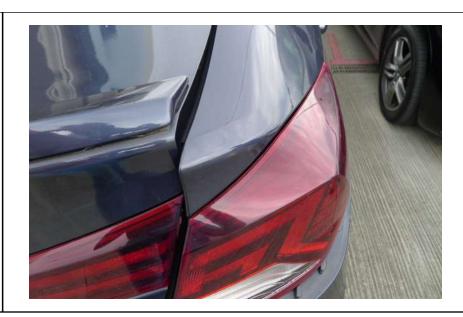
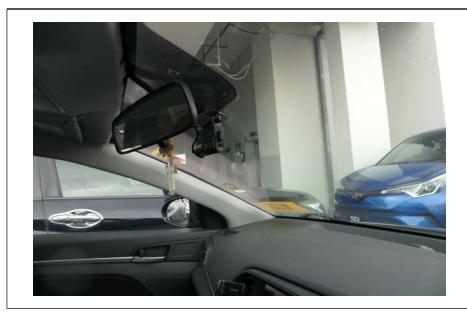
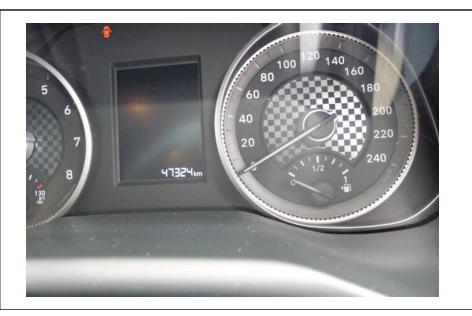
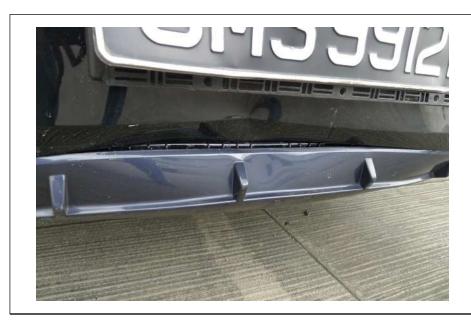
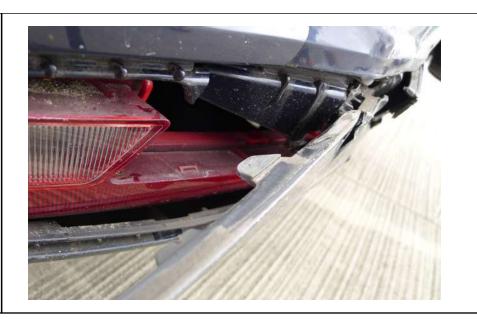
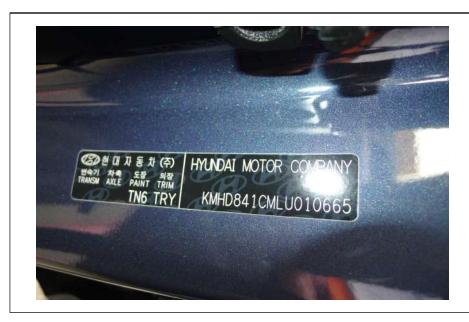
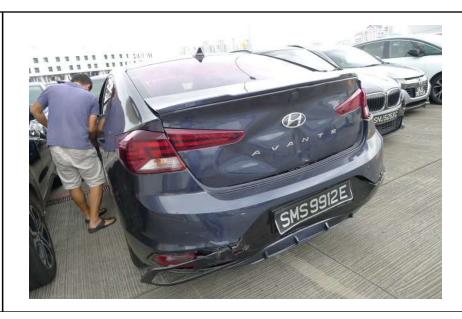
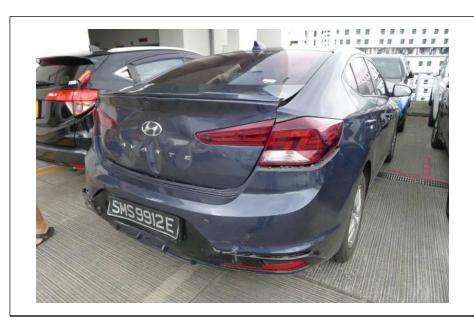
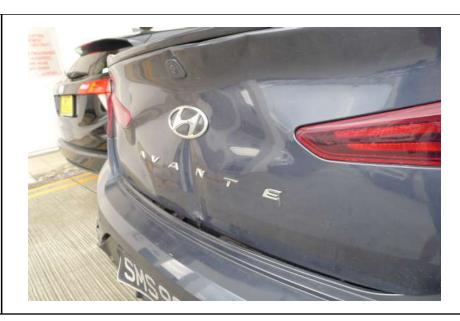
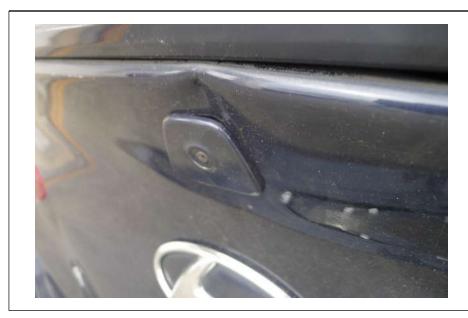
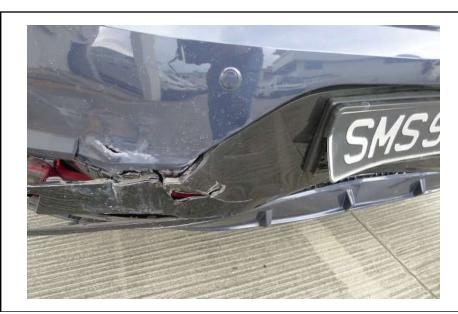
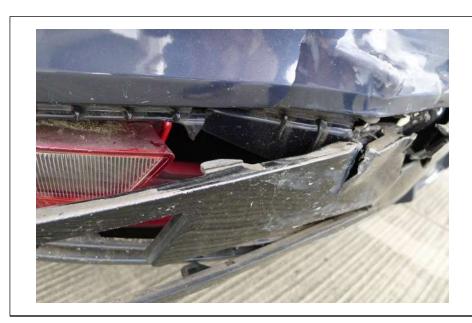
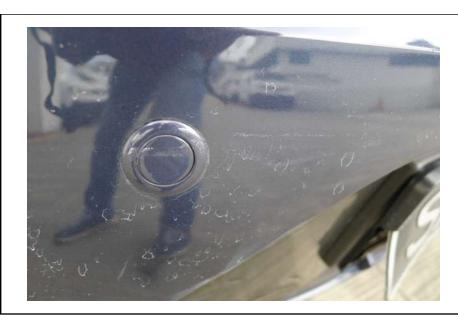
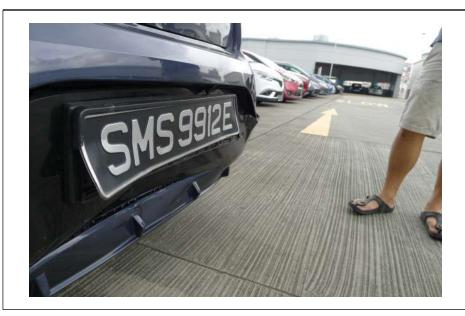
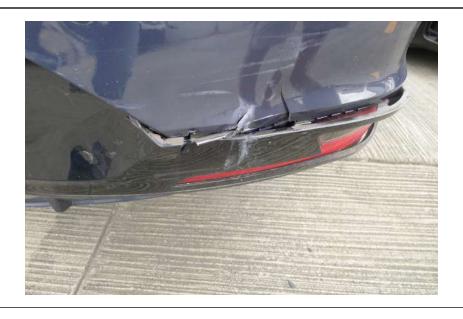
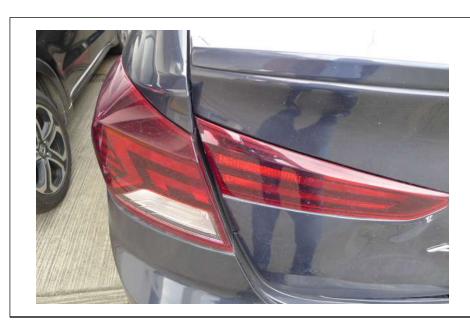
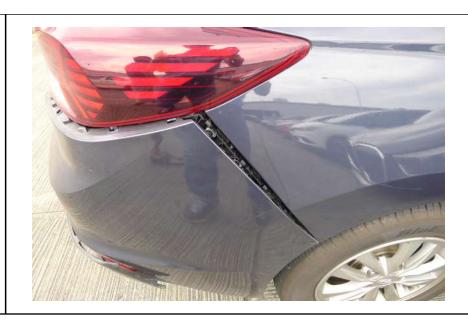
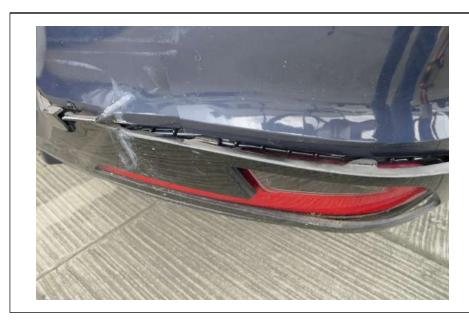
| | Affiliated to Federation Internationale Des Experts En Automobile | | | | | |
|---|---|---|---|---|--|--|
| | DAMAGES SEE D | ETAILS. | | | | |

| Qty | Description of Parts | Condition | Estimate By Workshop (\$)) | Our Adjusted (\$) |
|---|---|---|---|---|
| | RECOMMENDED COST OF LUMP SUM REPAIRS | | | 6,000.00 |
