Vehicle No. SLM 2680M  
Insured Veh. SHD 7066Z  
Claim No. D24011031MFCT  
Policy No. D-24101861MFCT  
Accident Date 16/12/2024  
Inspection Date 18/12/2024

# LKK Auto Consultants Pte Ltd

THE VEHICLE SUSTAINED DAMAGES AT THE REAR PORTION.

## ADJUSTMENT ON REPAIR COST FOR VEHICLE NO SLM 2680M

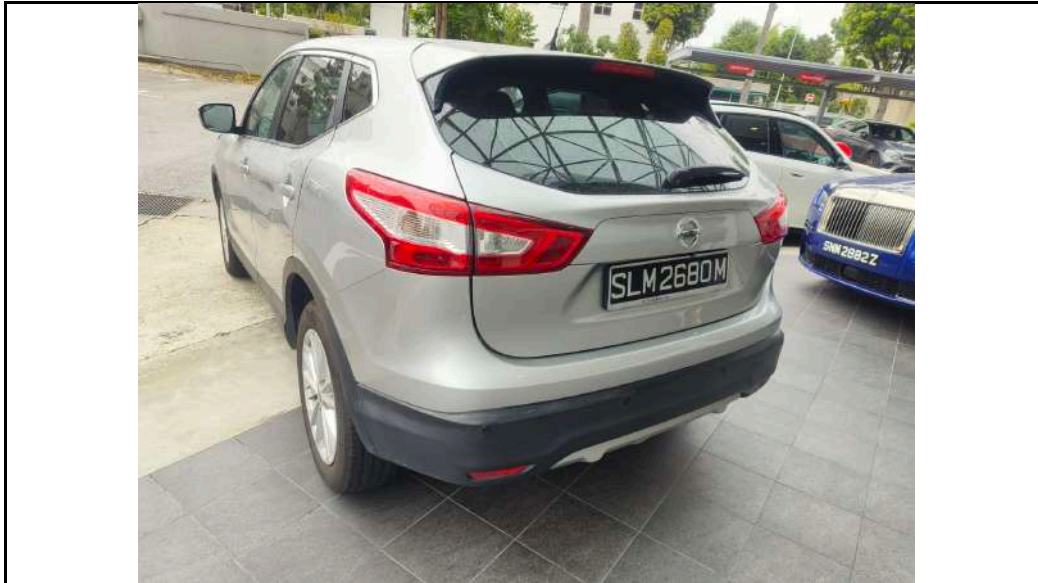
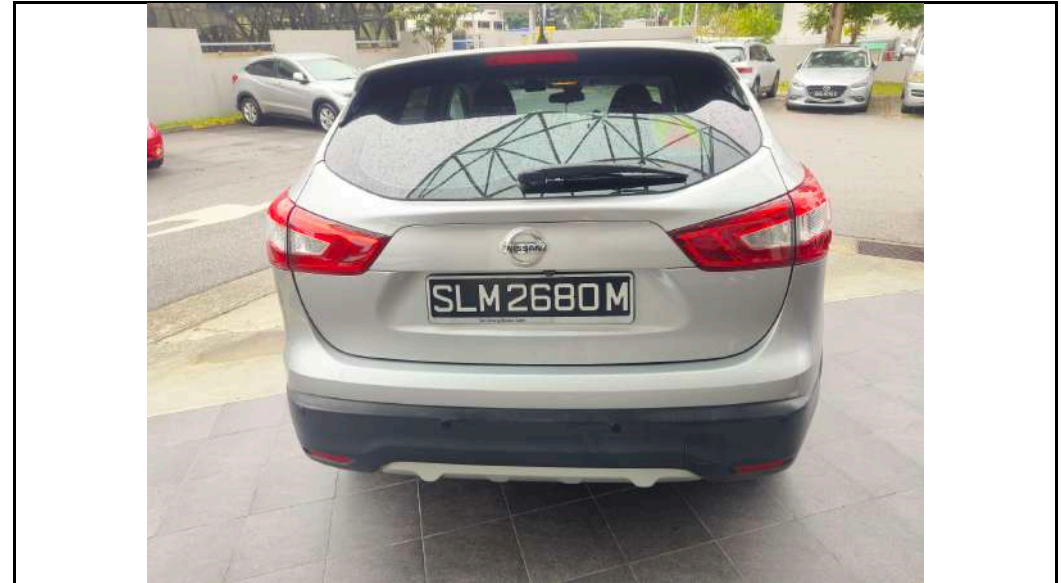
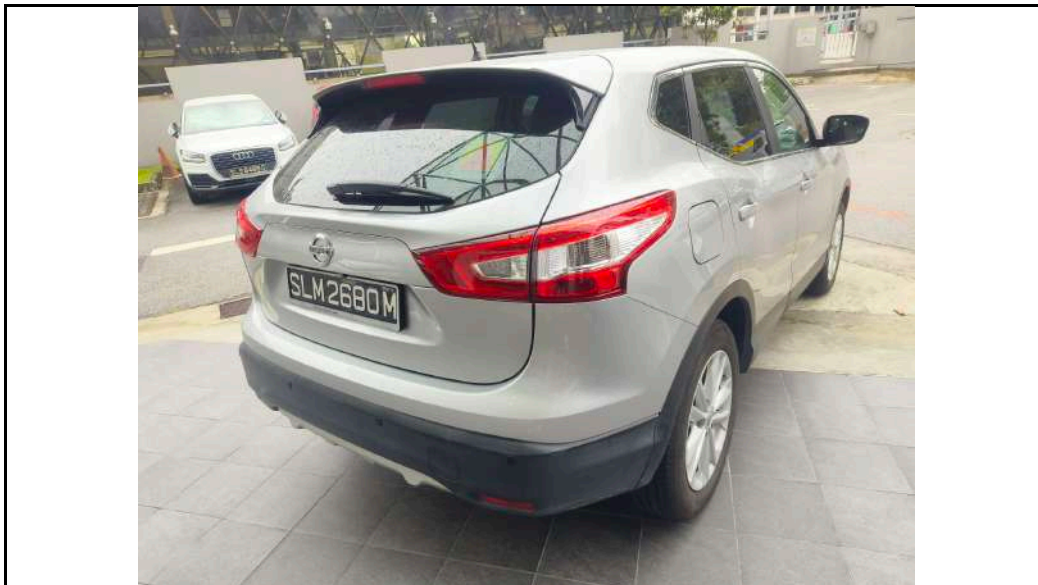
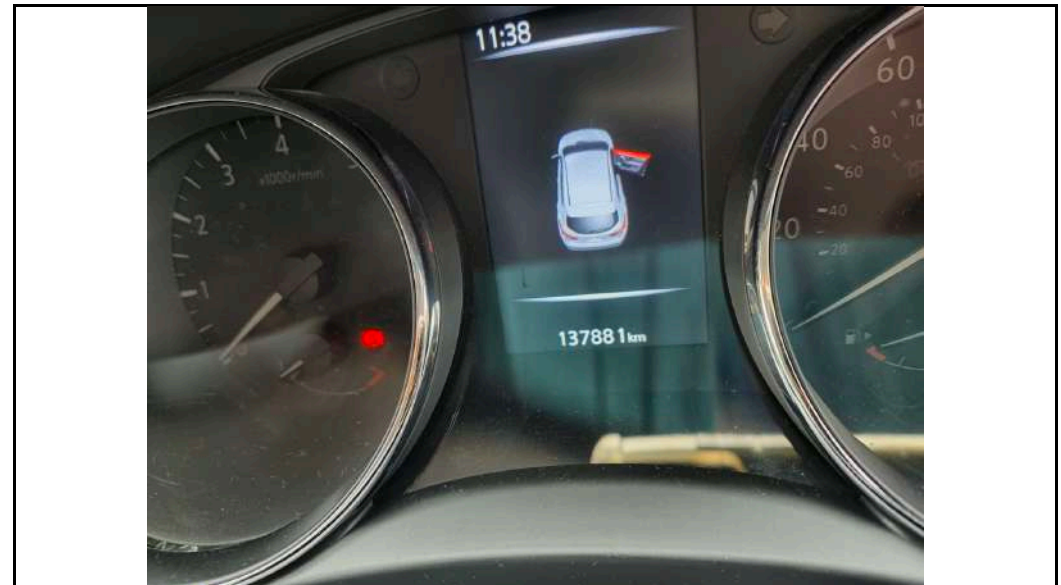
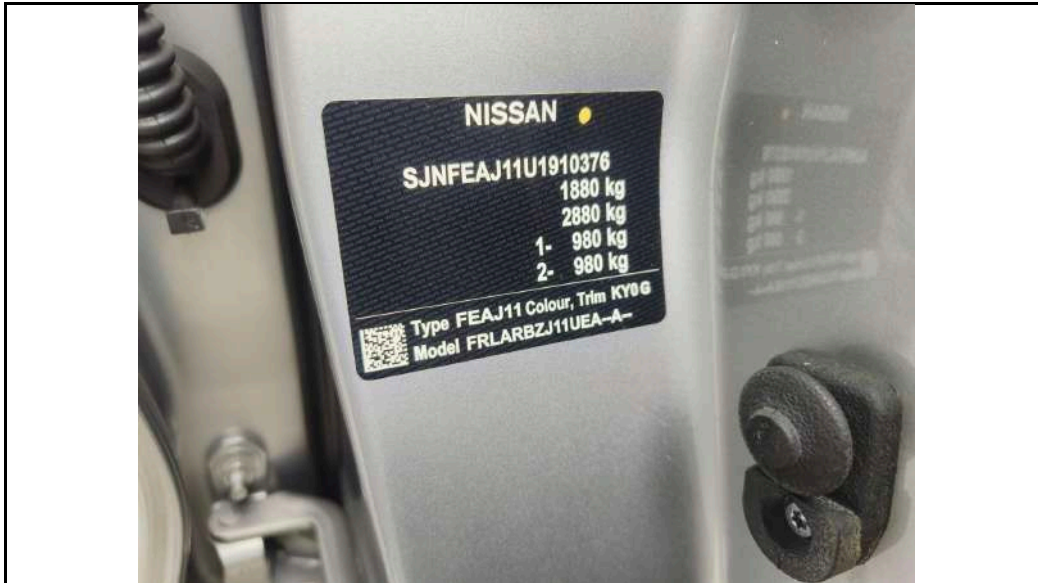
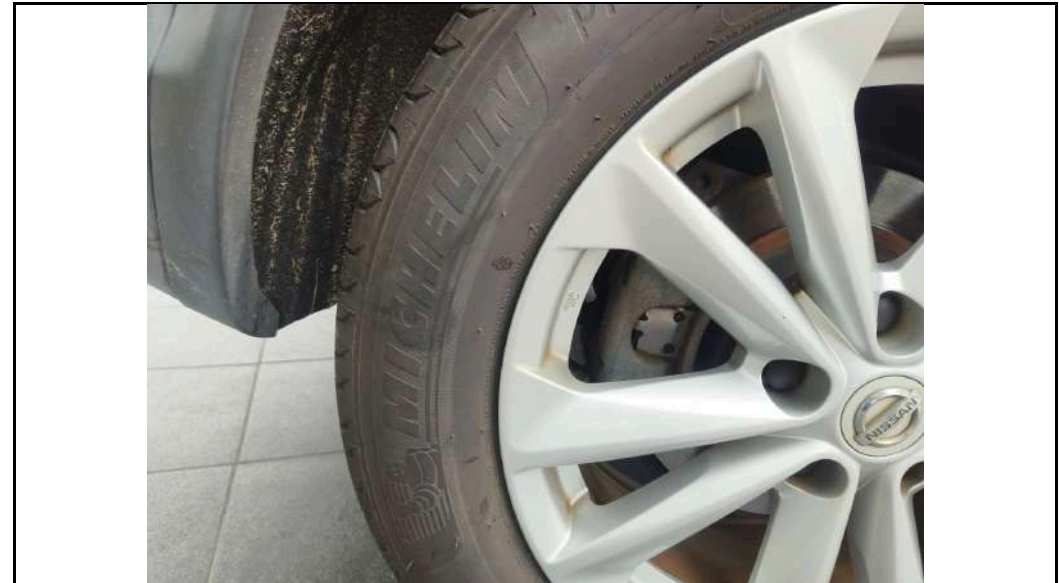
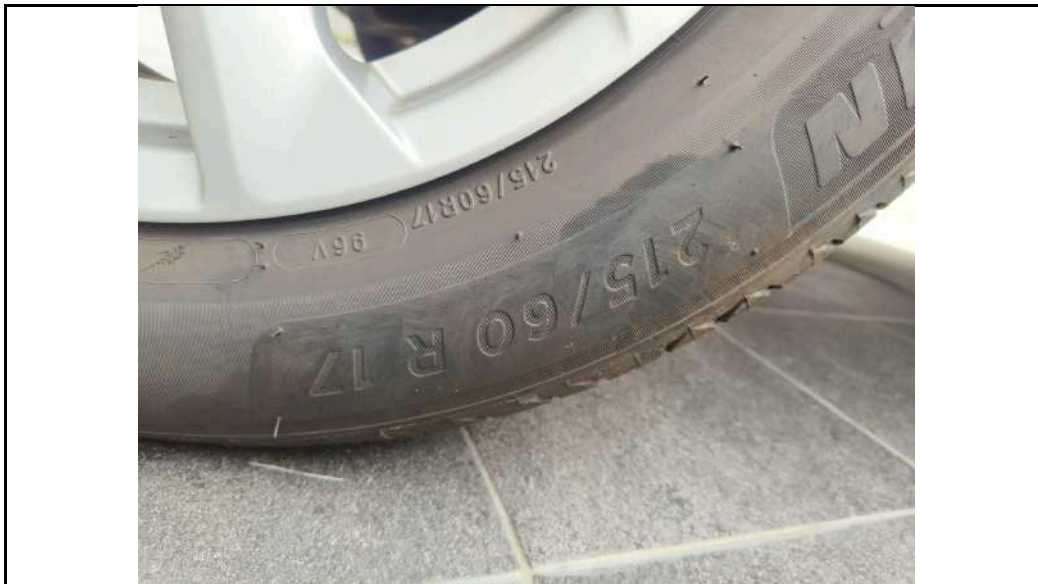
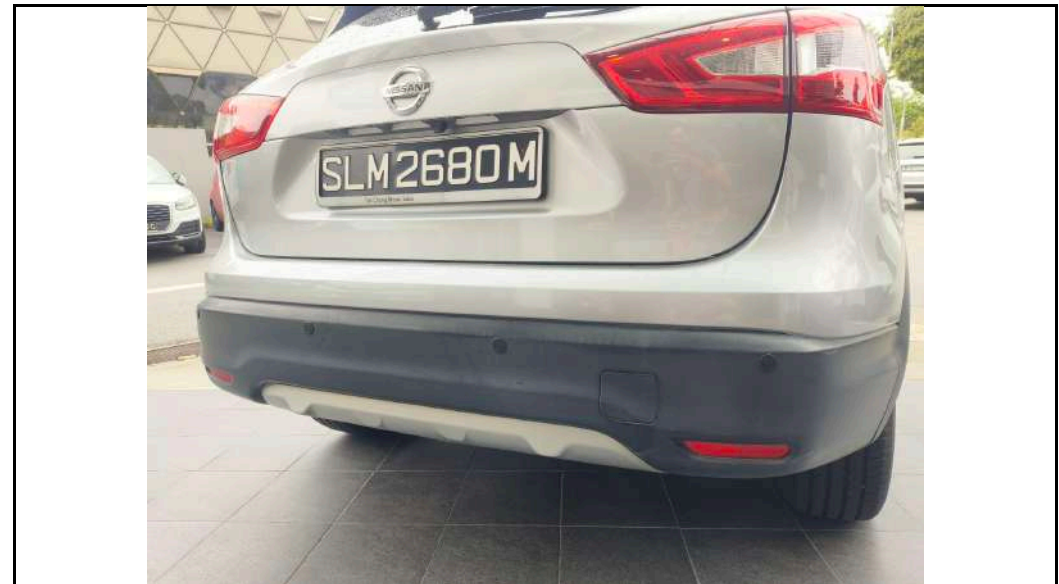
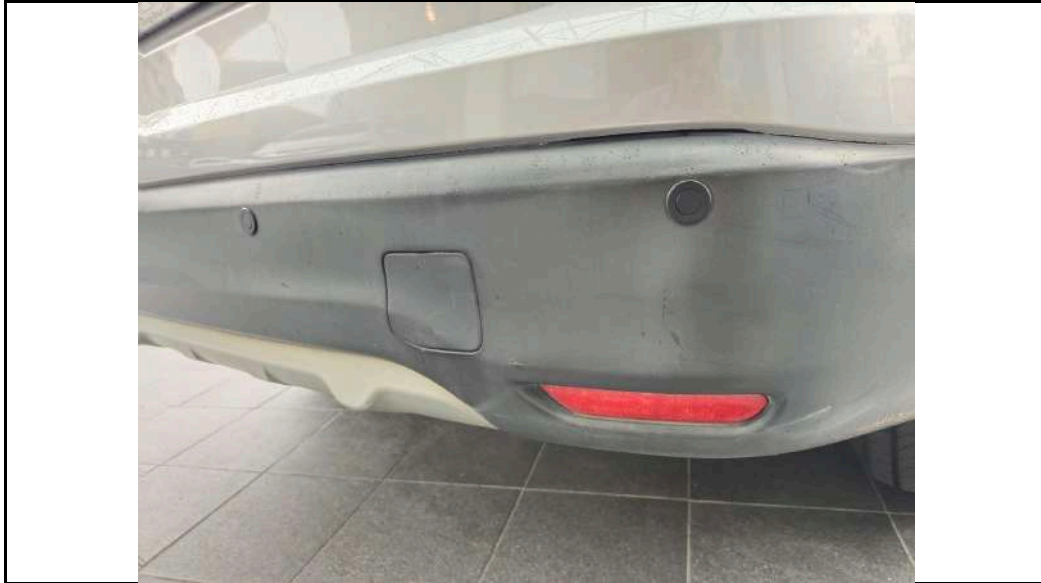
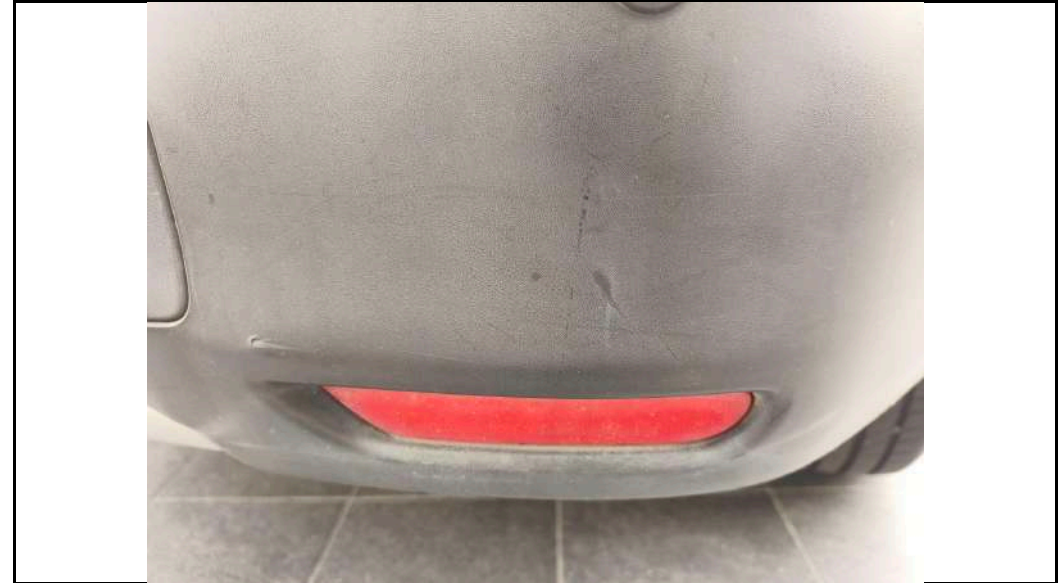
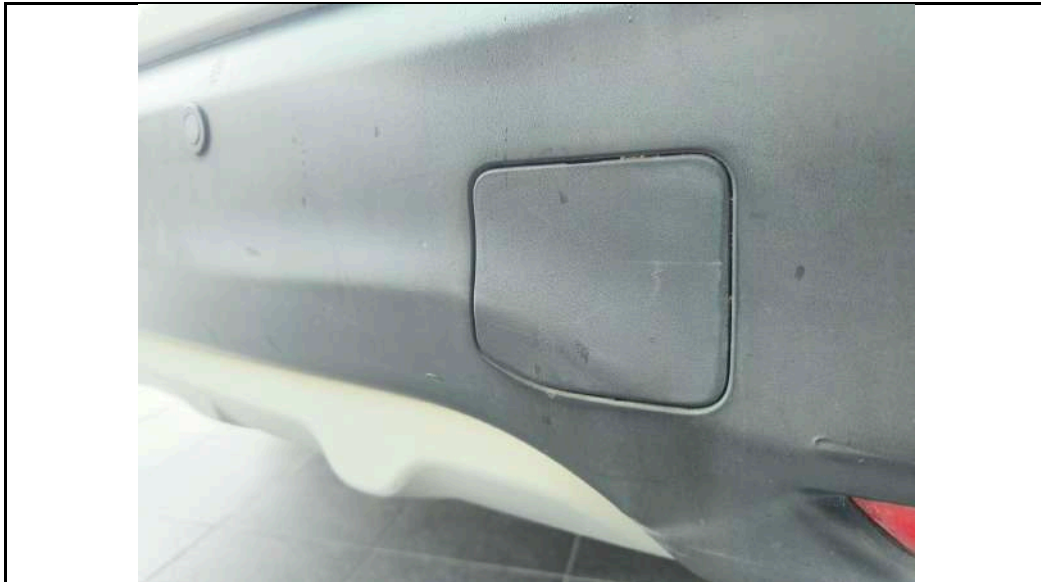
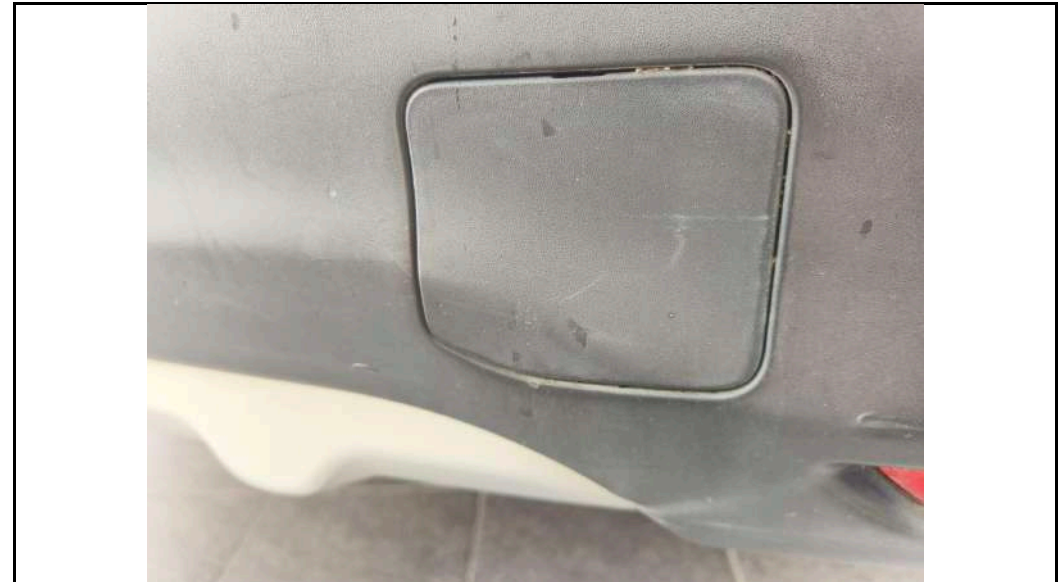
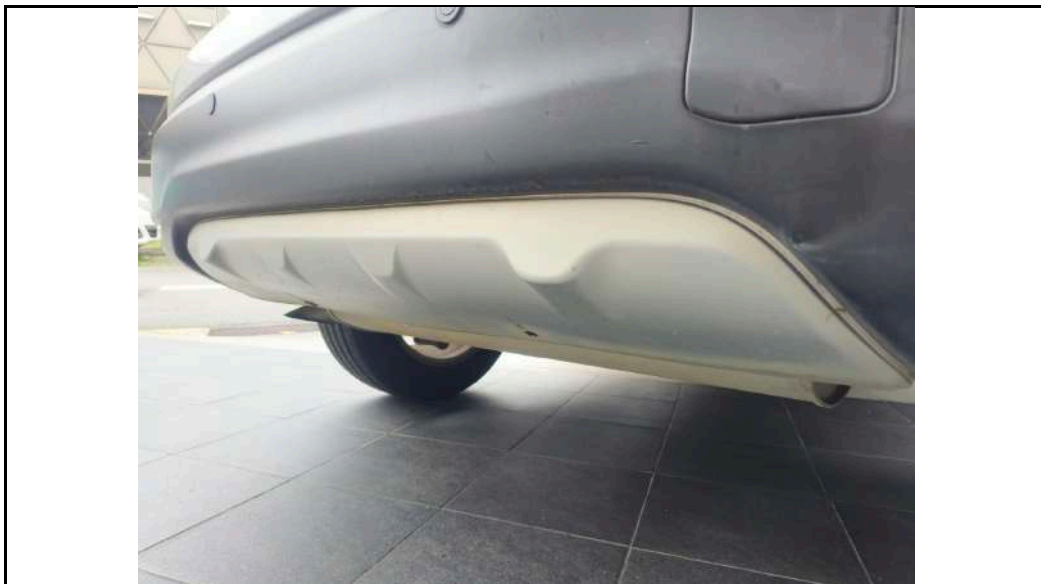
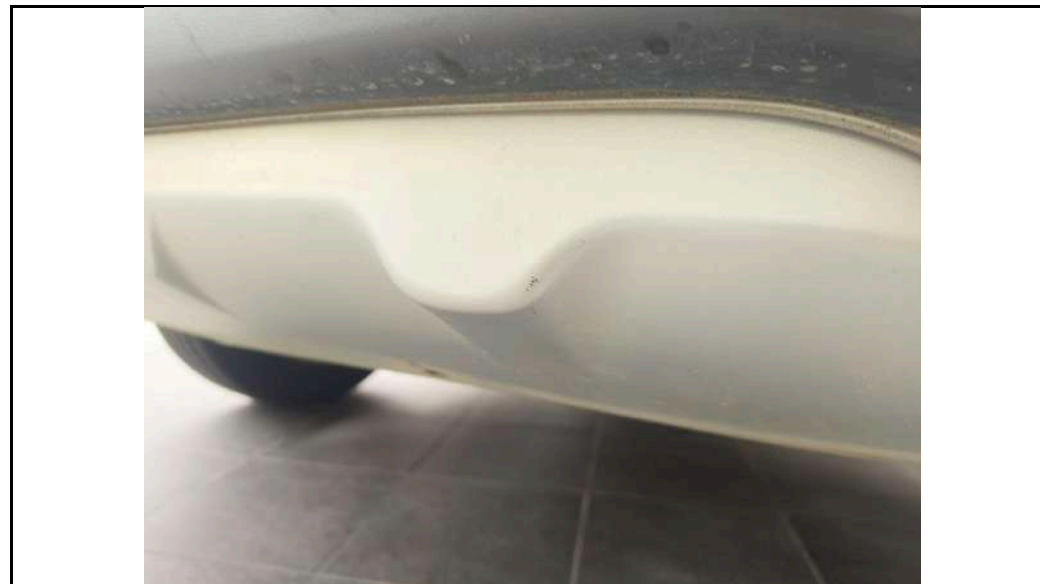
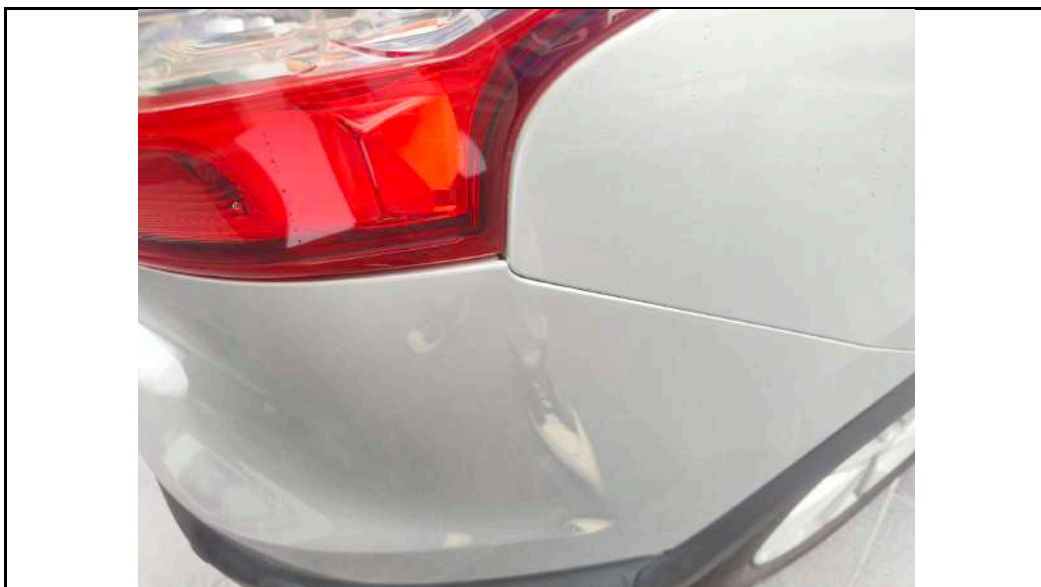
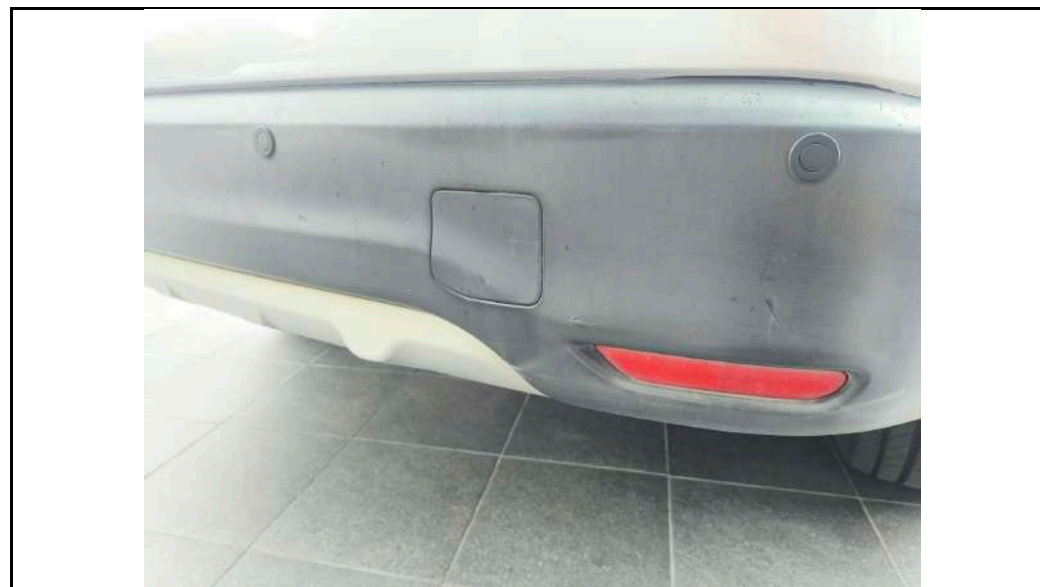
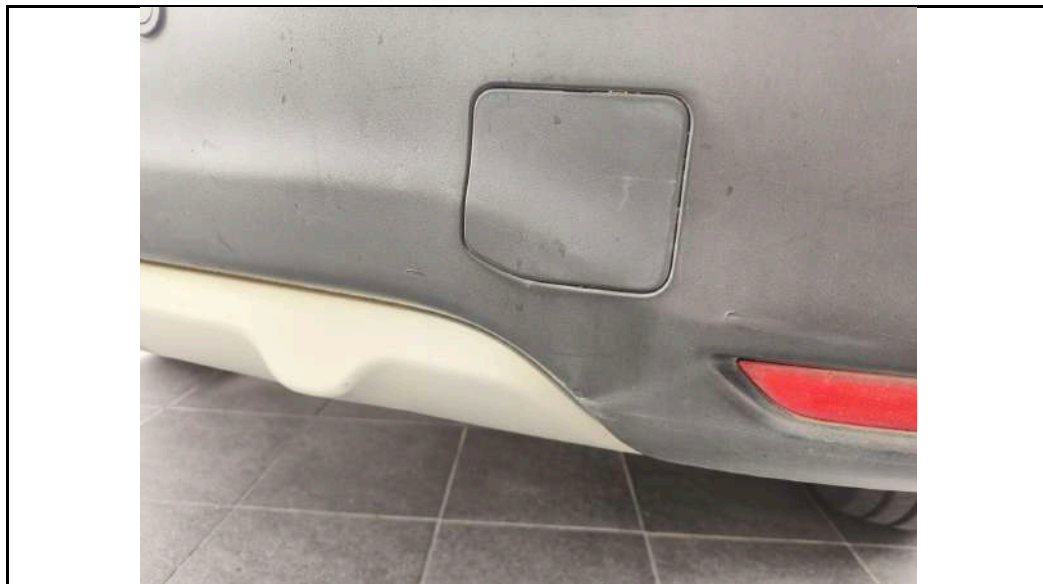
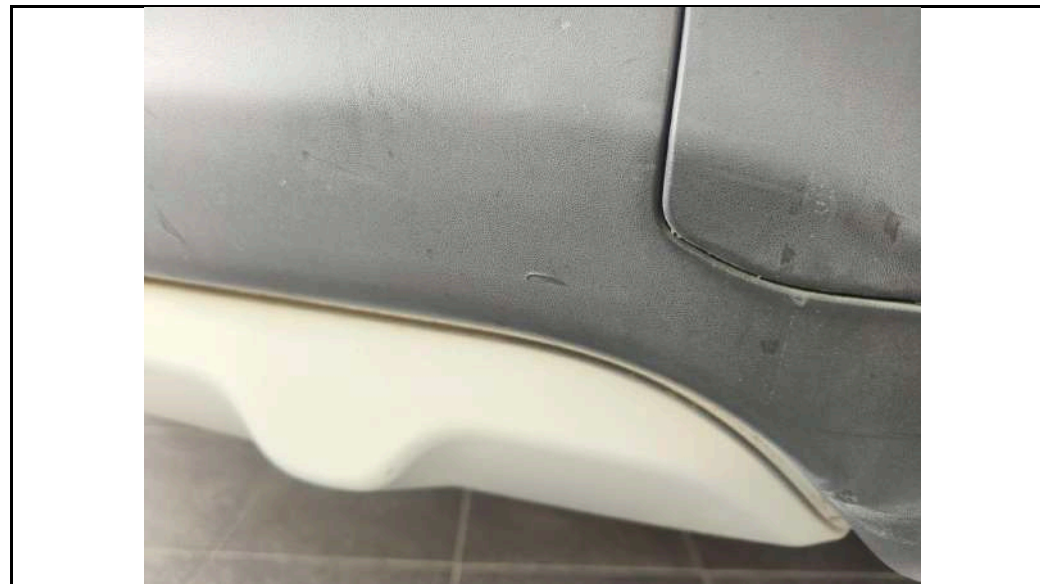
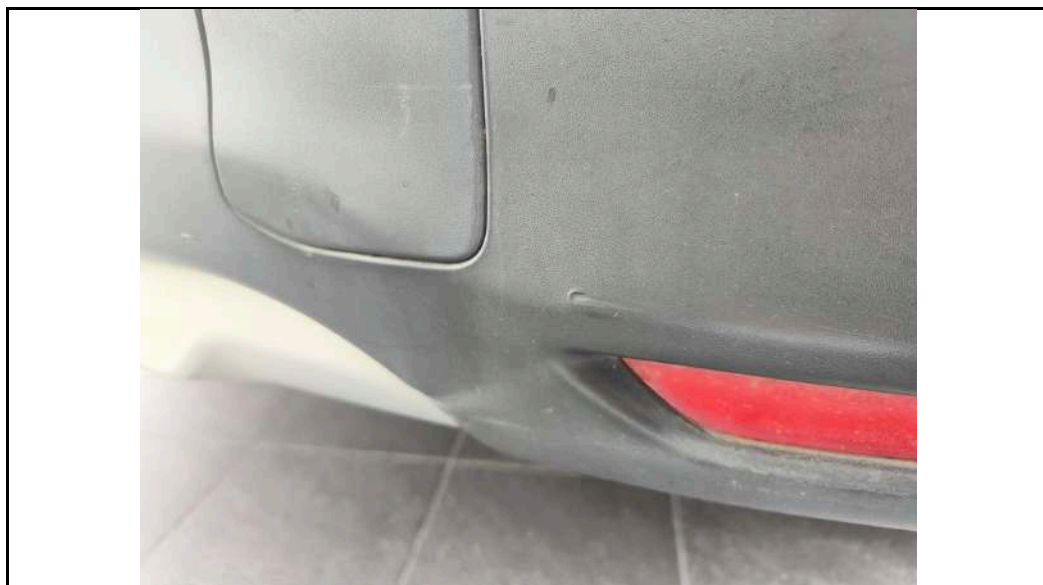
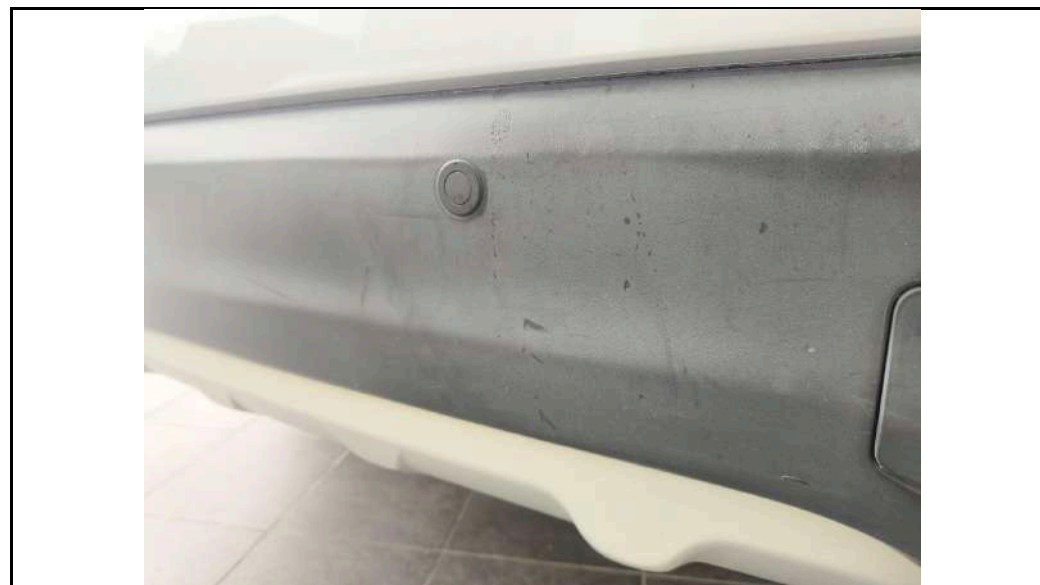
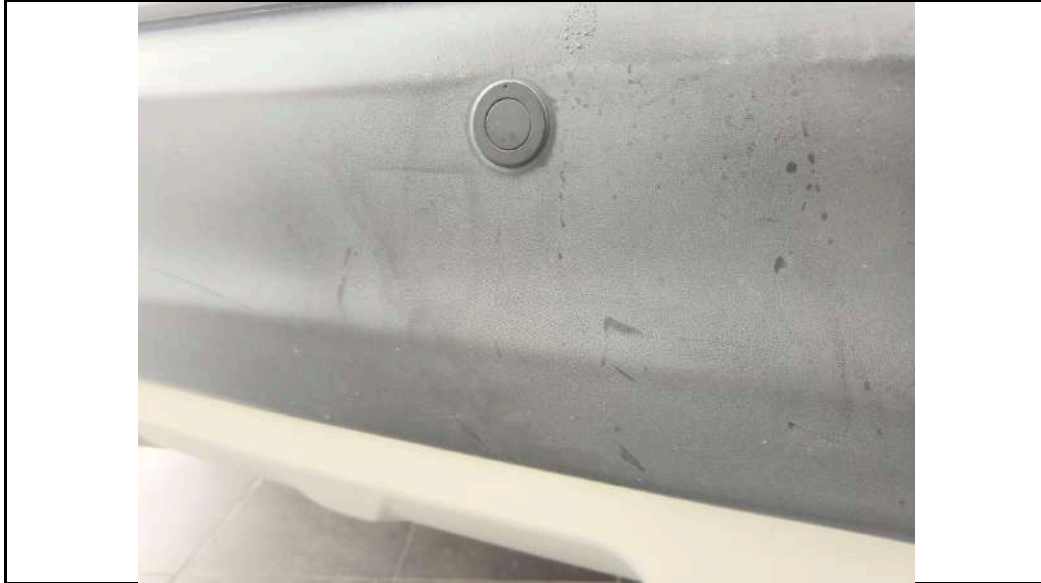
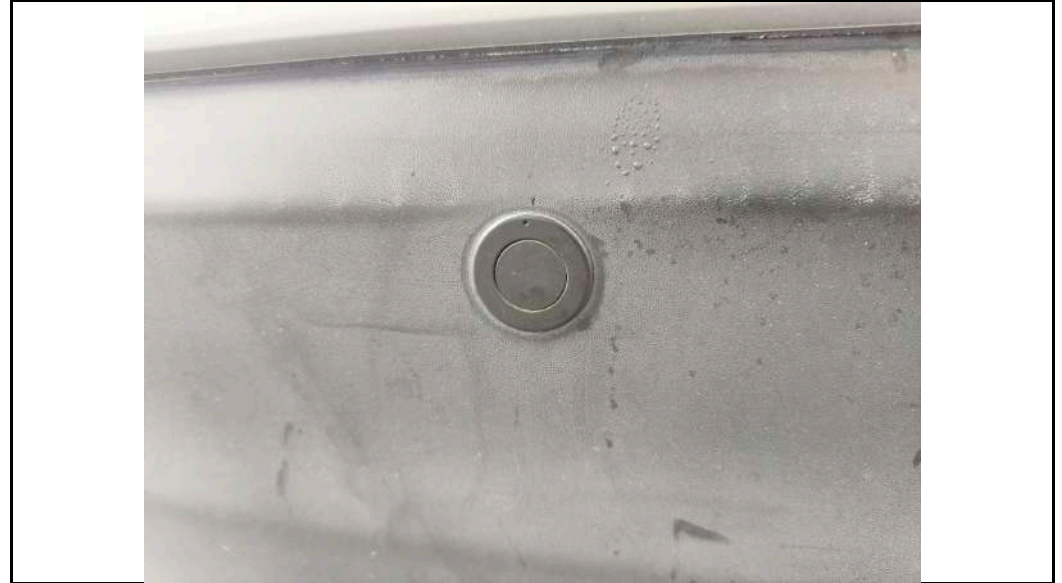
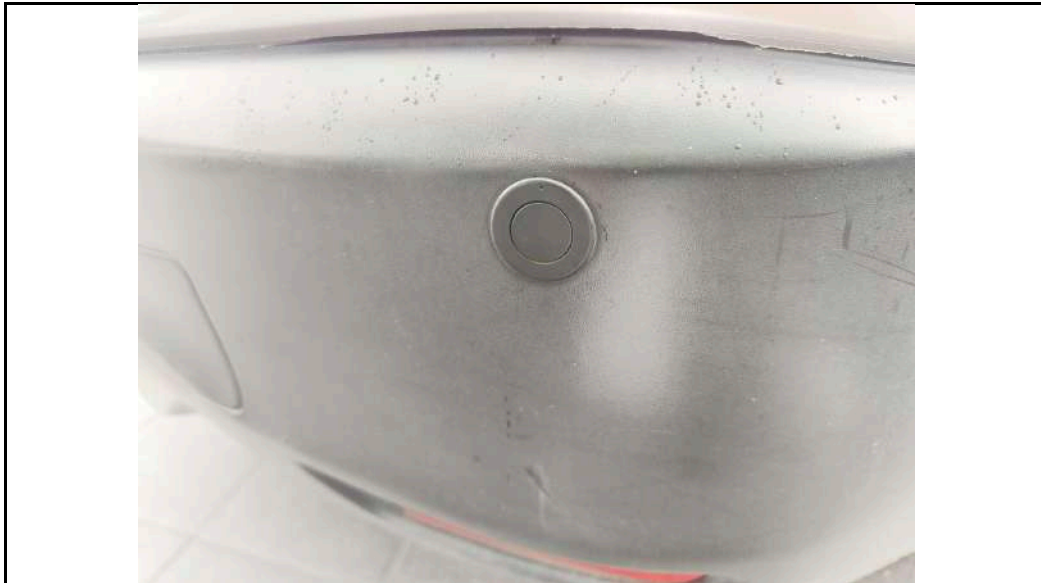
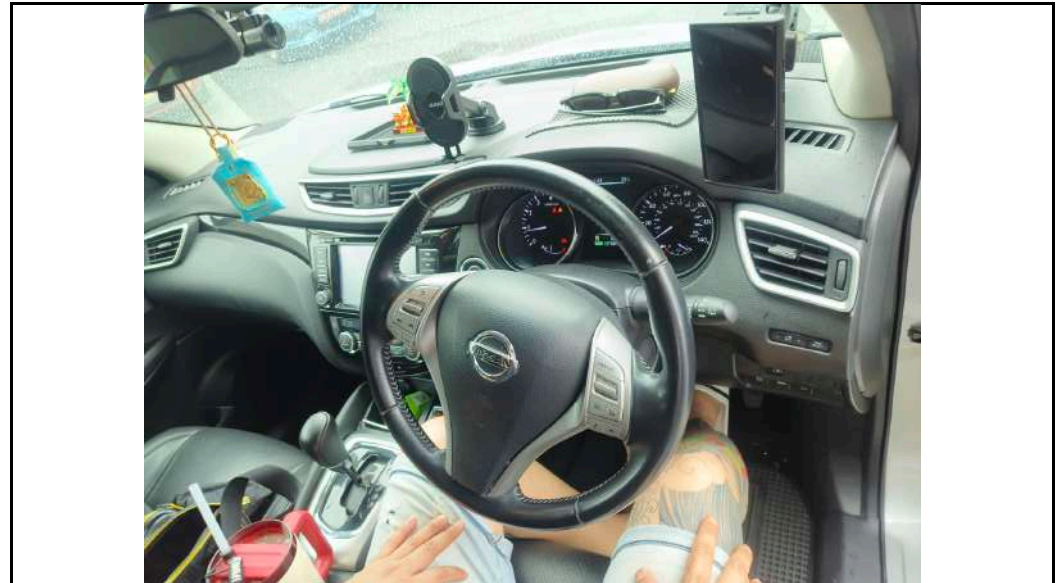
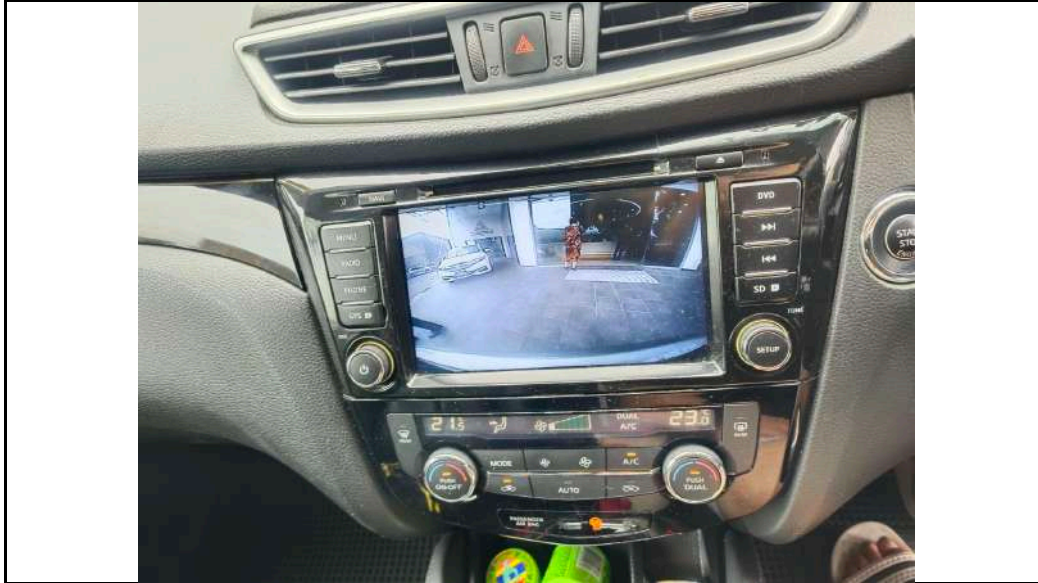
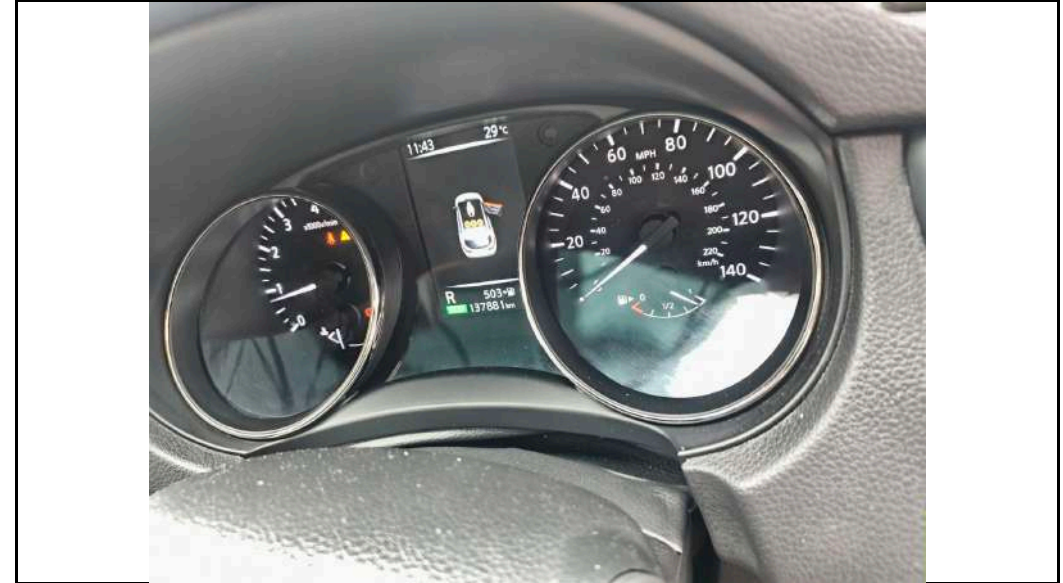
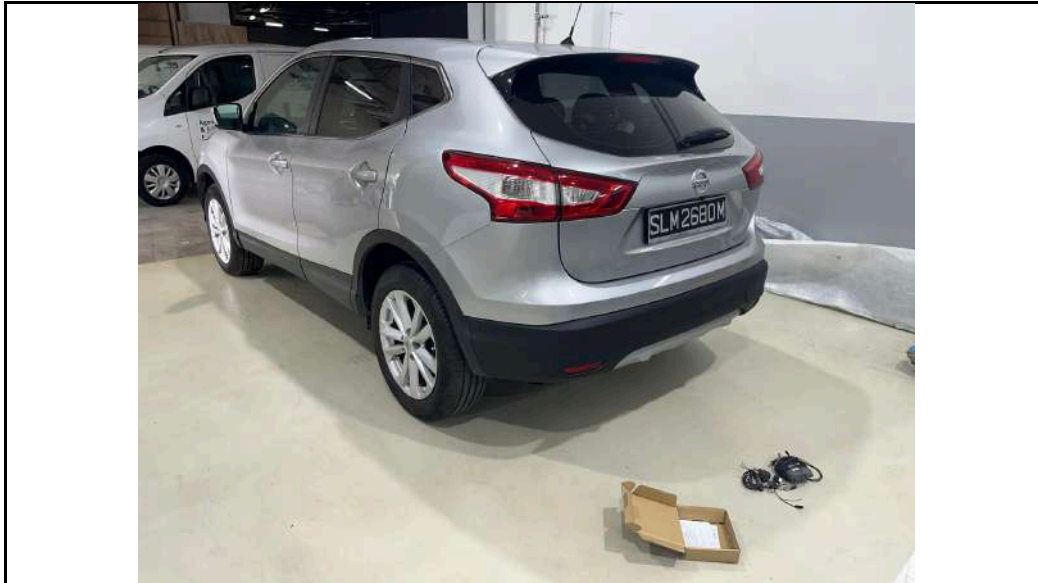
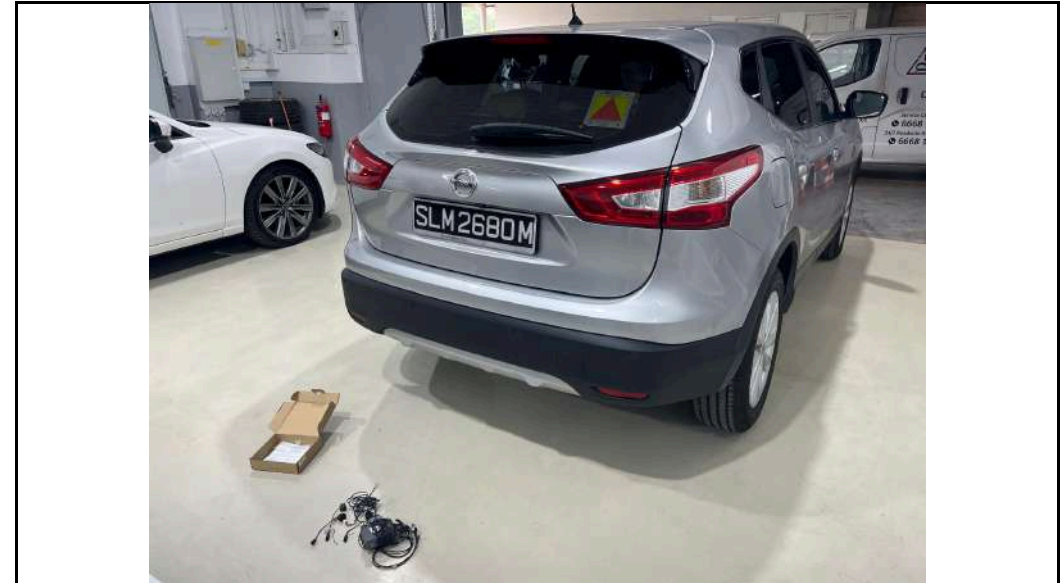
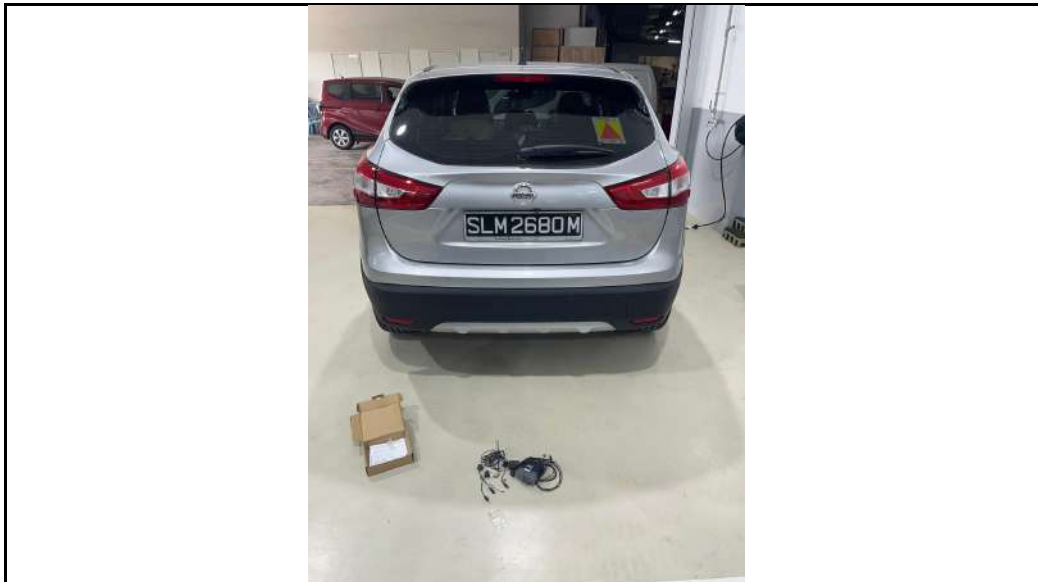
**PHOTOGRAPHS FOR VEHICLE NO. : SLM 2680M**

| REPLACEMENT OF PARTS | | | | |
|---|---|---|---|---|
| 1 | BUMPER REAR | DEFORMED | \$946.50 | \$755.00 |
| 1 | SENSOR REAR (SET) | SHORTED | \$250.00 | \$250.00 |
| 1 | TOW EYE COVER REAR RH | CUT | \$43.10 | \$43.10 |

| Labour | | | | |
|---|---|---|---|---|
| | TO REMOVE & REPLACE BUMPER REAR & ALL ACCIDENT DAMAGE BODY PARTS & ALL AREAS AFFECTED BY THE ACCIDENT. | | \$250.00 | \$200.00 |
| | TO SPRAY BUMPER REAR. | | \$250.00 | \$200.00 |
| | TO CHECK ELECTRICAL SYSTEM FOR PROPER FUNCTIONING. | | \$100.00 | \$30.00 |
| | TO TRANSFER ALL BUMPER REAR SENSOR. | | \$200.00 | \$30.00 |

| | RECOMMENDED COST OF LUMP SUM REPAIRS<br>(TO ITS PRE-ACCIDENT CONDITION) | | \$1,150.00 |
