**LKK Auto Consultants Pte Ltd**

## ADJUSTMENT ON REPAIR COST FOR VEHICLE NO SHD 3415B

**PHOTOGRAPHS FOR VEHICLE NO. : SHD 3415B**

REINSPECTION PHOTOS (Page 1 of 1)

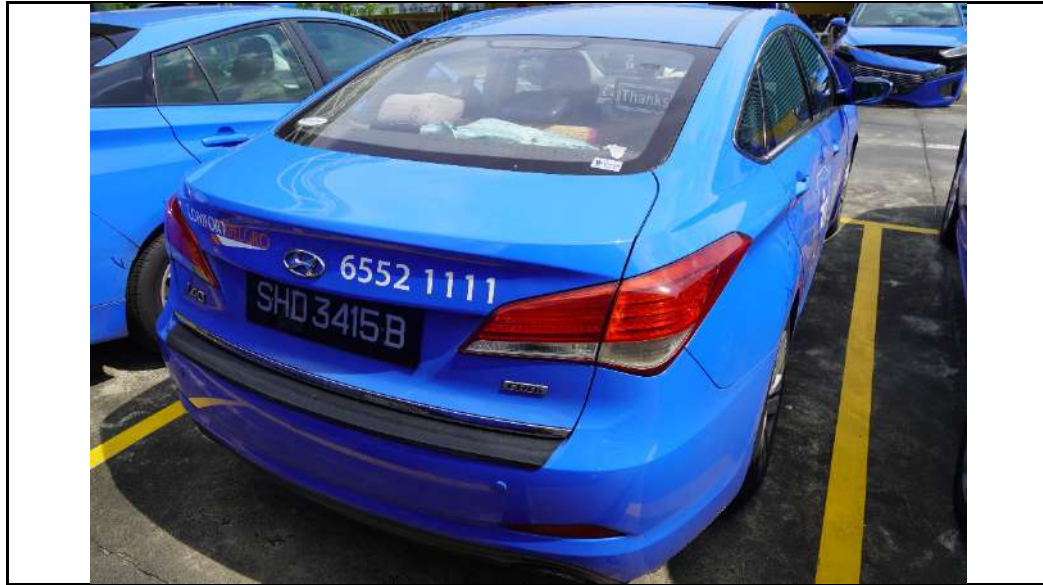
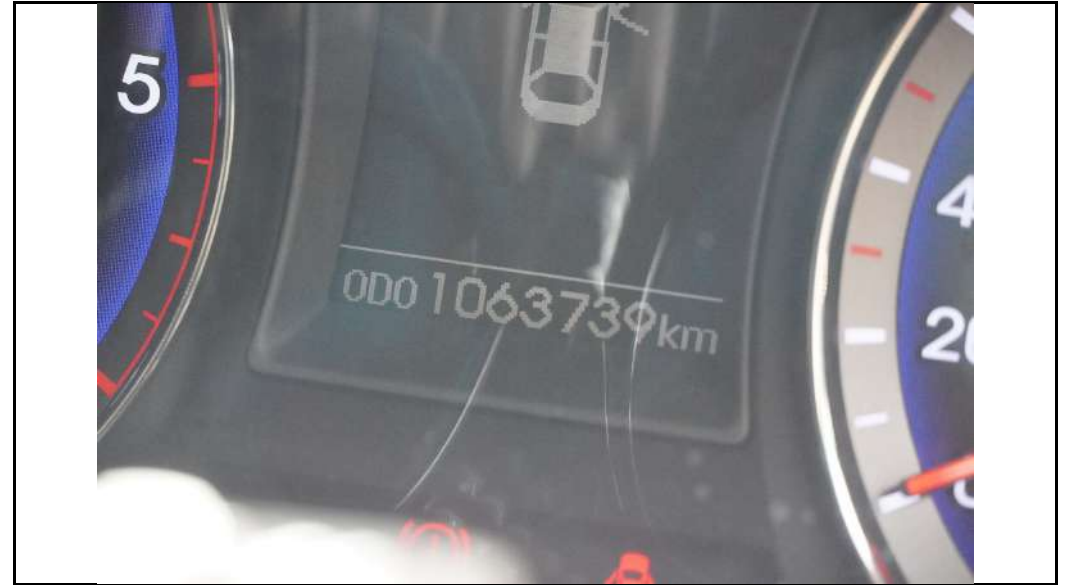
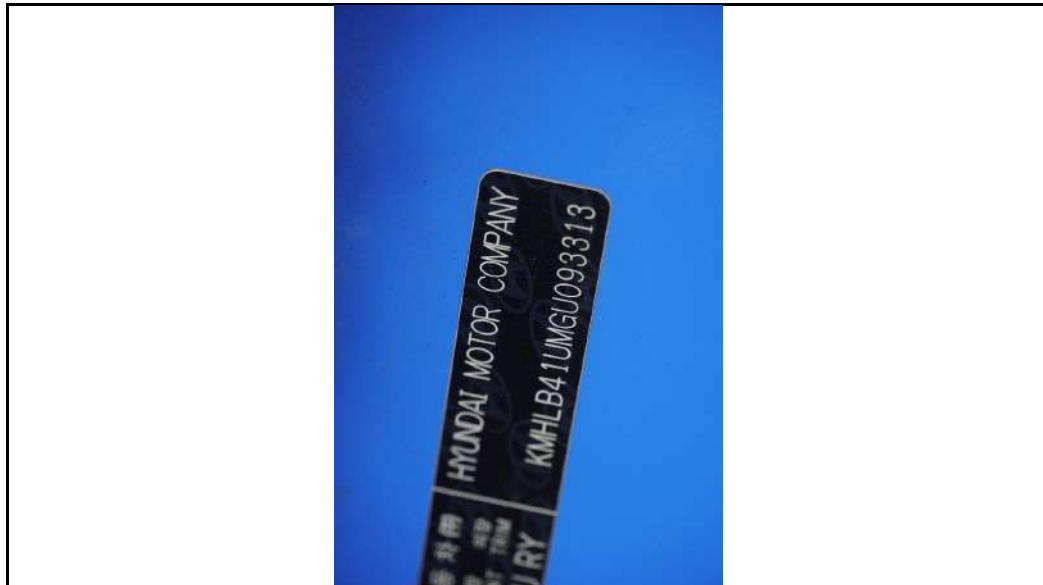
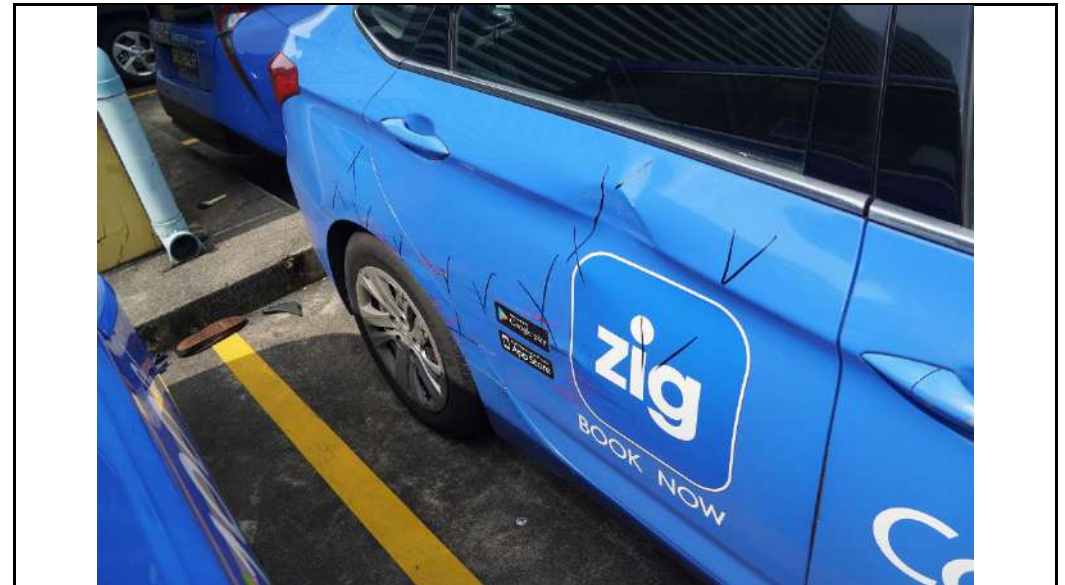
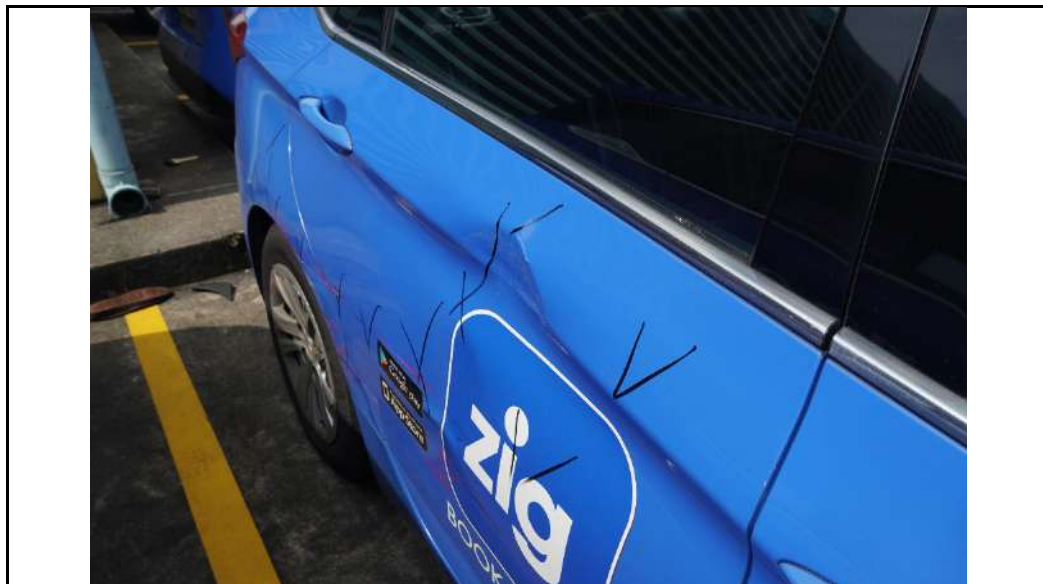
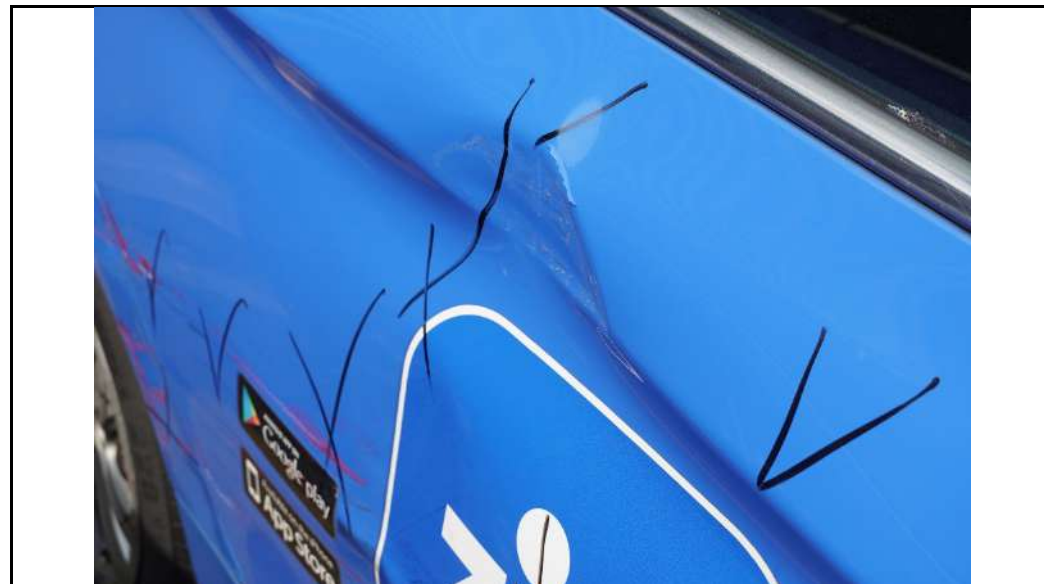
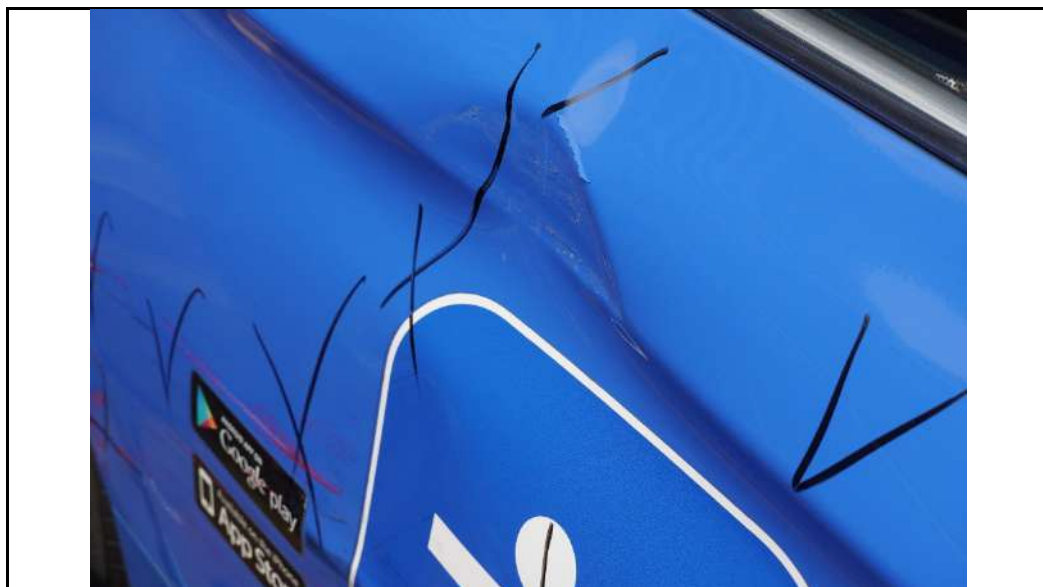
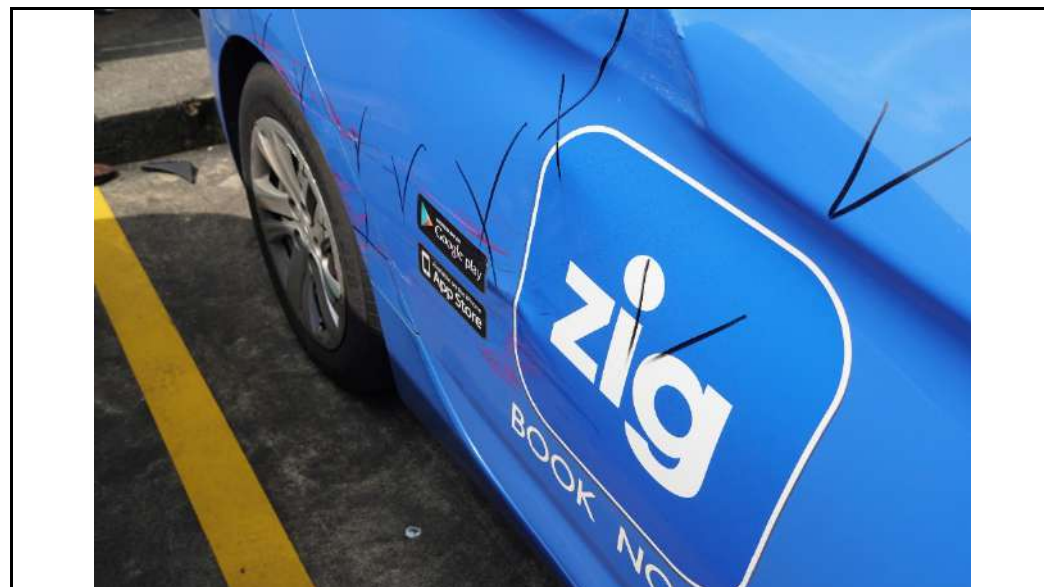
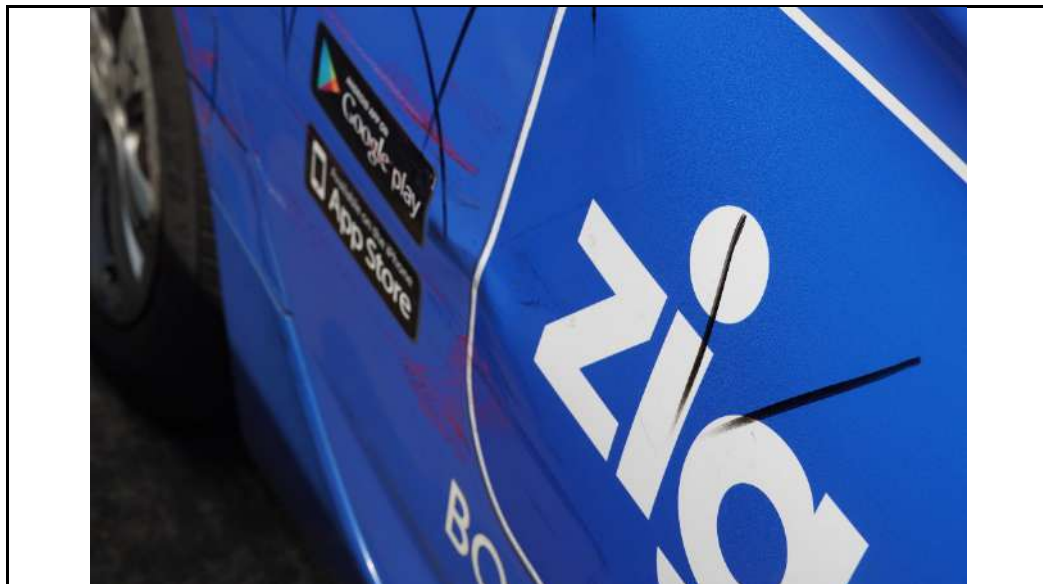
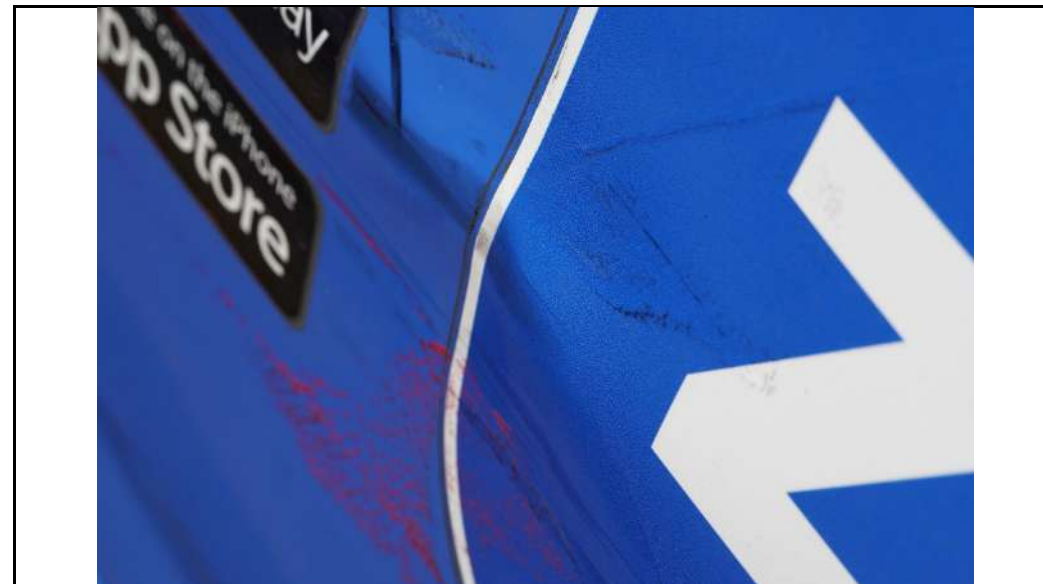
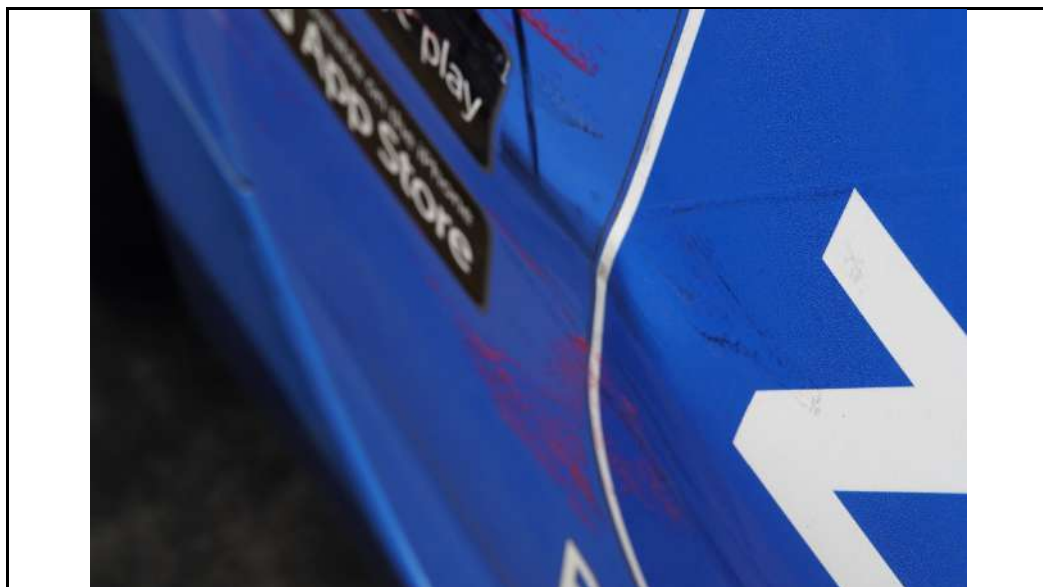
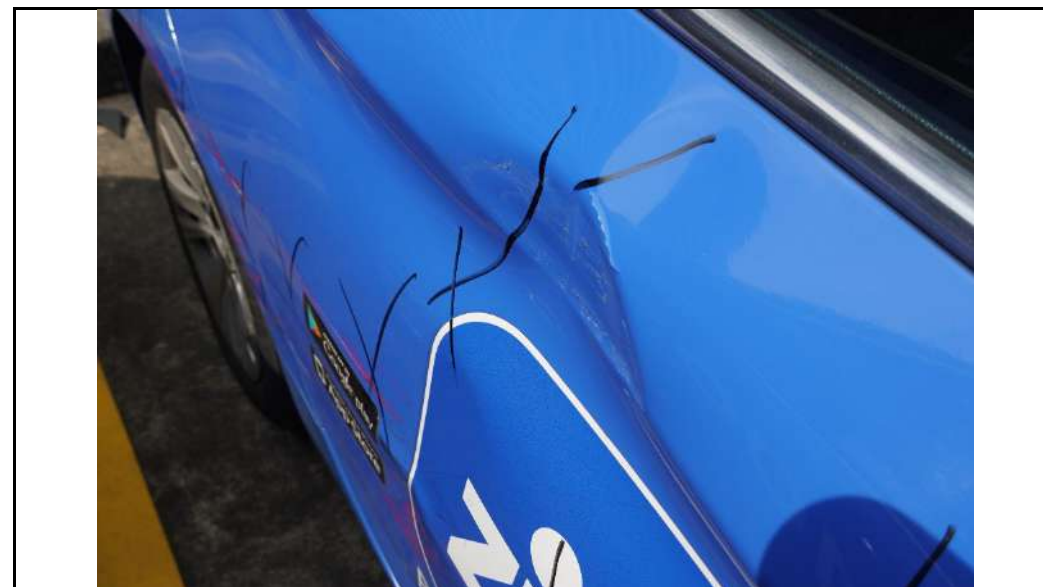
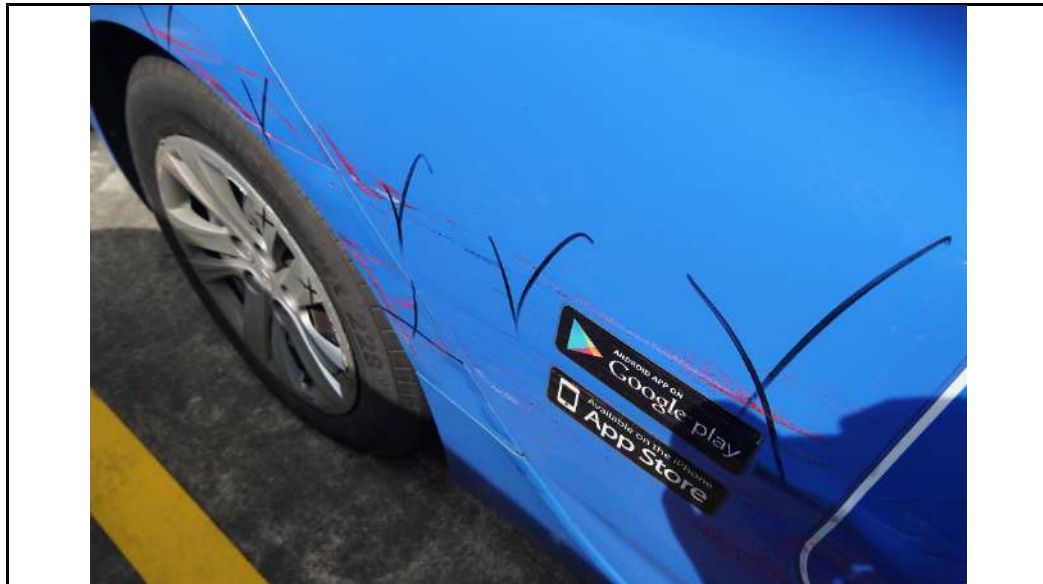
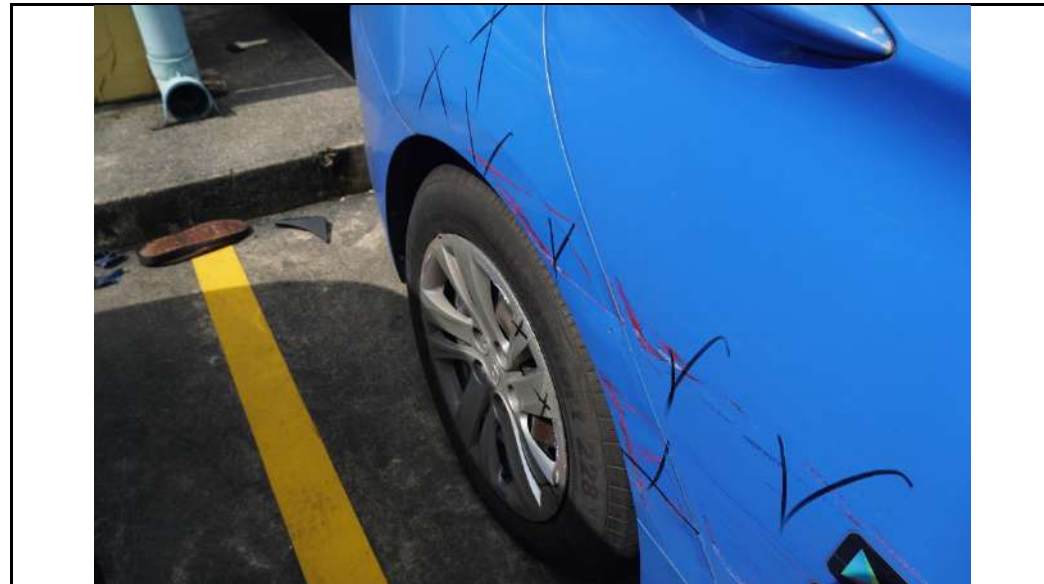
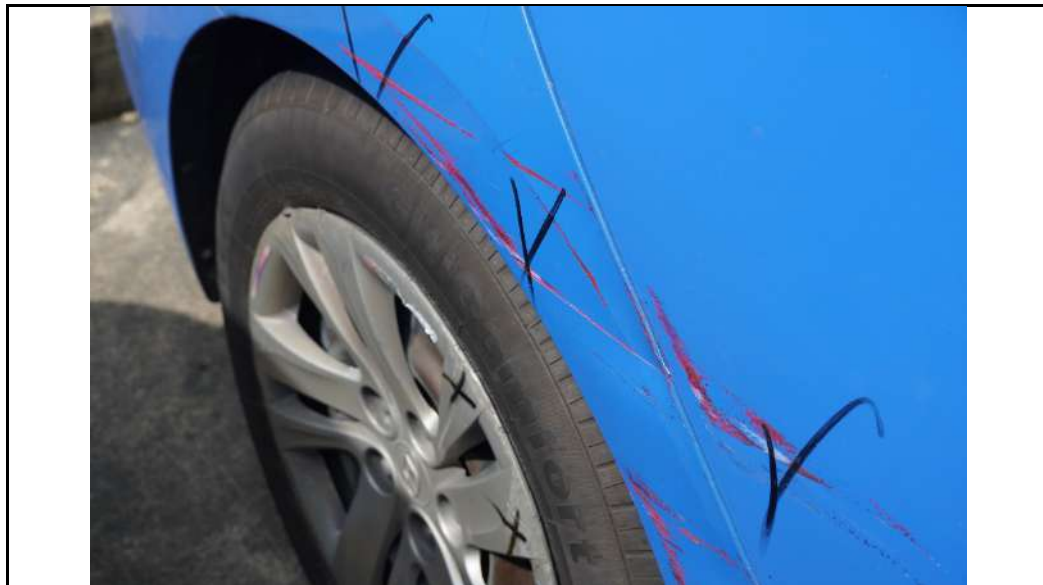
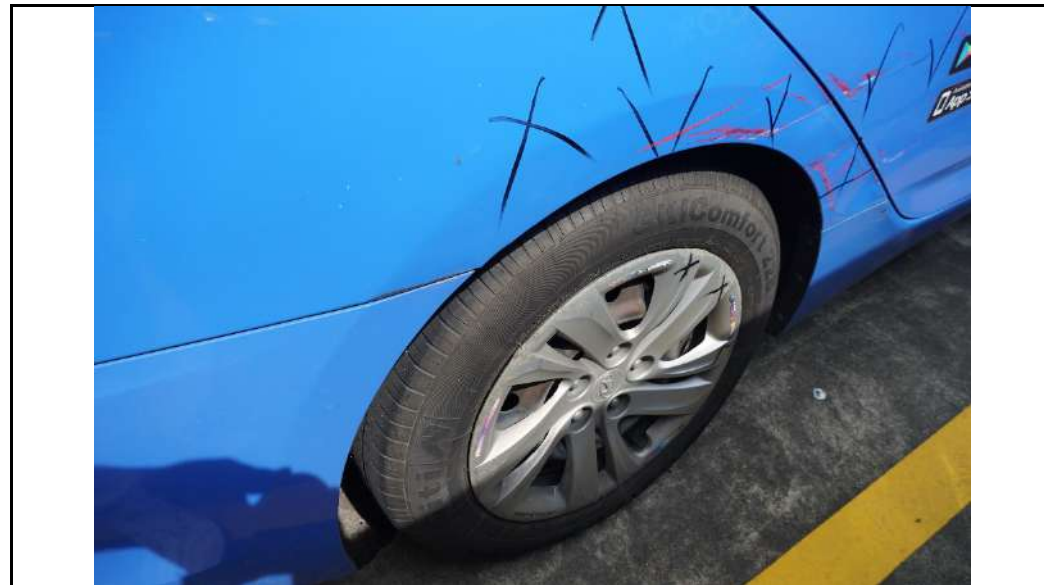
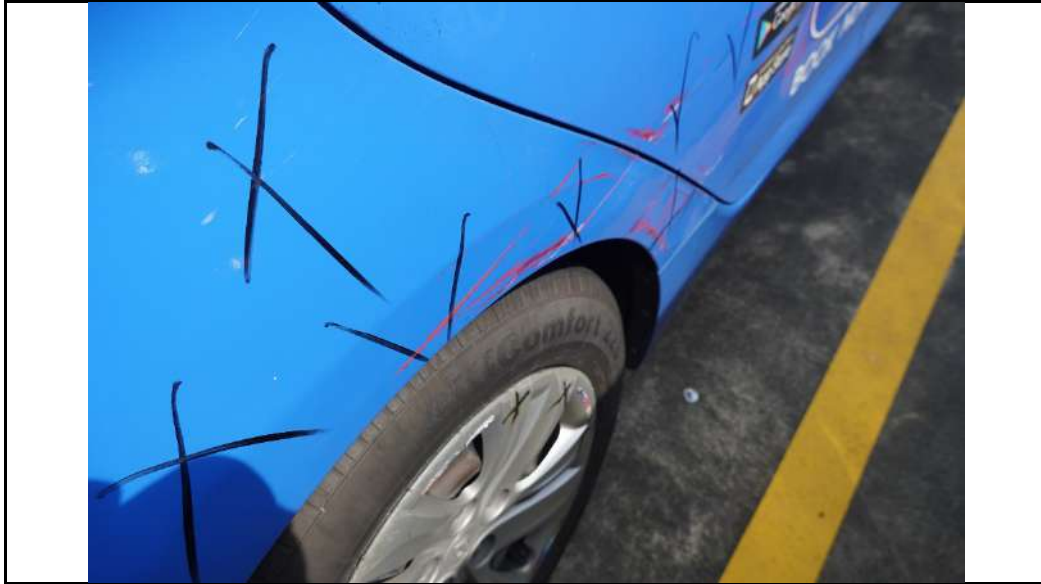
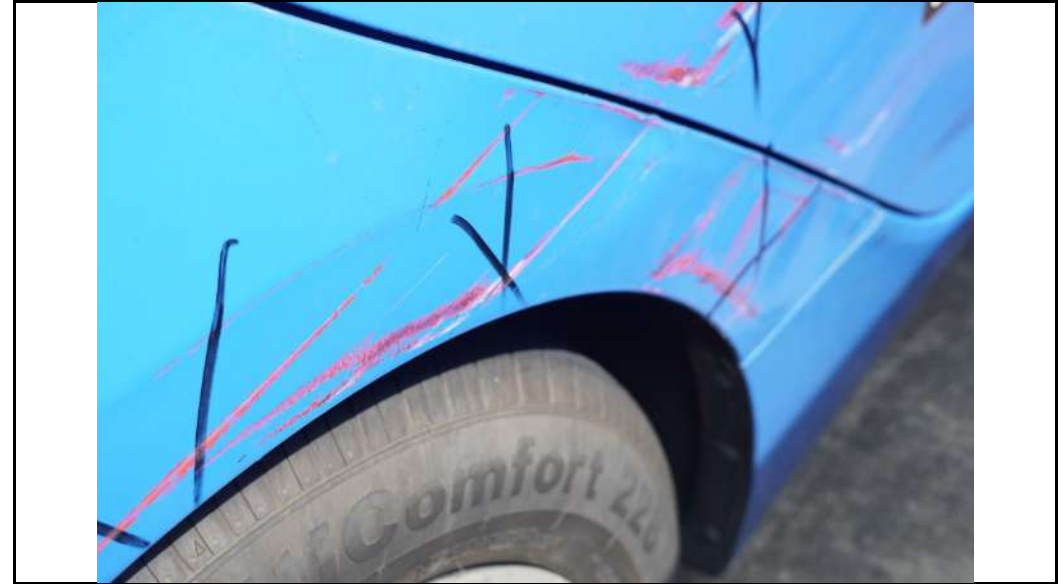
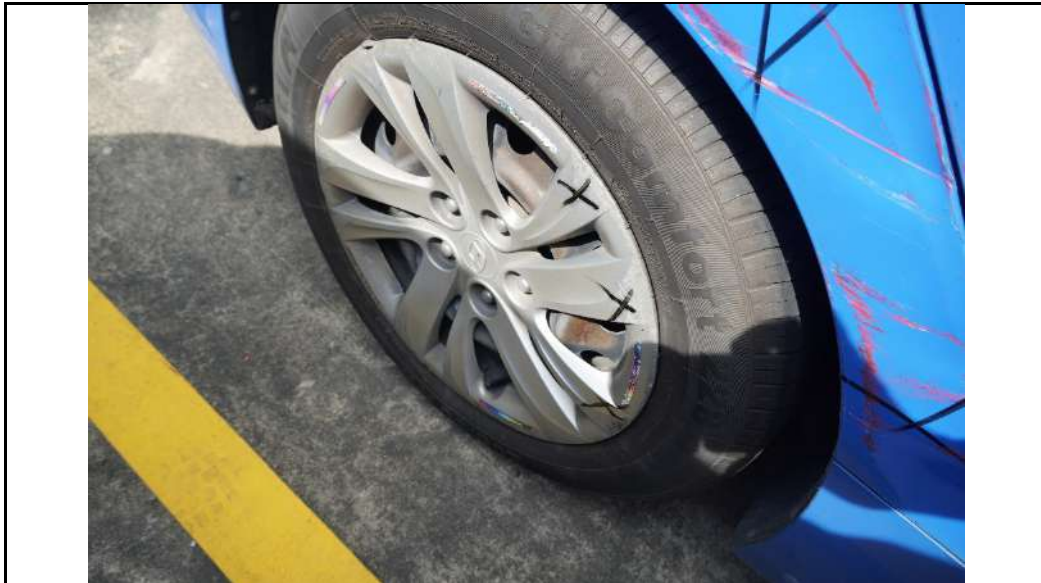
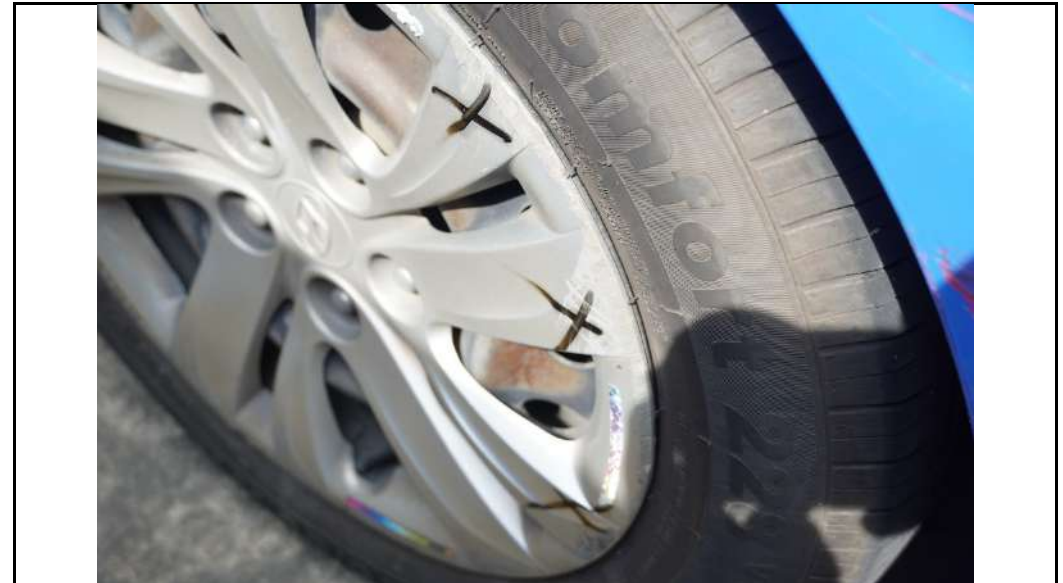
THE VEHICLE SUSTAINED DAMAGES AT THE O/S BODY.

| REPLACEMENT OF PARTS | | | | |
|---|---|---|---|---|
| 1 | REAR DOOR RH | DENTED | \$2,416.80 | \$2,416.80 |
| | PANEL BEATING-REAR FENDER ARCH RH ETC | NOT NECESSARY | \$700.00 | \$300.00 |
| | SPRAY PAINTING-ROCKER PANEL RH ETC | | \$900.00 | \$560.00 |

| REPLACEMENT OF PARTS | | | | |
|---|---|---|---|---|
| | RECOMMENDED COST OF LUMP SUM REPAIRS<br>(TO ITS PRE-ACCIDENT CONDITION) | | | \$2,300.00 |

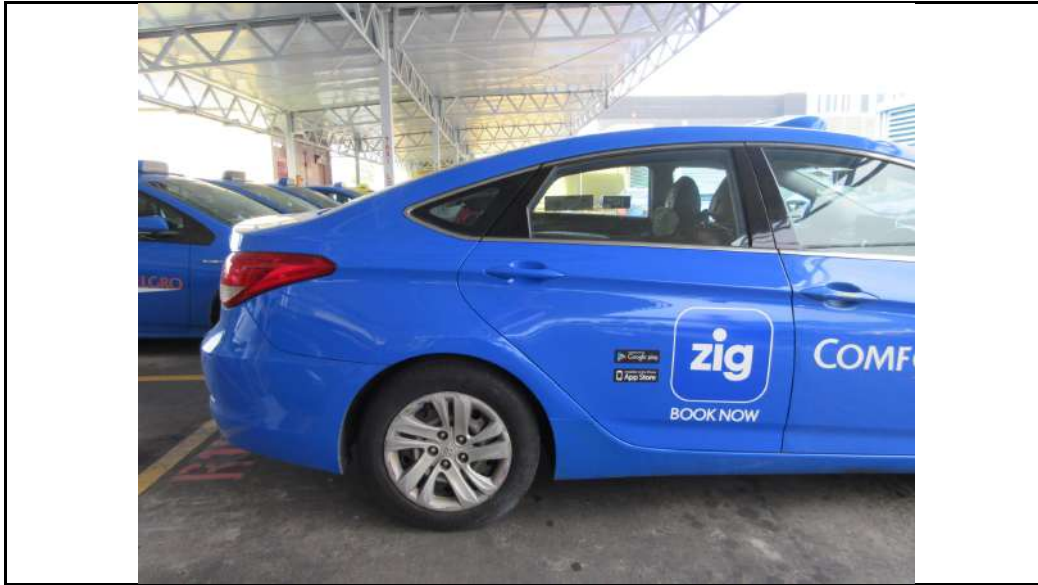
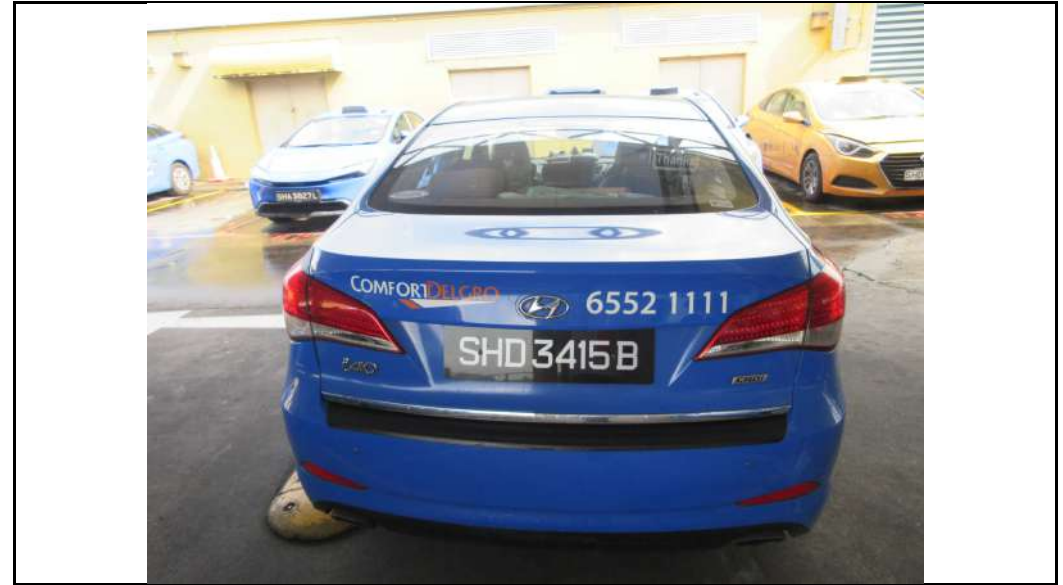
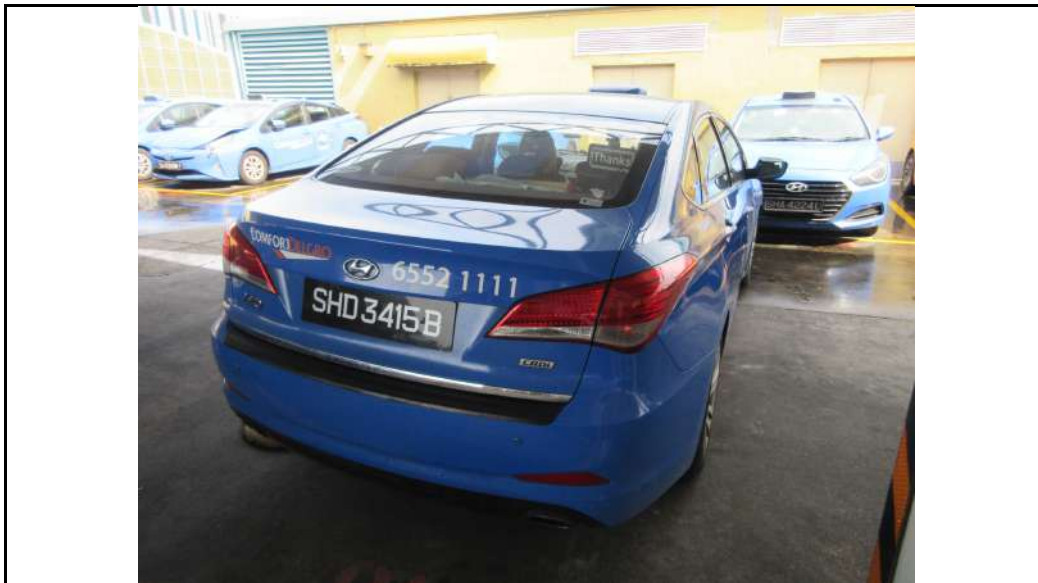
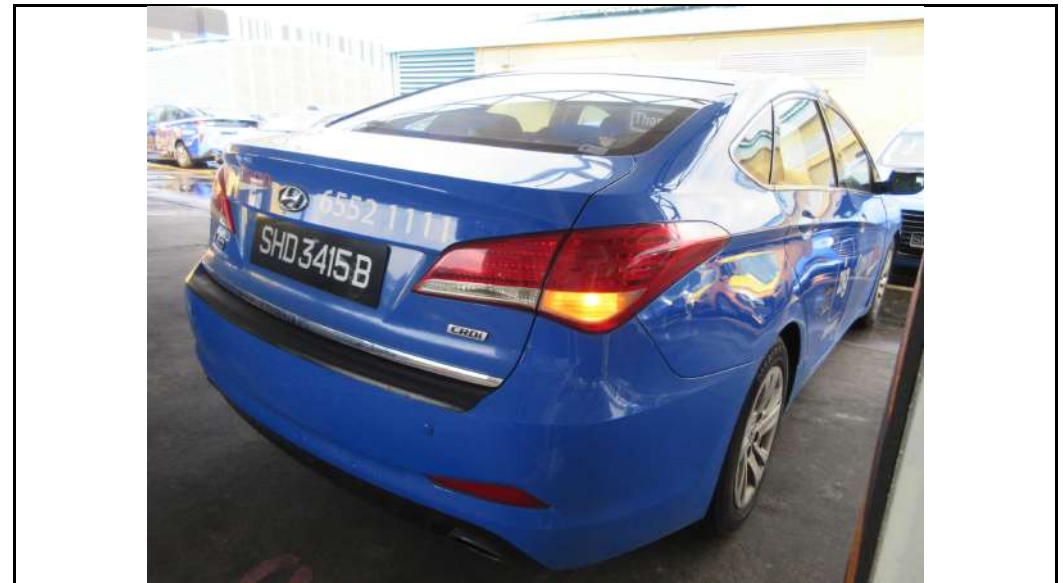
### PHOTOGRAPHS FOR VEHICLE NO. : SHD 3415B

DAMAGES SEE DETAILS.
