Vehicle No. SJZ 1951T Insured Veh. SMB 1408L

4.		Description	of Damages	
ΗE	VEHICLE SUSTAIN	ED DAMAGES AT THE REAR PORTIC	ON.	
DΑN	MAGES SEE DETAIL	S.		
5.		General Ir	nformation	
	Accident Date	27/07/2024	Inspection Date	01/08/2024
	Survey held at	LEONG AUTO PTE LTD - 160 SIN MI 575722	NG DRIVE #02-13 \$	SIN MING AUTOCITY SINGAPORE
5a.		Rem	arks	
		AS CONDUCTED ON A"WITHOUT PR) YOUR INSTRUCTIONS, WE HAVE N		REPAIRS.
5b.		Fatimata Da	ys of Repair

ADJUSTMENT ON REPAIR COST FOR VEHICLE NO SJZ 1951T

INSPECTION PHOTOS (Page 1 of 5)

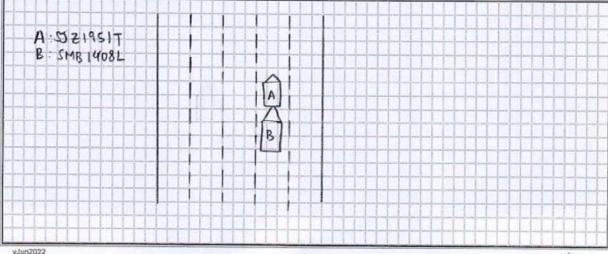
Sketch Plan

Describe Circumstance of the Accident	
Pefer Topolice Report.	
Leter (0) Lebers	
Declaration	
I/We declare the foregoing particulars are true in every respect.	
Do dal must be	
(lo 29/07/24 14:45. My 21/04/24 14:45	
(Policyholder's Signature / Date & Time Actual Driver's Signature (if driver is not the policyholder) / Date & Time	Witnessed by Reporting Centre Personnel (Name as in NRIC/ID card)
