OD/TP Re-inspection / Evaluation 'SJE'

To Inspect Vehicle No: GBC 2743L Insured: SKF50609

1. Policy Particulars :- THIRD PARTY CLAIM (RESURVEY INSPECTION)

ADJUSTMENT ON REPAIR COST FOR VEHICLE NO. GBC 2743L

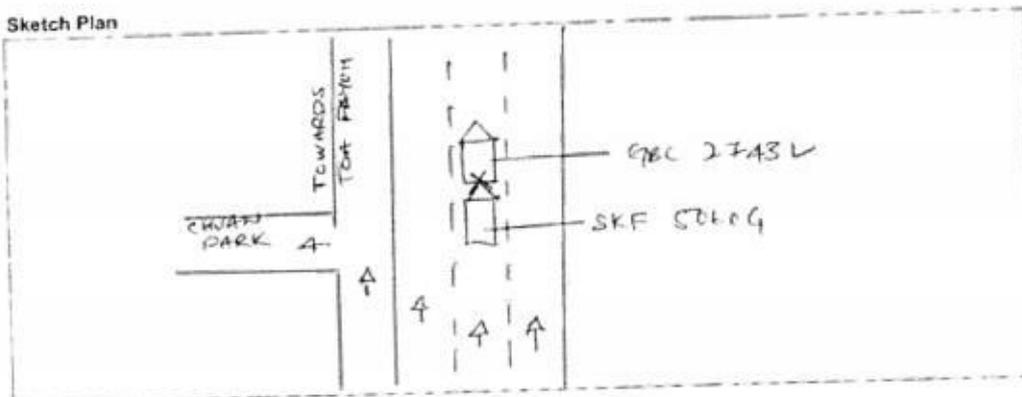
Sketch Plan

A long driver was a driver man, he told us why he suddenly stop because besides his long a car suddenly ~~see~~ changed into his lane, so he was brake. After the accident, we sighted and ask the long driver why he stop suddenly and asked him did he saw the number plate of the car that changed lane into his lane but he said he didn't see it. After that we asked him like this is his fault and not our, so the driver claim that it is his fault to brake suddenly and caused this accident.

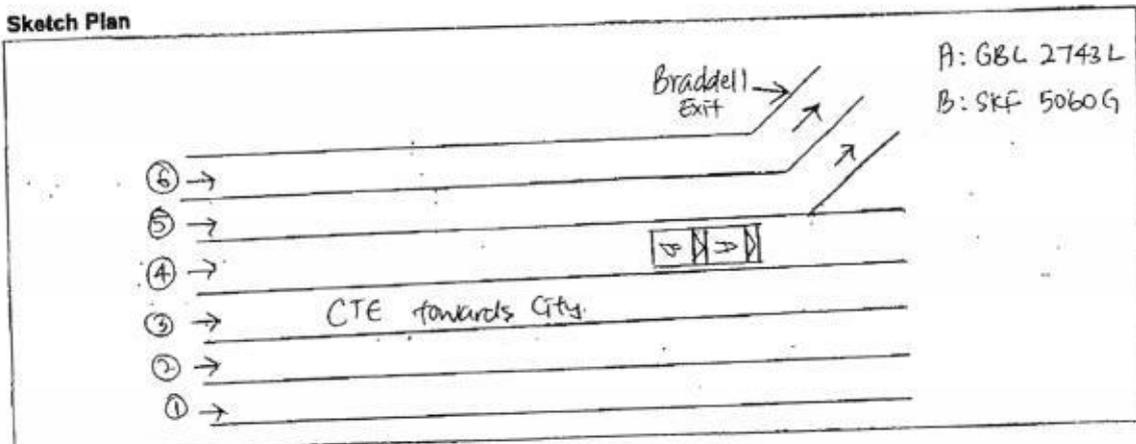
Sketch Plan

I was travelling along CTE towards City before Braddell Exit on lane 4. Due to the heavy traffic, I slow down to stop (stationary). Suddenly, vehicle B hit onto my rear portion.
