# LKK Auto Consultants Pte Ltd

**Preliminary Advice**

**ASSESSMENT FOR REPAIR : FBL 6952 B**

## VEHICLE DAMAGE INSPECTION REPORT

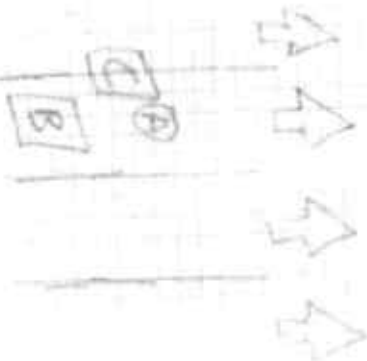
#### Sketch Plan

Along Road 2  
Tampines Expressway  
Towards Padi Ris  
after Lor Hatus exit

A - F6L615.0  
B - D7287M  
C - J2317X
